Restoration of a Flood-Damaged Pocket Watch

Shaun Clarke

NAWCC San Jacinto Chapter 139

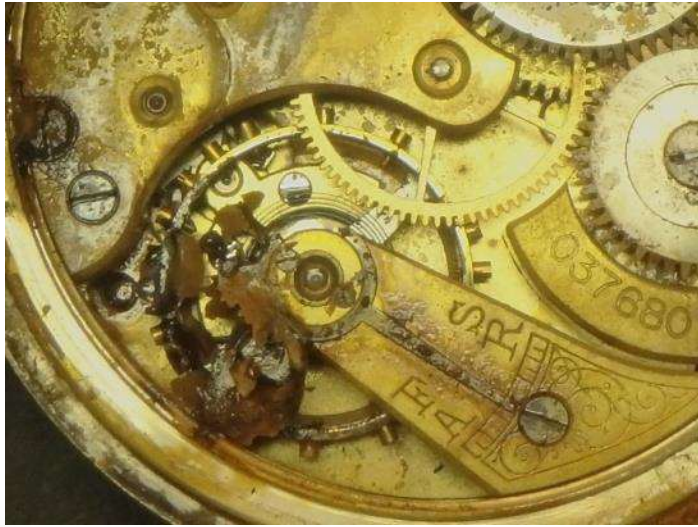
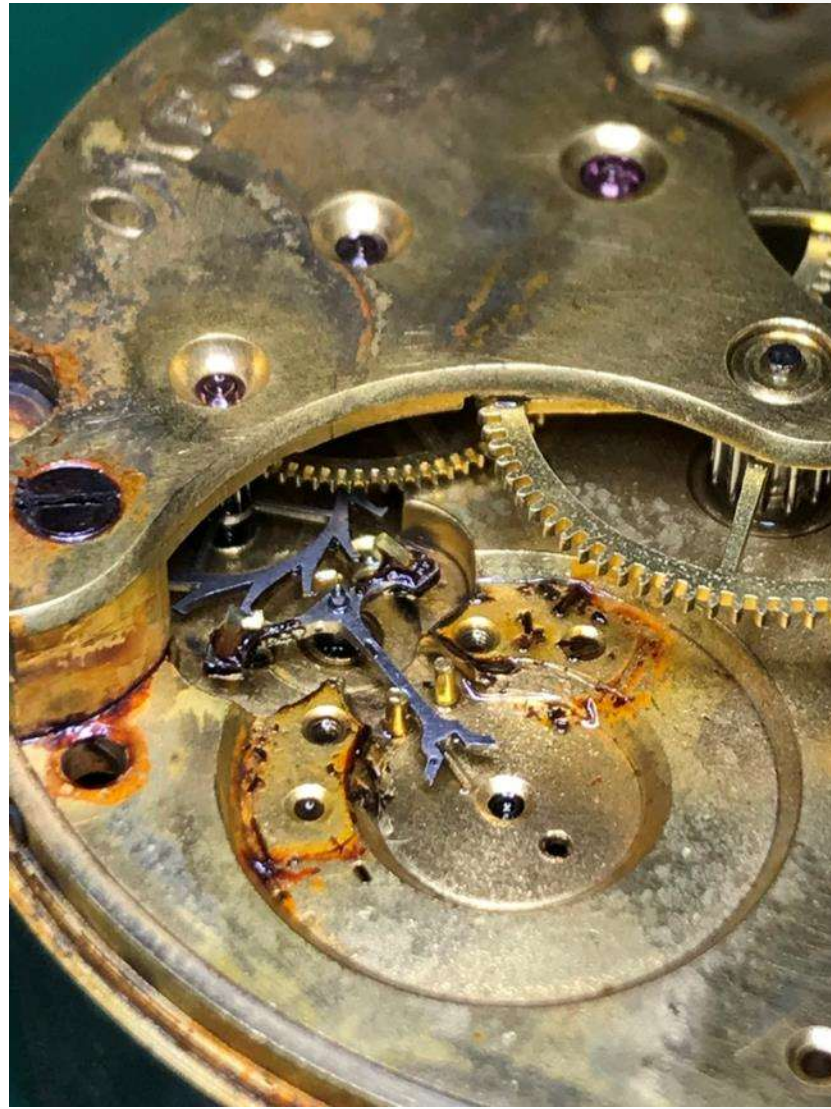
- An attempt was made to remove the balance assembly but unfortunately the hairspring had sustained extensive rust damage and broke almost immediately
- The balance cock, balance assembly and case were separately soaked in Naphtha

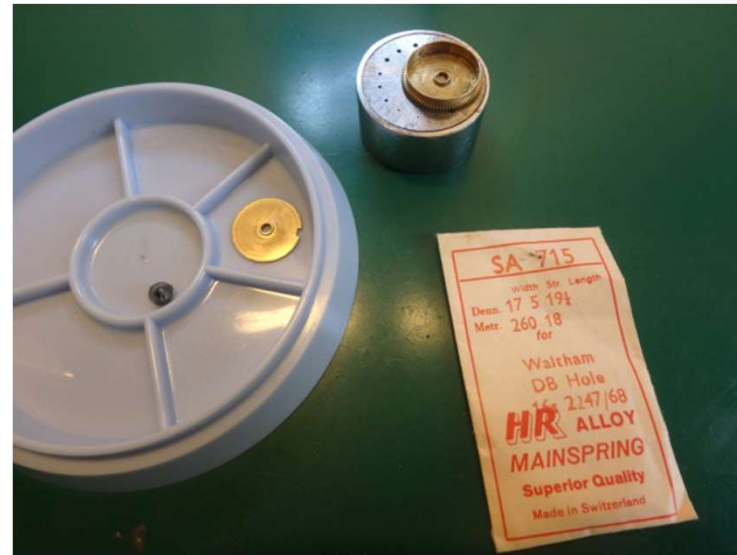
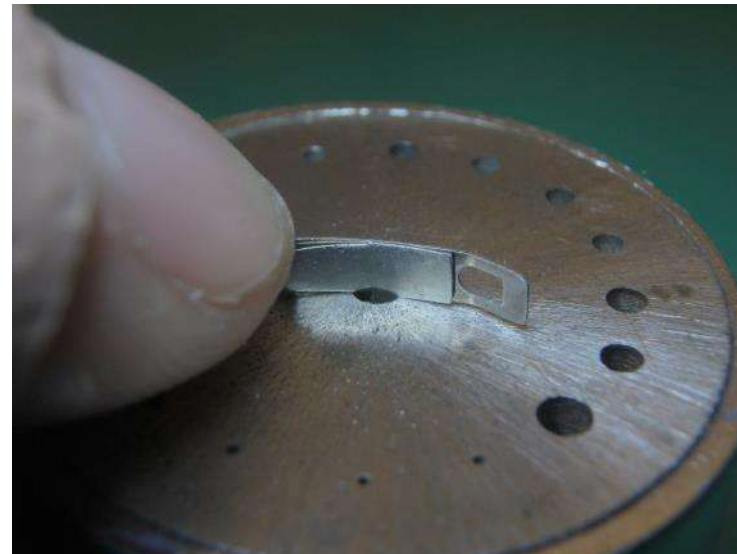
- The mainspring appeared to be an incorrect length and somewhat set, so the decision was made to replace it.
- A replacement was not immediately available so options for a replacement were investigated. The following information was established:

- This data was compared with mainspring tables and matched to an alloy **16s Waltham #2247 mainspring** (2.60mm wide, 0.18mm thick, 535mm/21 inches long).
- The end style on the original Omega mainspring was Hole End, but the replacement Waltham mainspring was Double Brace and Hole End
- The protruding double brace tang was removed by file before the mainspring was cleaned, greased and installed in the mainspring barrel.

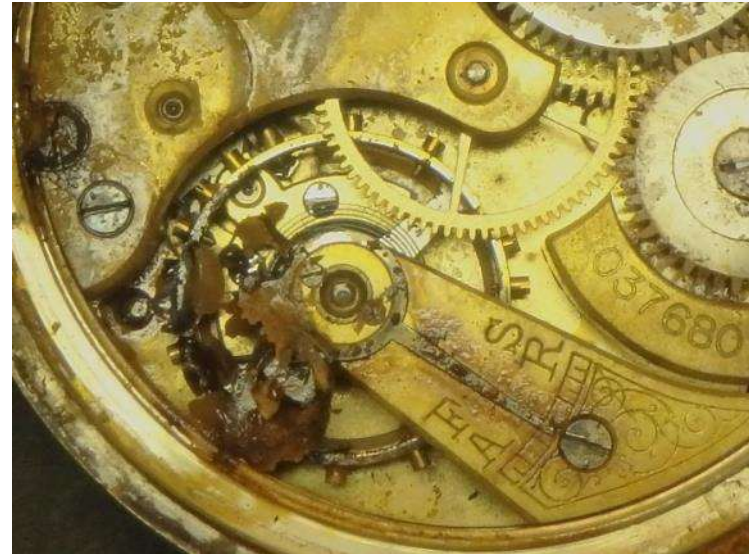
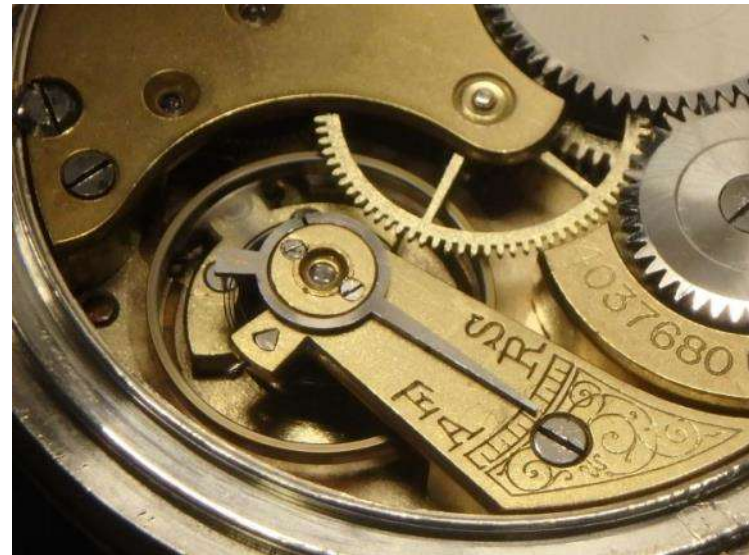
- The perimeter of the original balance wheel was encrusted with a hardened residue and the hairspring broke during the disassembly process.
- The decision was made to completely replace the balance assembly with the assembly recovered from the donor movement.
- The size and clearance of the roller jewel in the pallet fork was checked.
- The balance staff pivots were polished and shaped to fit the original movement upper and lower balance jewels.
- The hairspring was adjusted to correctly fit the regulator pins.

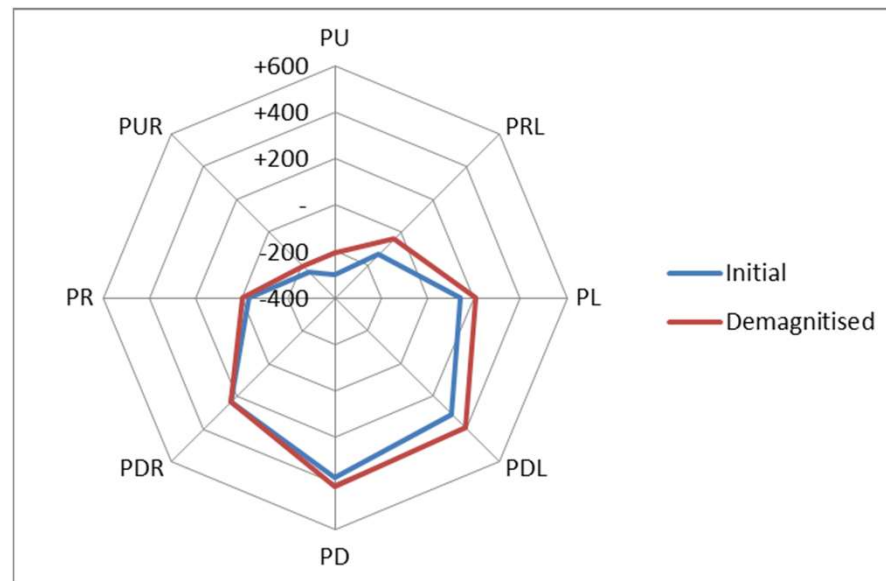
- The balance had good amplitude in all positions. The initial DU (dial up) and DD (dial down) were close; DD +12 and DD +6 but there was discrepancies in the vertical positions.
- Weight was added to the balance timing screw close to the PU (pendent up). The process was repeated, with weight being added until there was consistency in the vertical positions.
- The movement was then regulated and checked on the timing machine in all positons.
