Behind the Scenes at the Watchmakers Bench

Shaun Clarke – August 2017
NAWCC San Jacinto Chapter 139

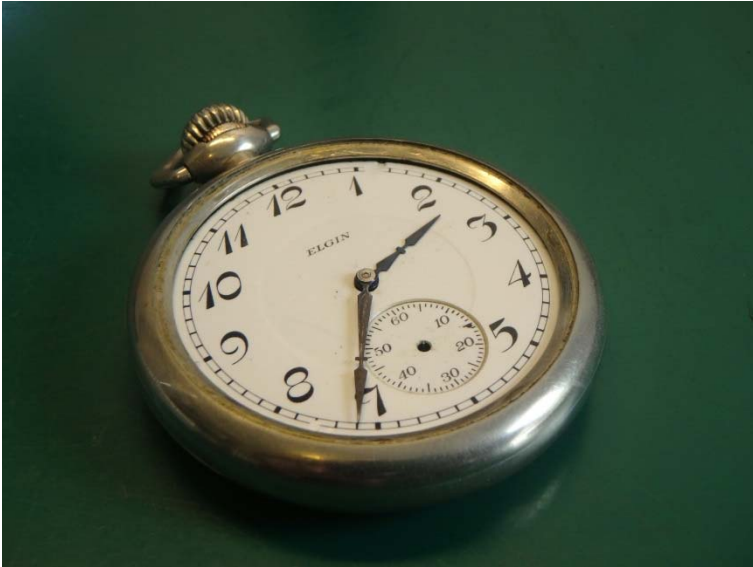
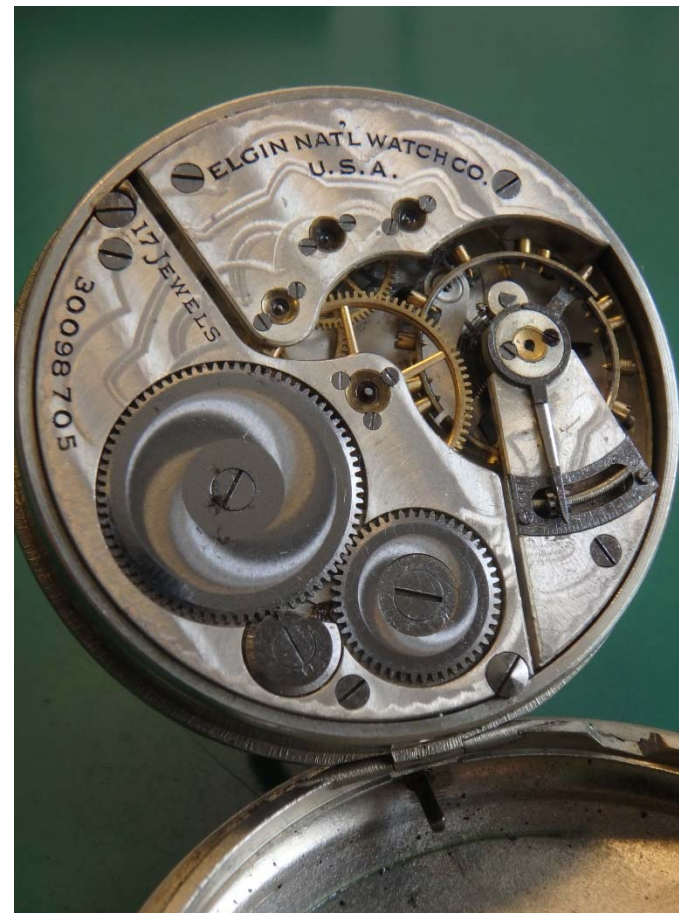
Technical Details

- Grade 387
- Manufactured in 1928
- Star Watch Case Company swing out case

- Elgin, Serial Number #30,098,705
- 17 jewel, 16 size

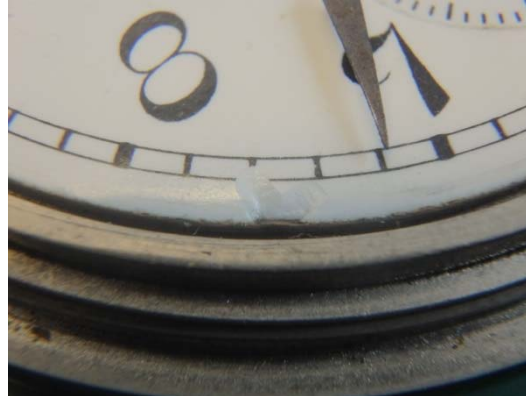
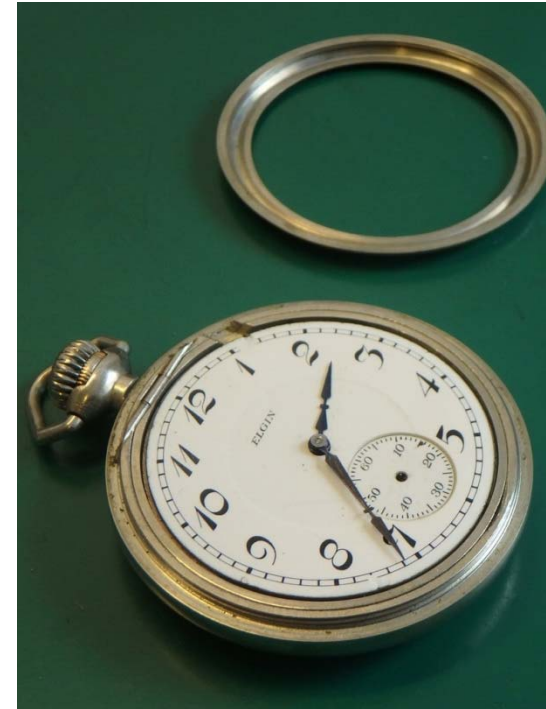
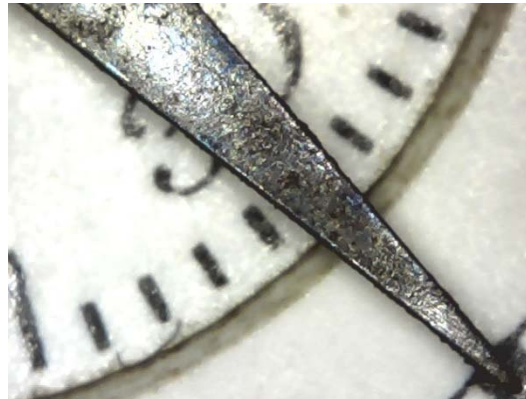
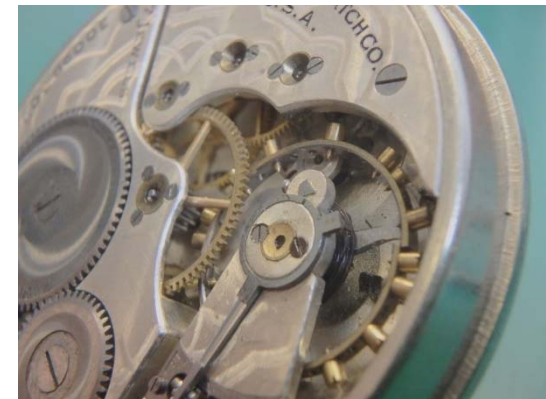
Initial Observations

- Missing crystal
- Missing second hand
- Two chips on dial
- Winding and setting problem
- Broken balance staff
- Hand worn through bluing

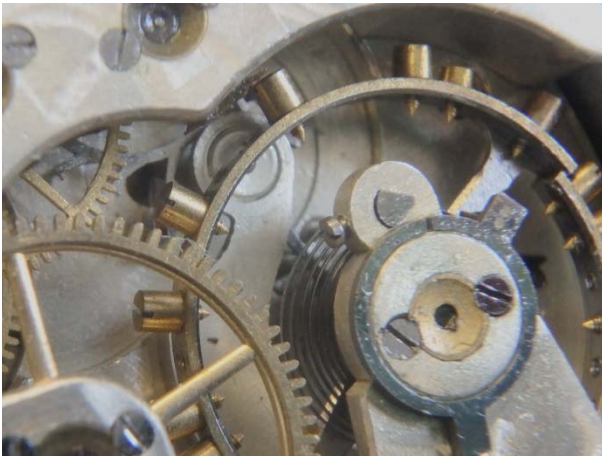
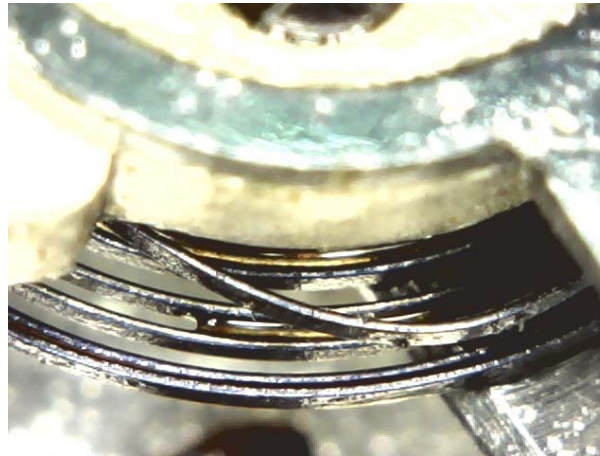
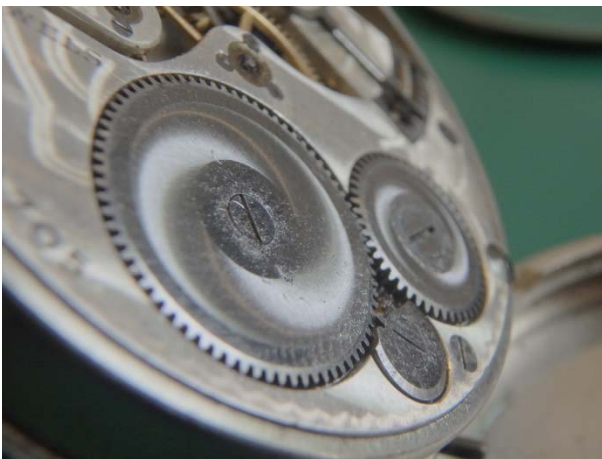
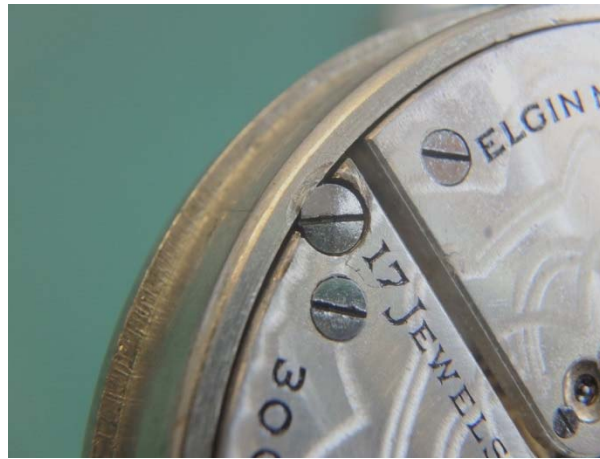
Initial Observations

- No pallet action (damaged roller jewel?)
- Oily and dirty movement
- Hairspring oily and coils sticking together
- One incorrect case screw

- Crystal (needs to be measured)
- Second hand
- Balance Staff (#861, common)
- Possibly mainspring (#817, common)
- Possibly upper balance hole jewel
- Roller jewel (needs to be measured)
- Setting components?

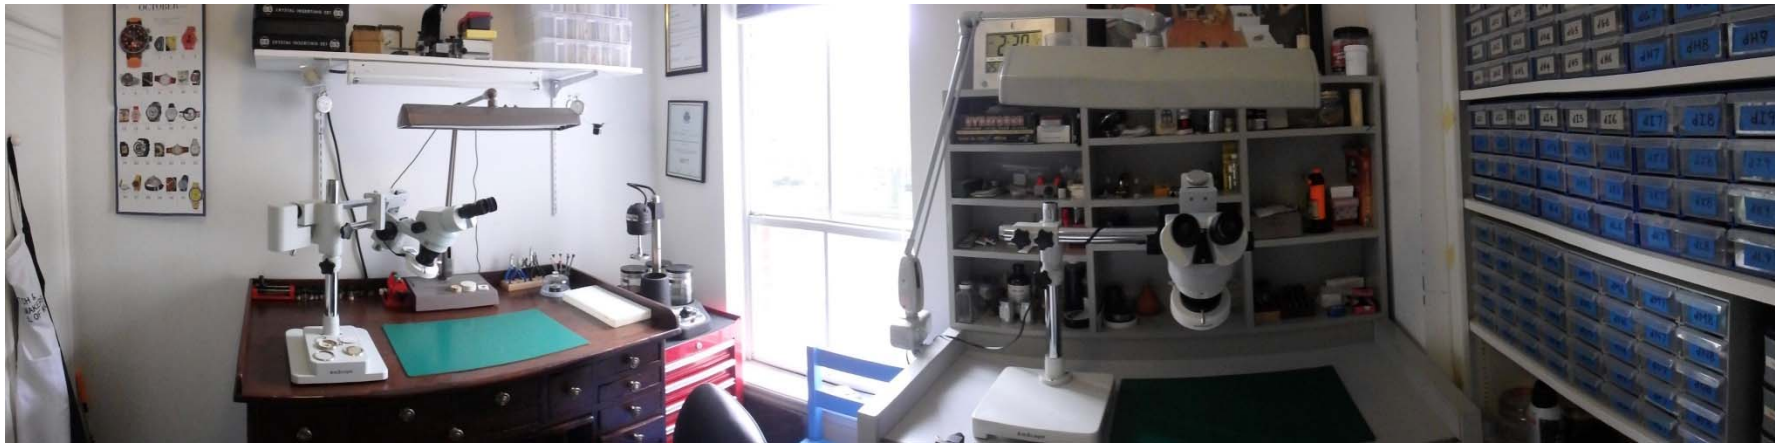
Disassembly & Inspection Workshop Layout

Clean Bench
Post cleaning
inspection and
reassembly

Natural Light

Dirty Bench
Disassembly, initial
inspection, lathe
work

Parts & Spare
Movements

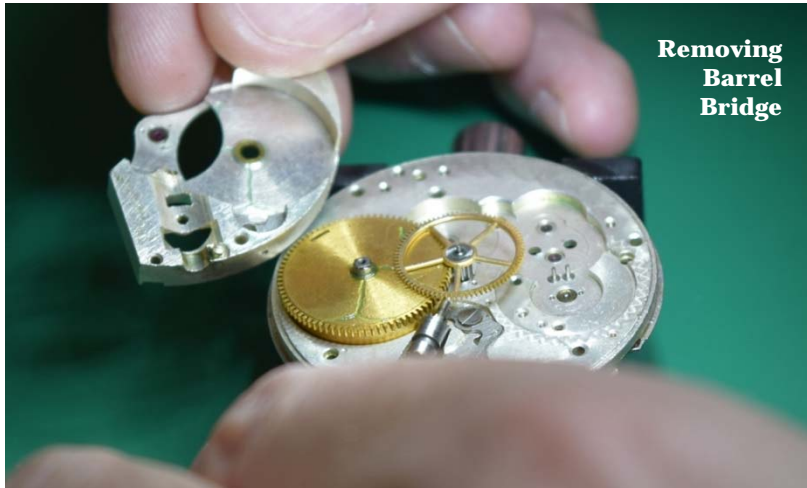
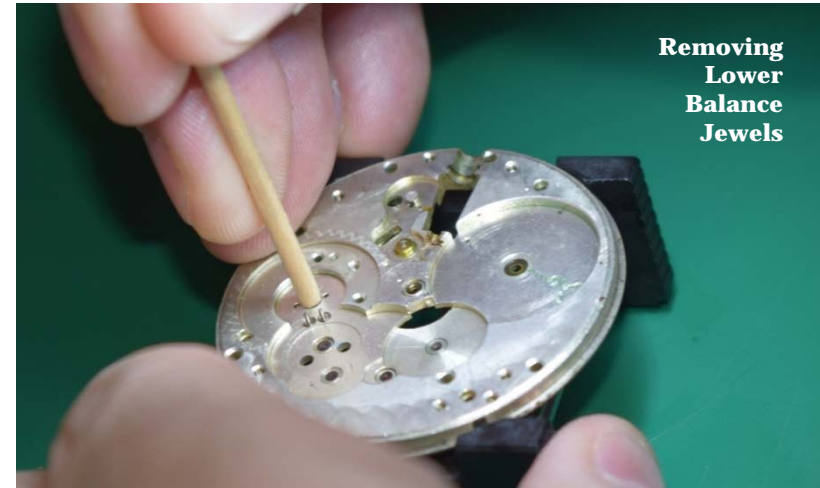
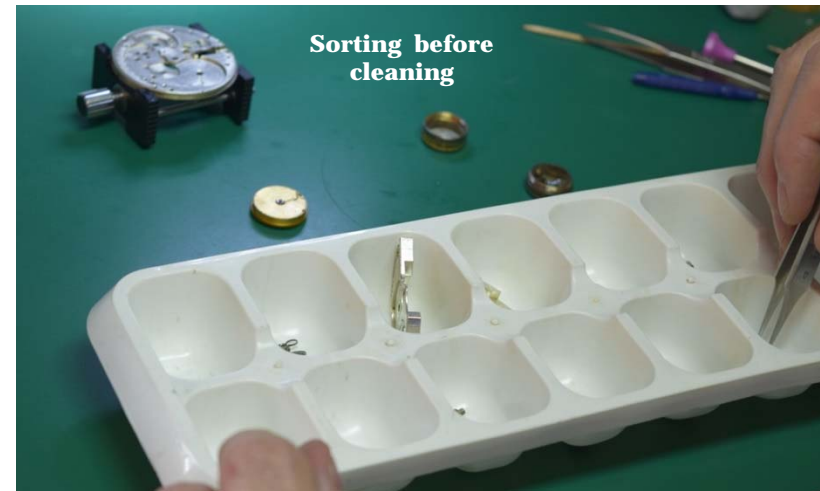
Disassembly Process

- Very oily and dirty, but generally in good condition (no rust)
- Upper pivot worn to nub, lower pivot slightly worn
- Upper pivot broken, jewel cracked
- Roller table jewel is missing
- Mainspring a little set, but good for reuse
- No obvious damage to winding mechanism
- Setting stem is out of alignment

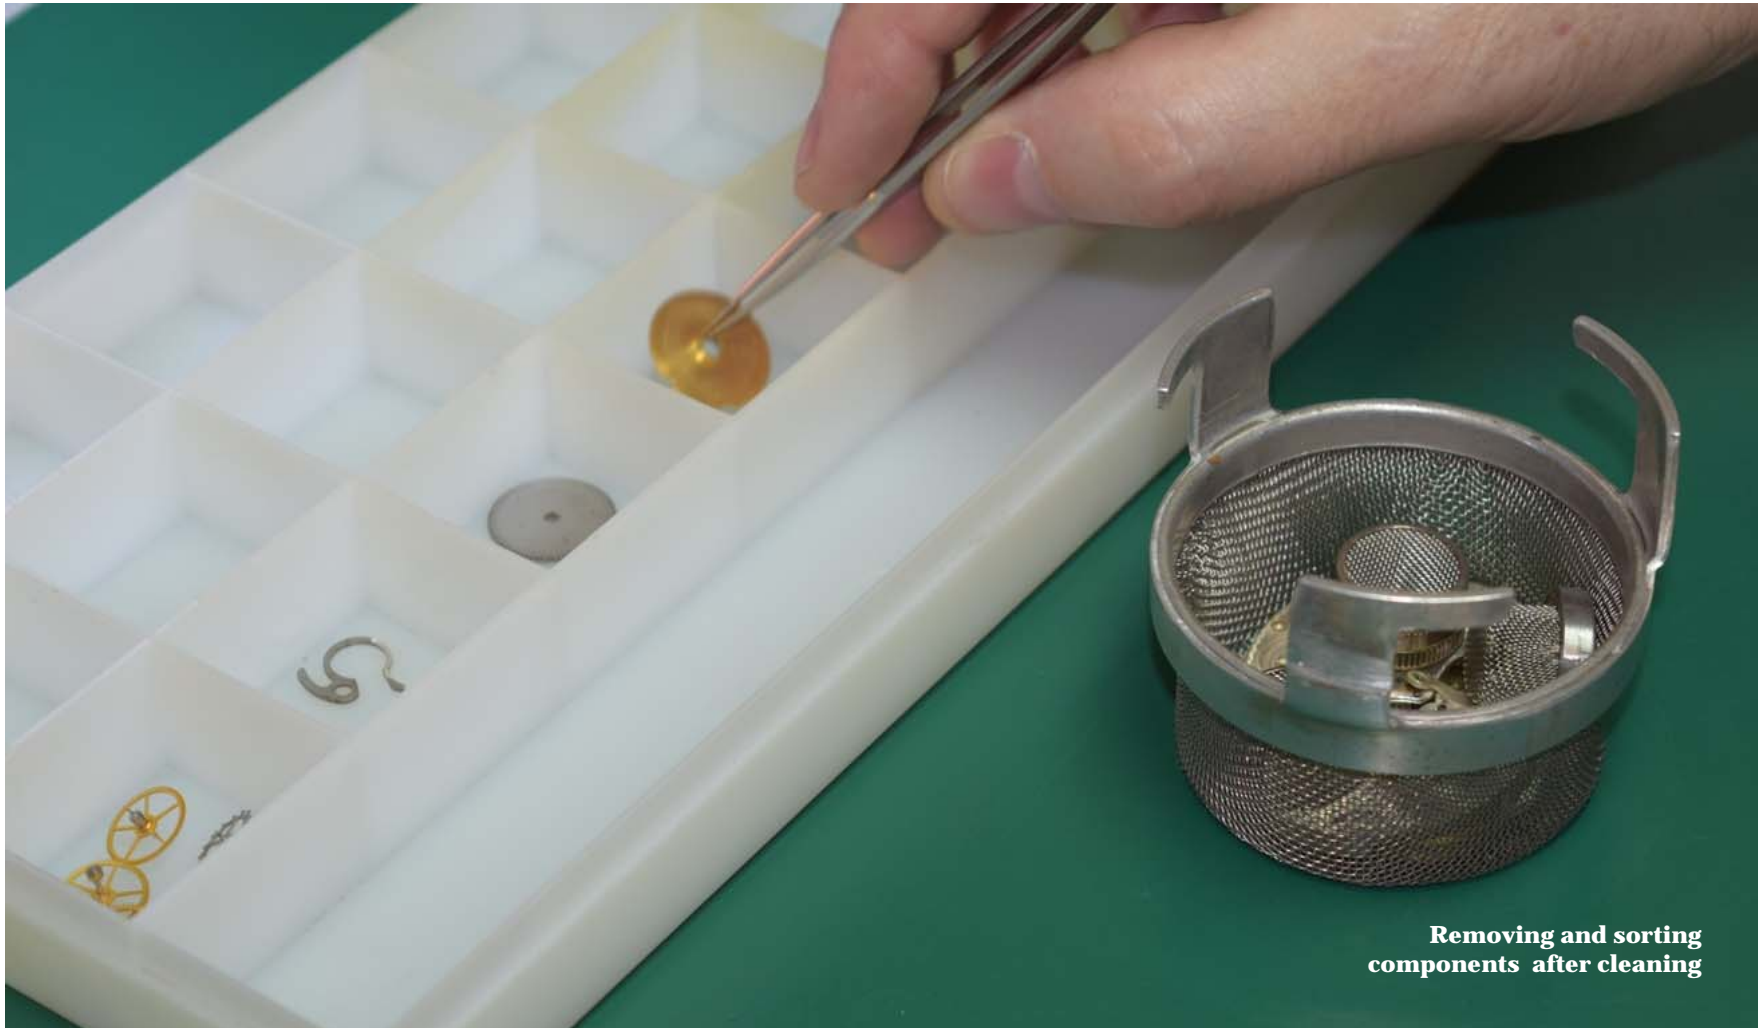
Cleaning

**Removing and sorting
components after cleaning**

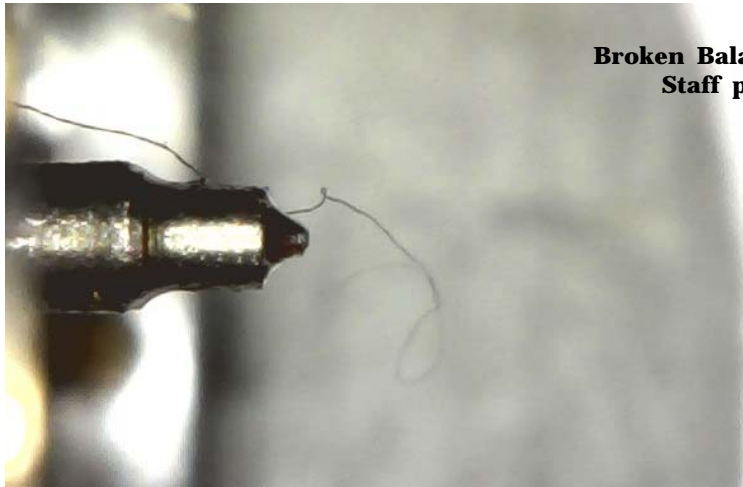
**Broken Balance
Staff pivot**

Replacing the Balance Staff

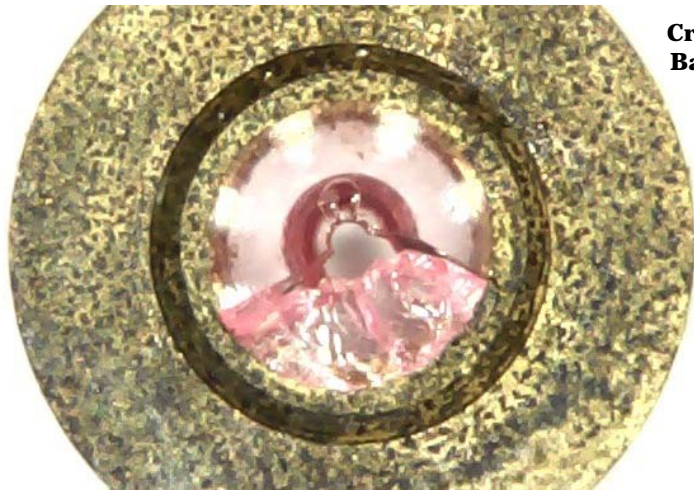
**Cracked
Balance
Jewel**

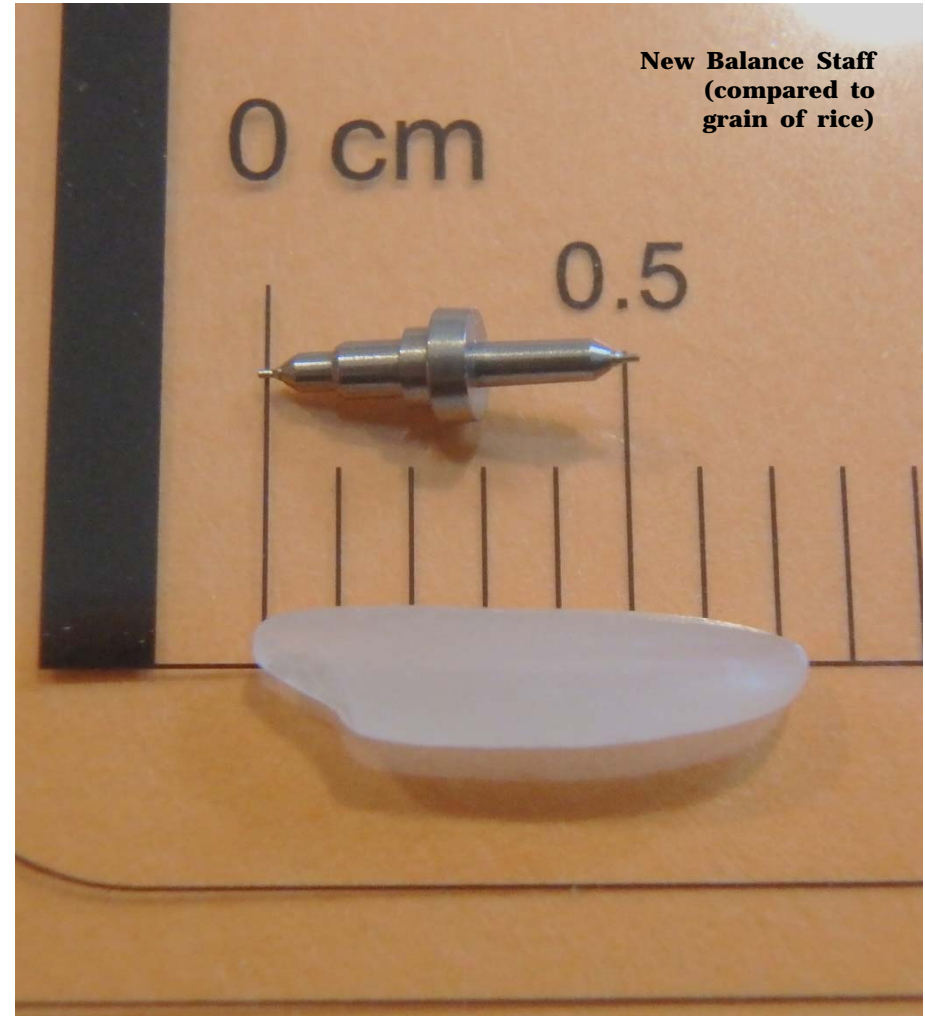
**New Balance Staff
(compared to
grain of rice)**
