E Howard Tower Clock Renovation

Today's Discussion

The subject of this monograph is the smallest sized E Howard time and strike tower clock made. A local collector/dealer purchased it at the 2012 NAWCC Texas regional in Houston. It changed hands to a second party and 3 months later found its way to my shop. The owner asked

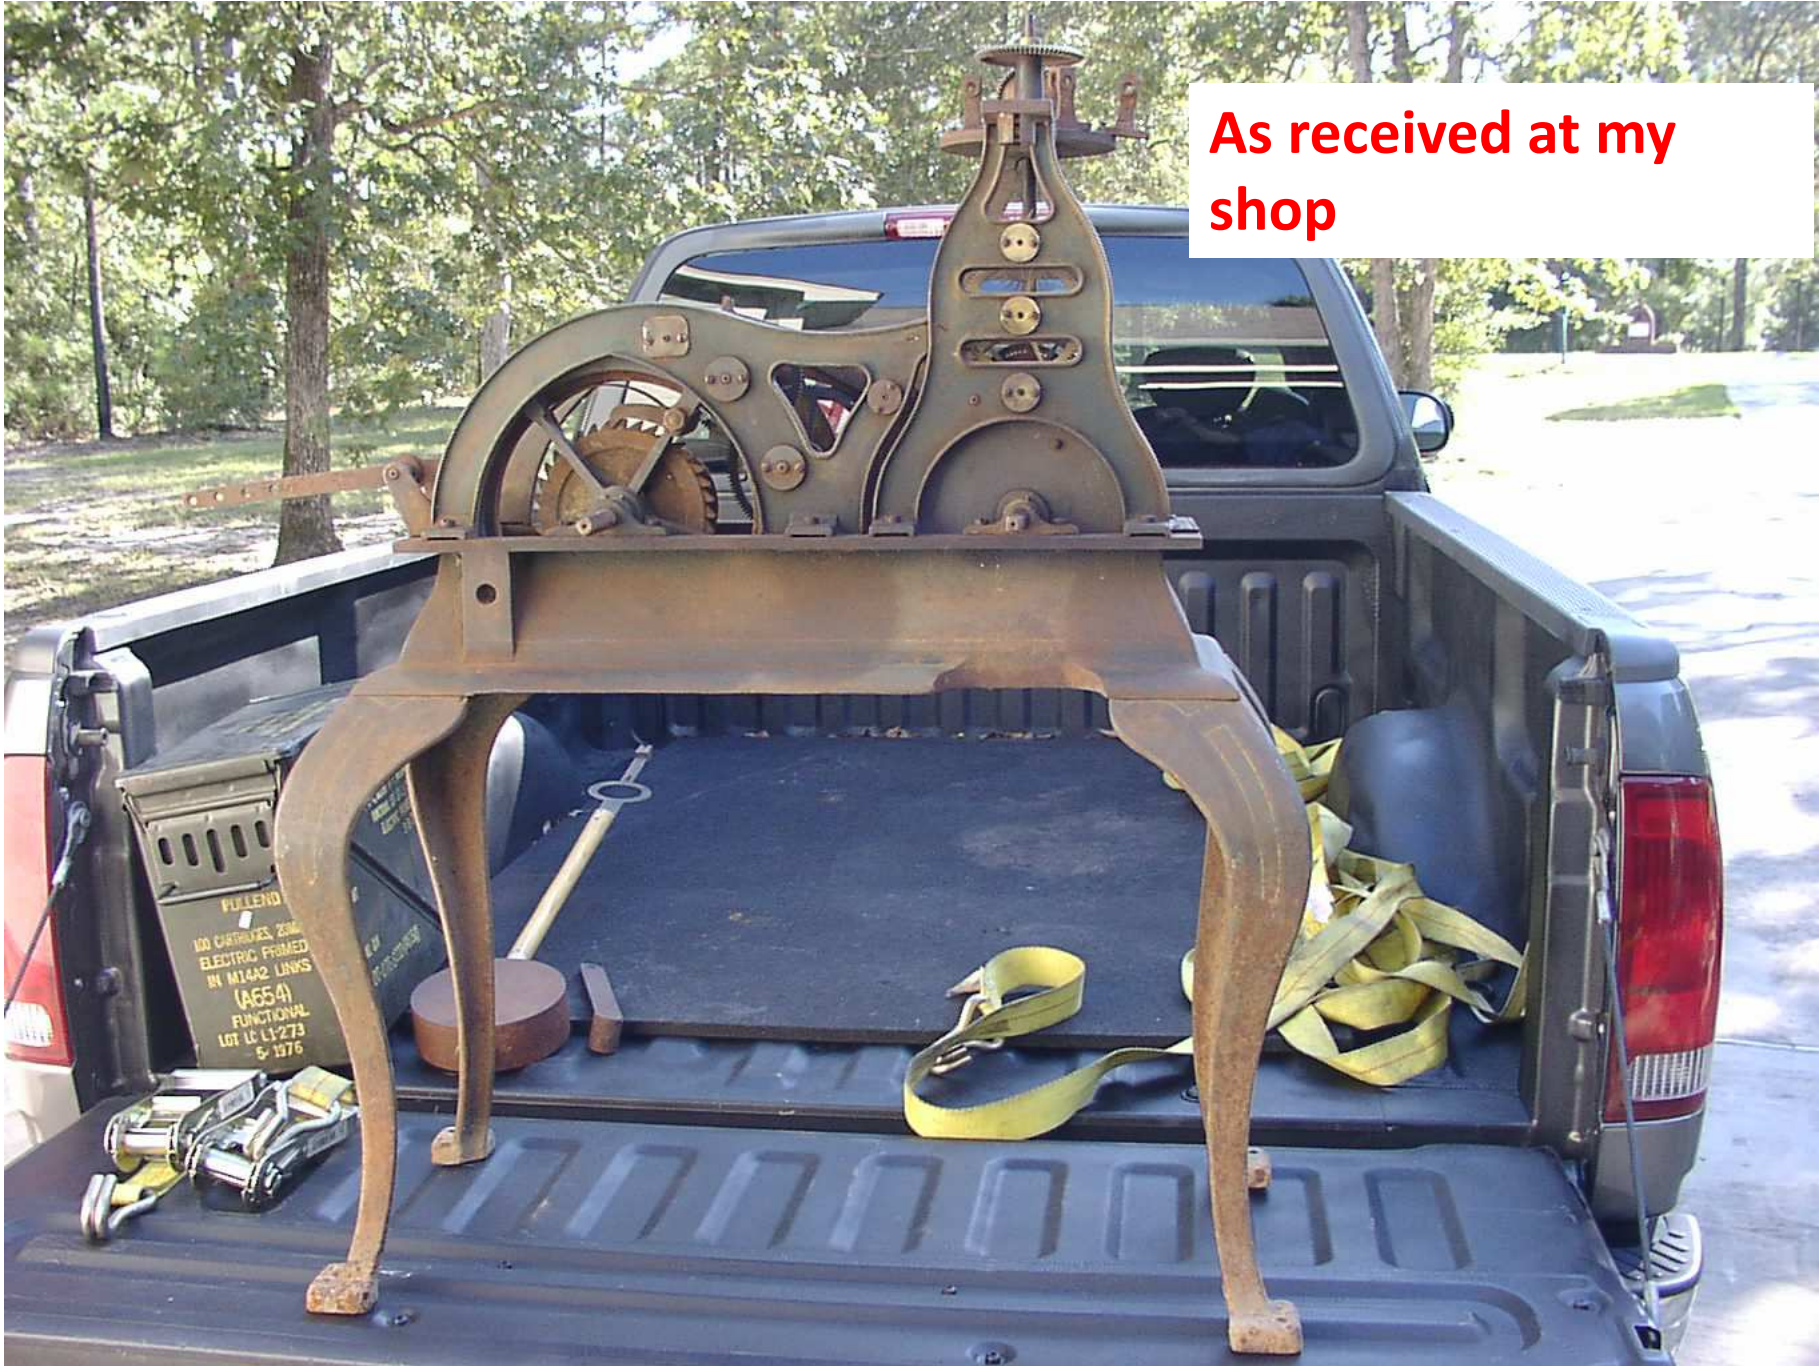
As received at my shop

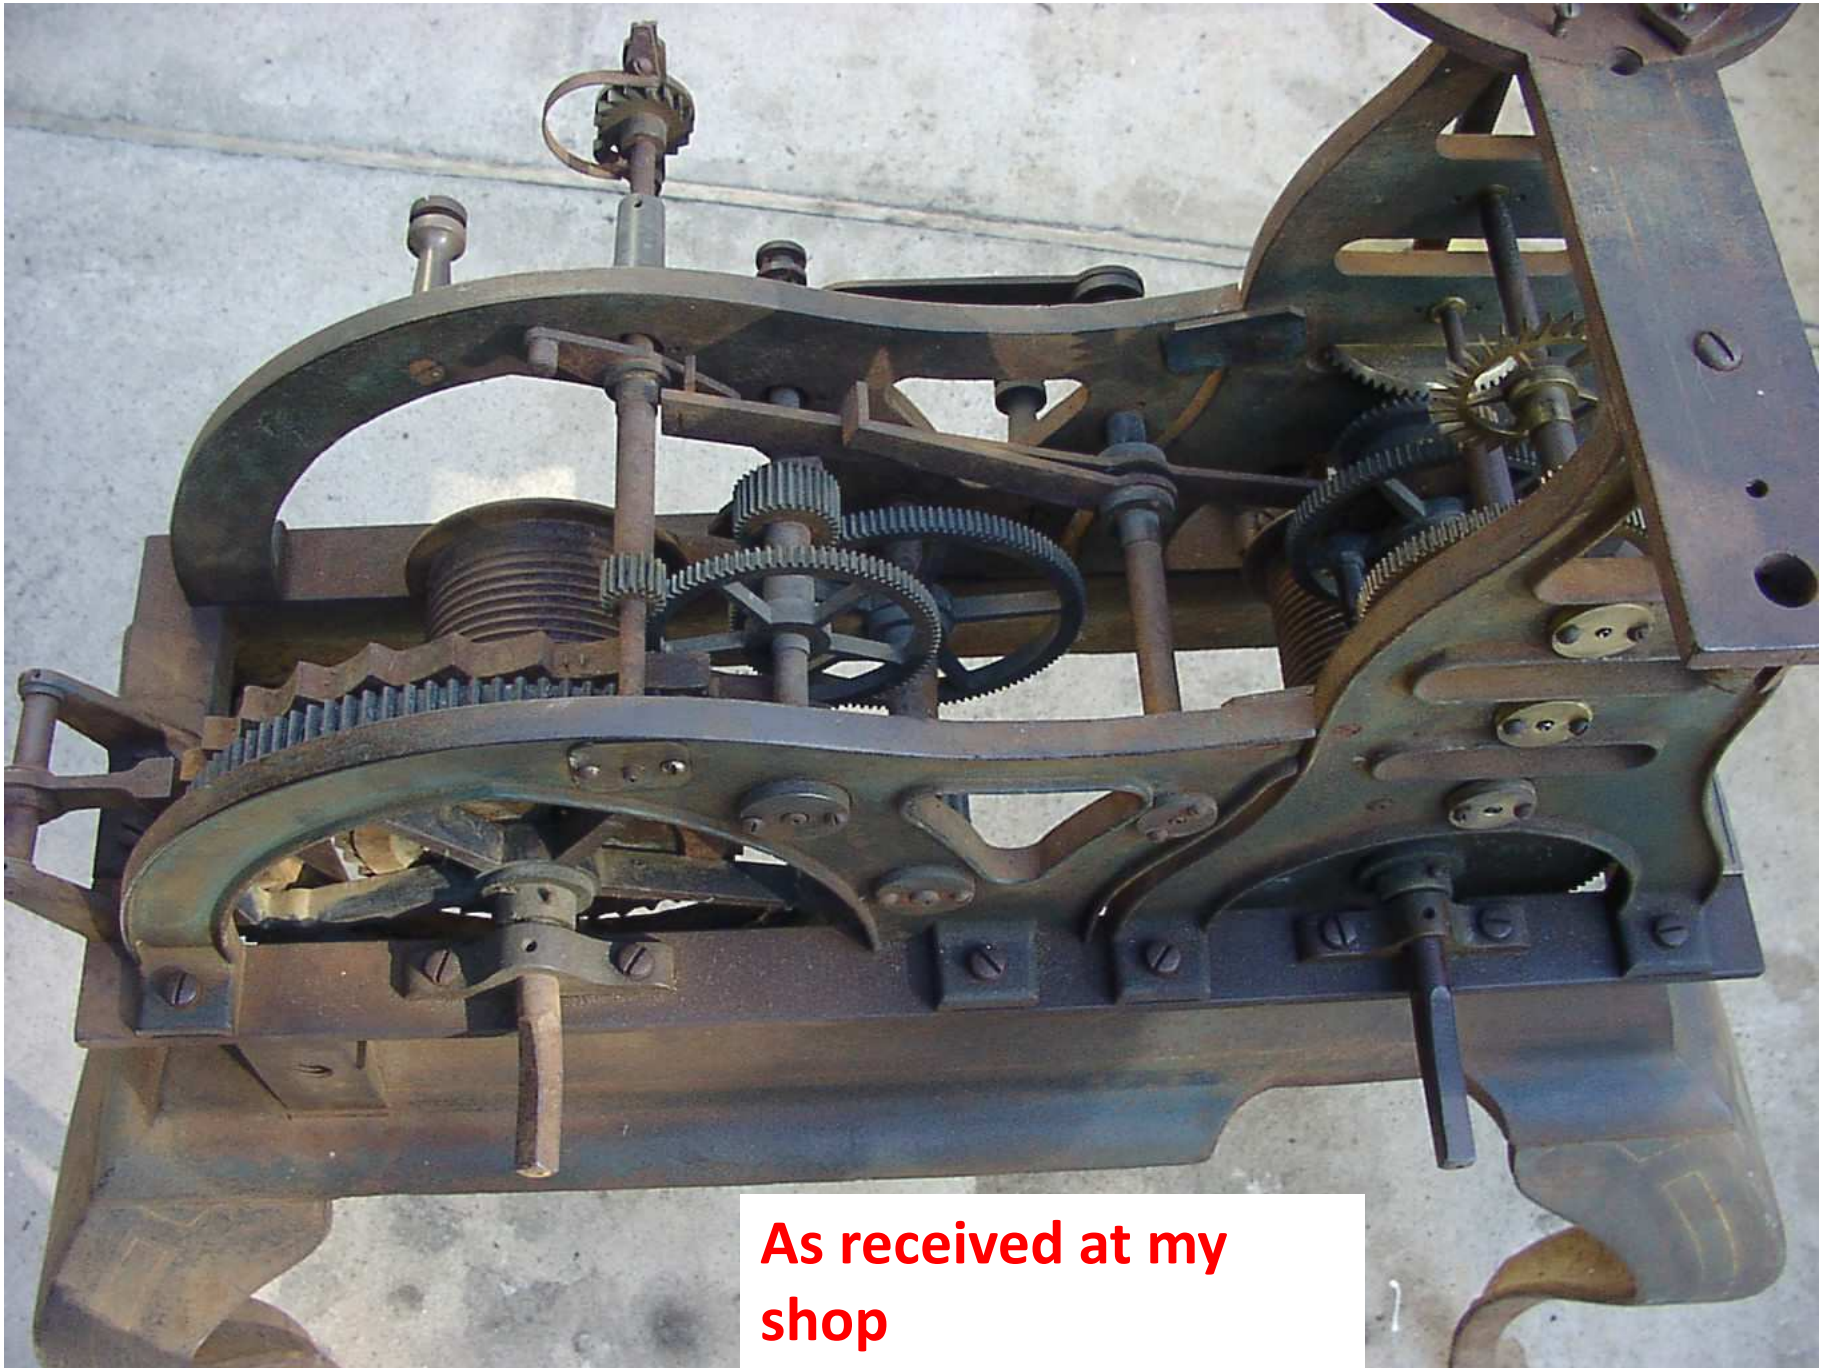
**As received at my
shop**

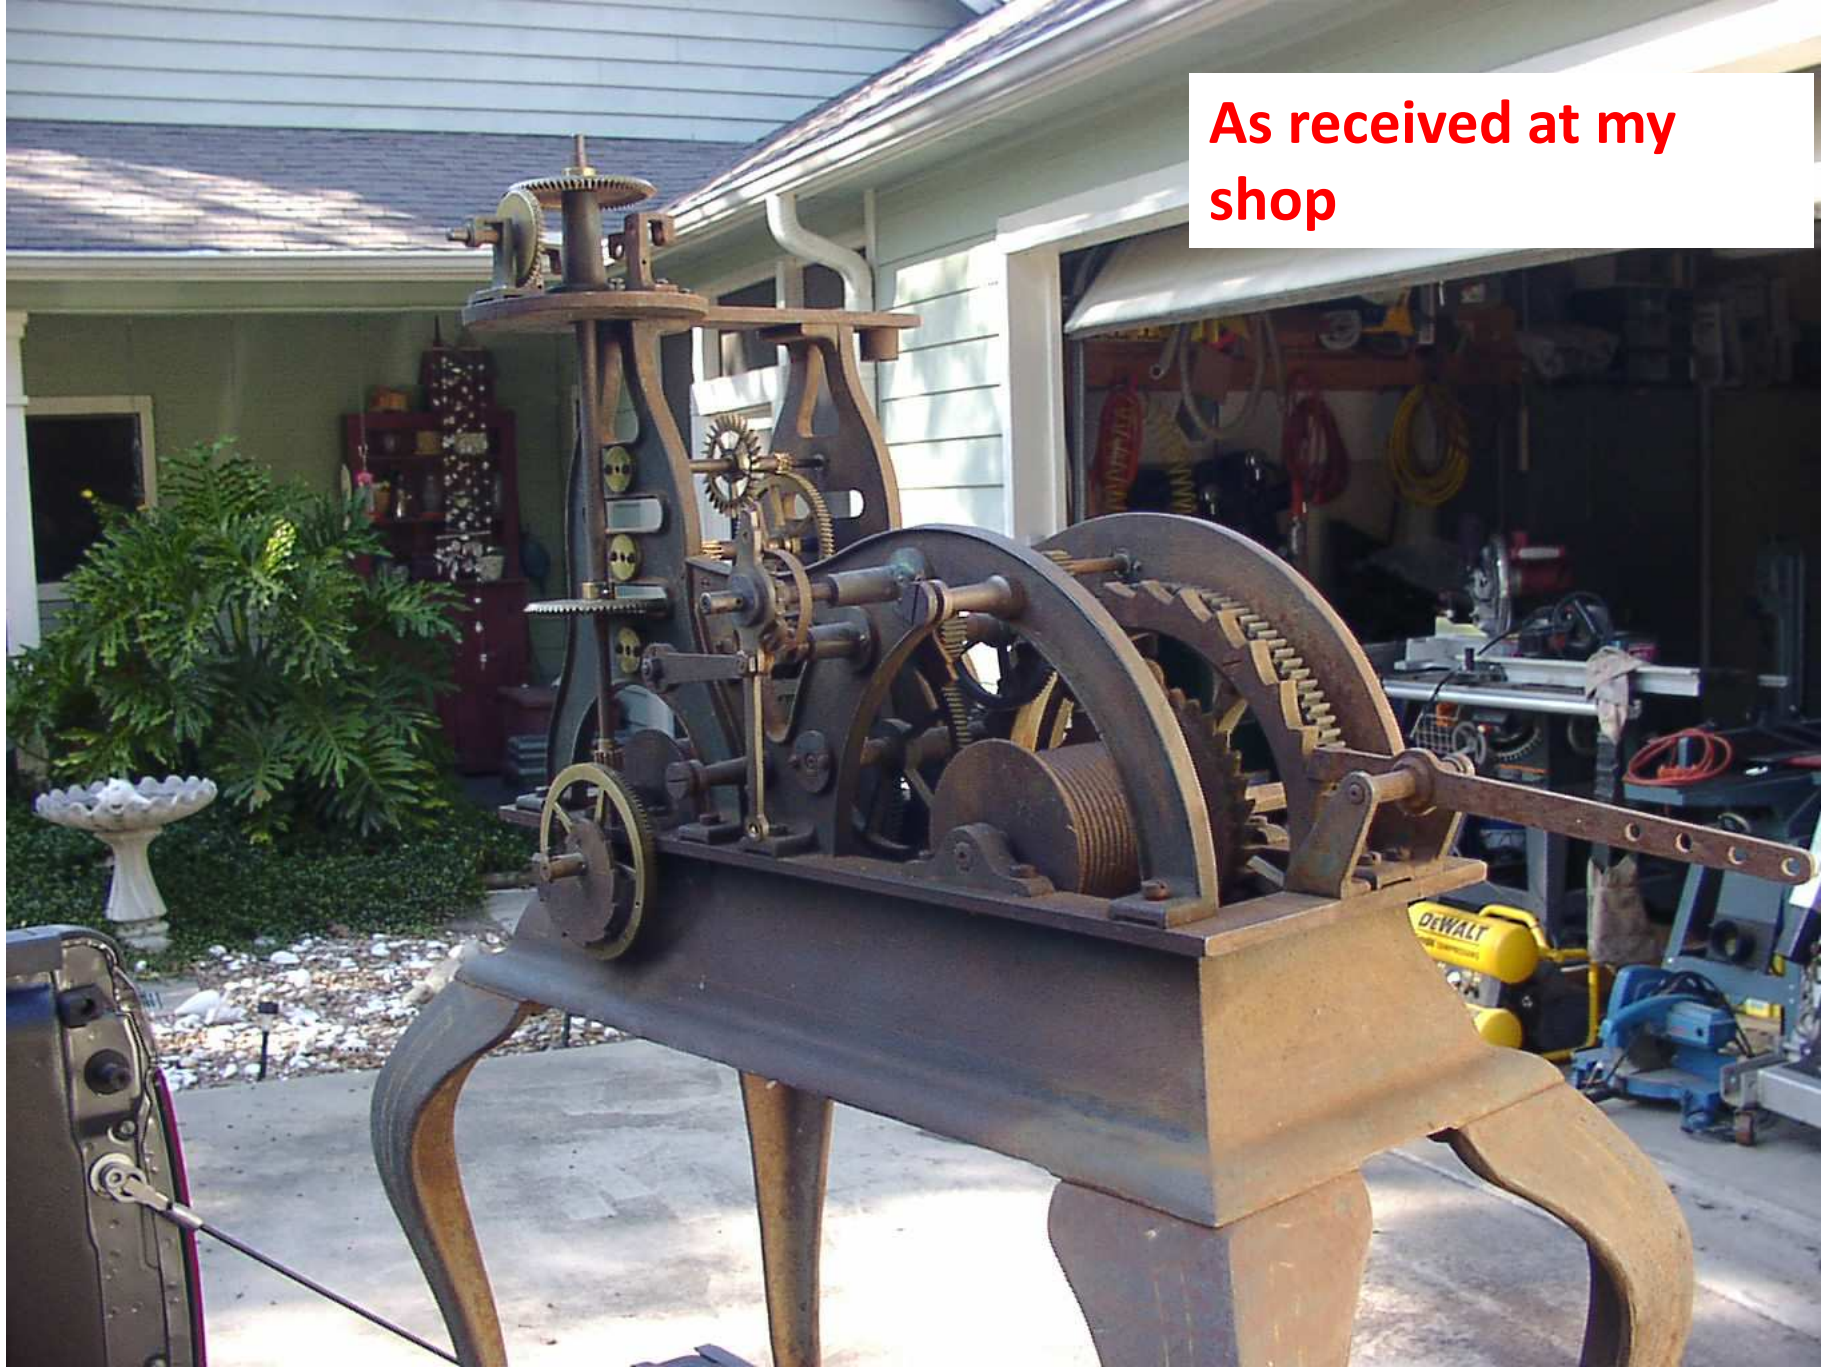
As received at my shop

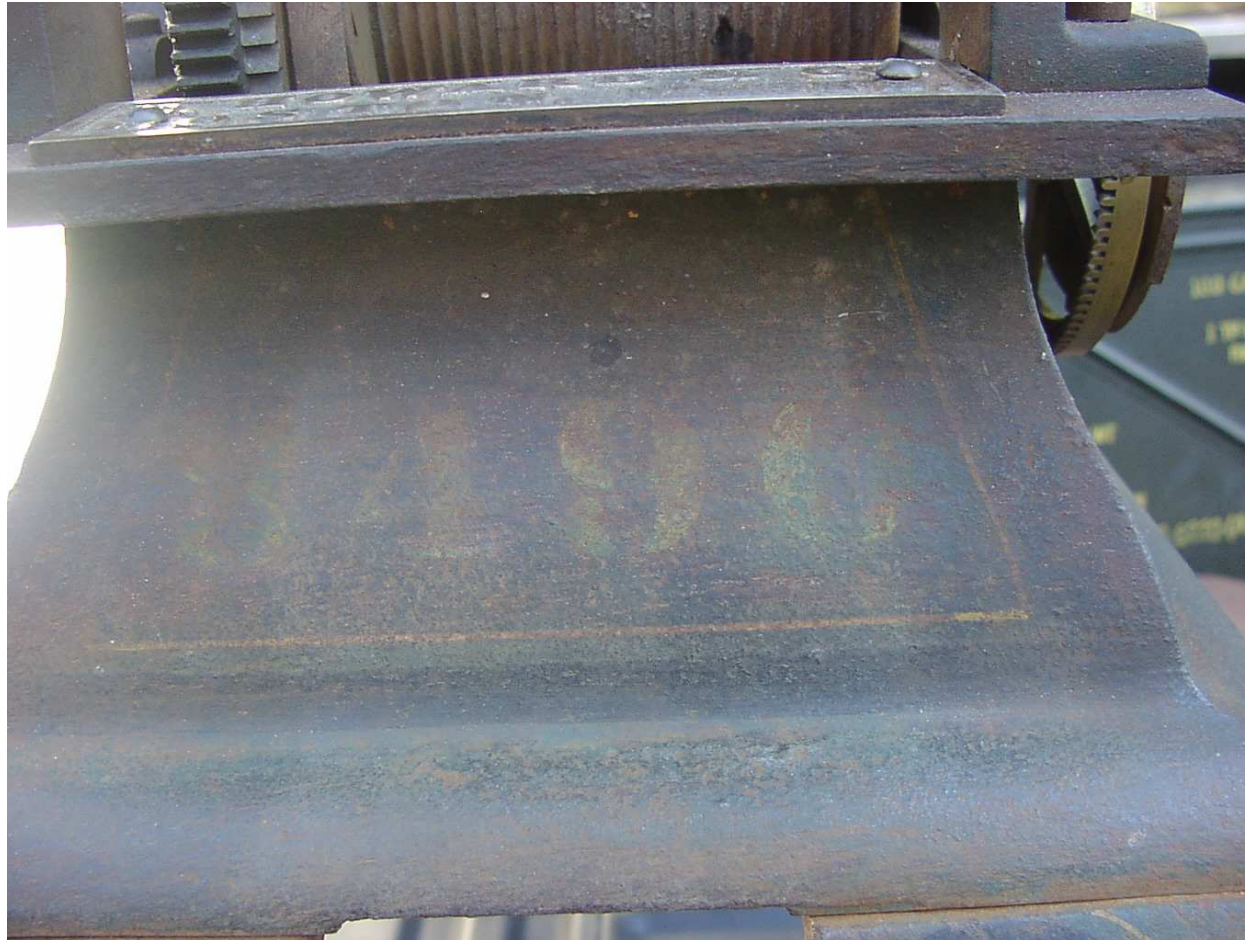
**Original serial number painted on
frame 3490**

The serial number is painted on the frame, very difficult to read, but reads 3490. The number is also stamped on the frame under the brass name plate. While there are many records of E Howard production and installation locations, this clock is slightly later production than the files we have. I believe its serial number suggests it was made about 1920 or 1921. In the normal E Howard fashion most of the parts of the clock are stamped with the last digit of the serial number, in this case a "0". Replacement parts I made I also stamped with a 0.

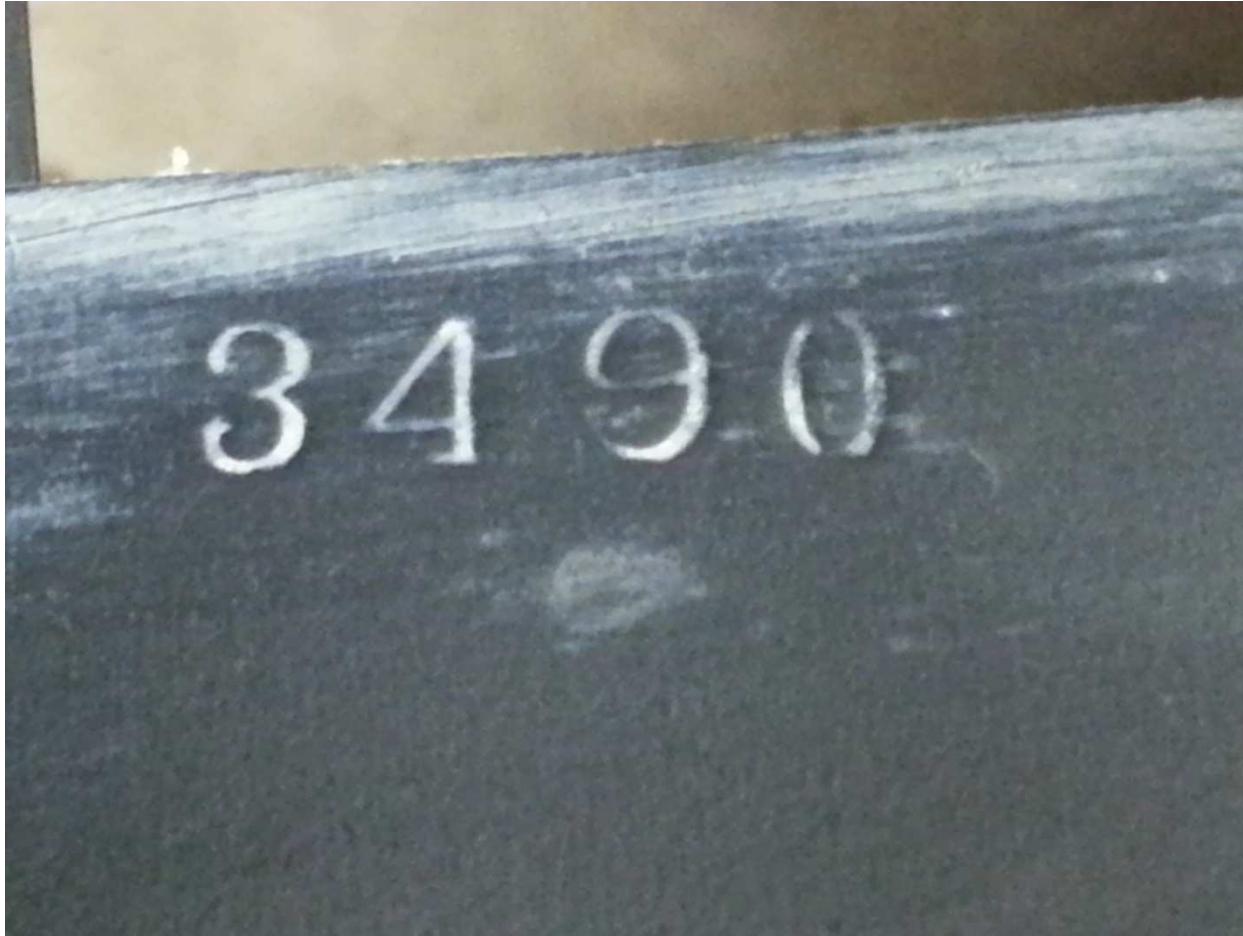
**Serial number stamped on
frame under brass plaque**

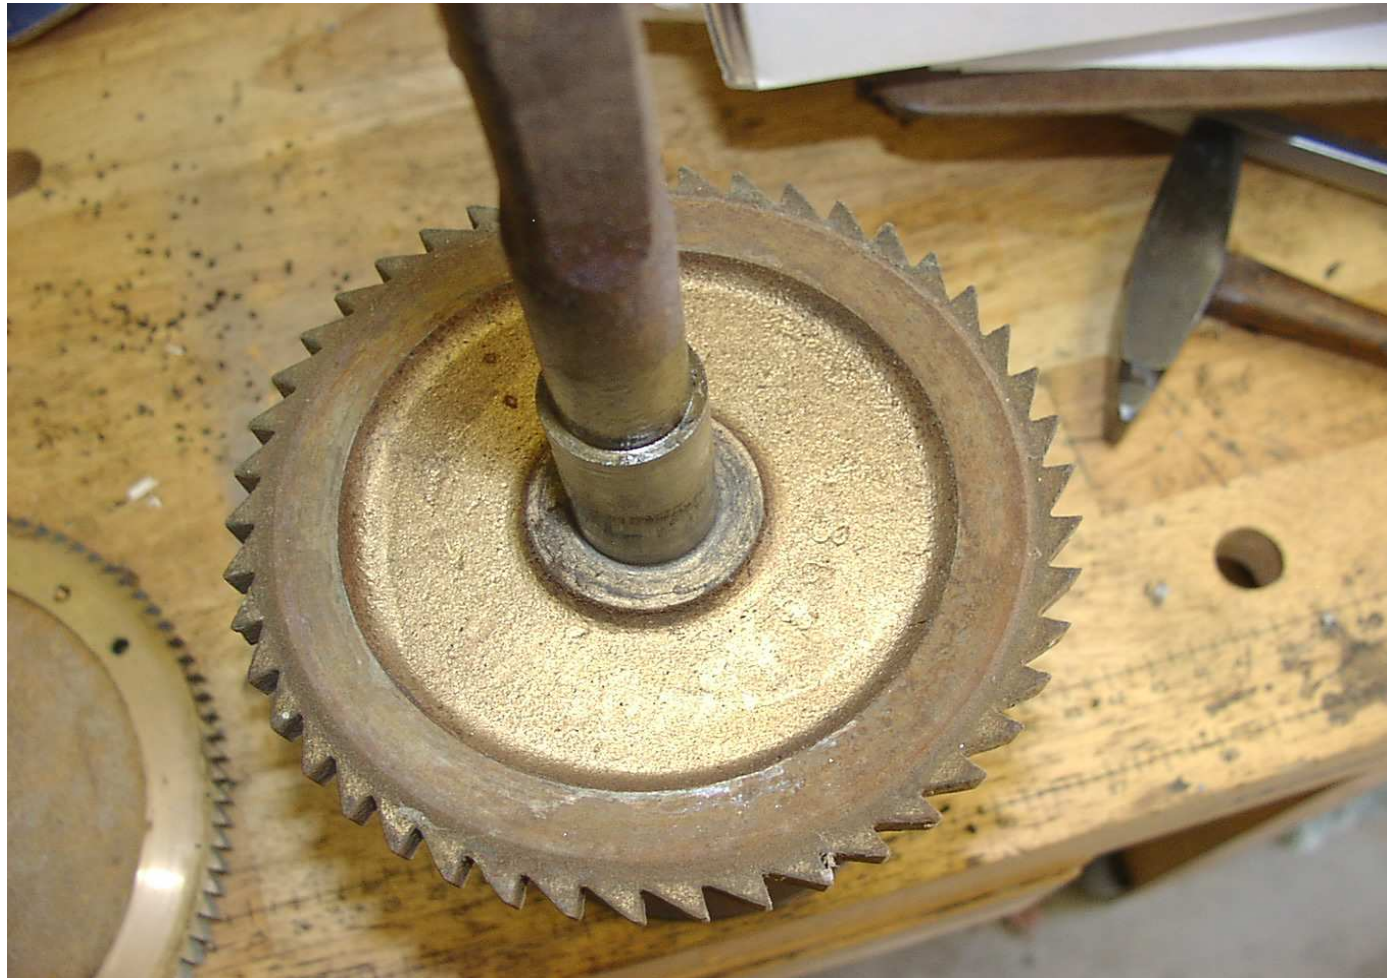
Traces of original paint

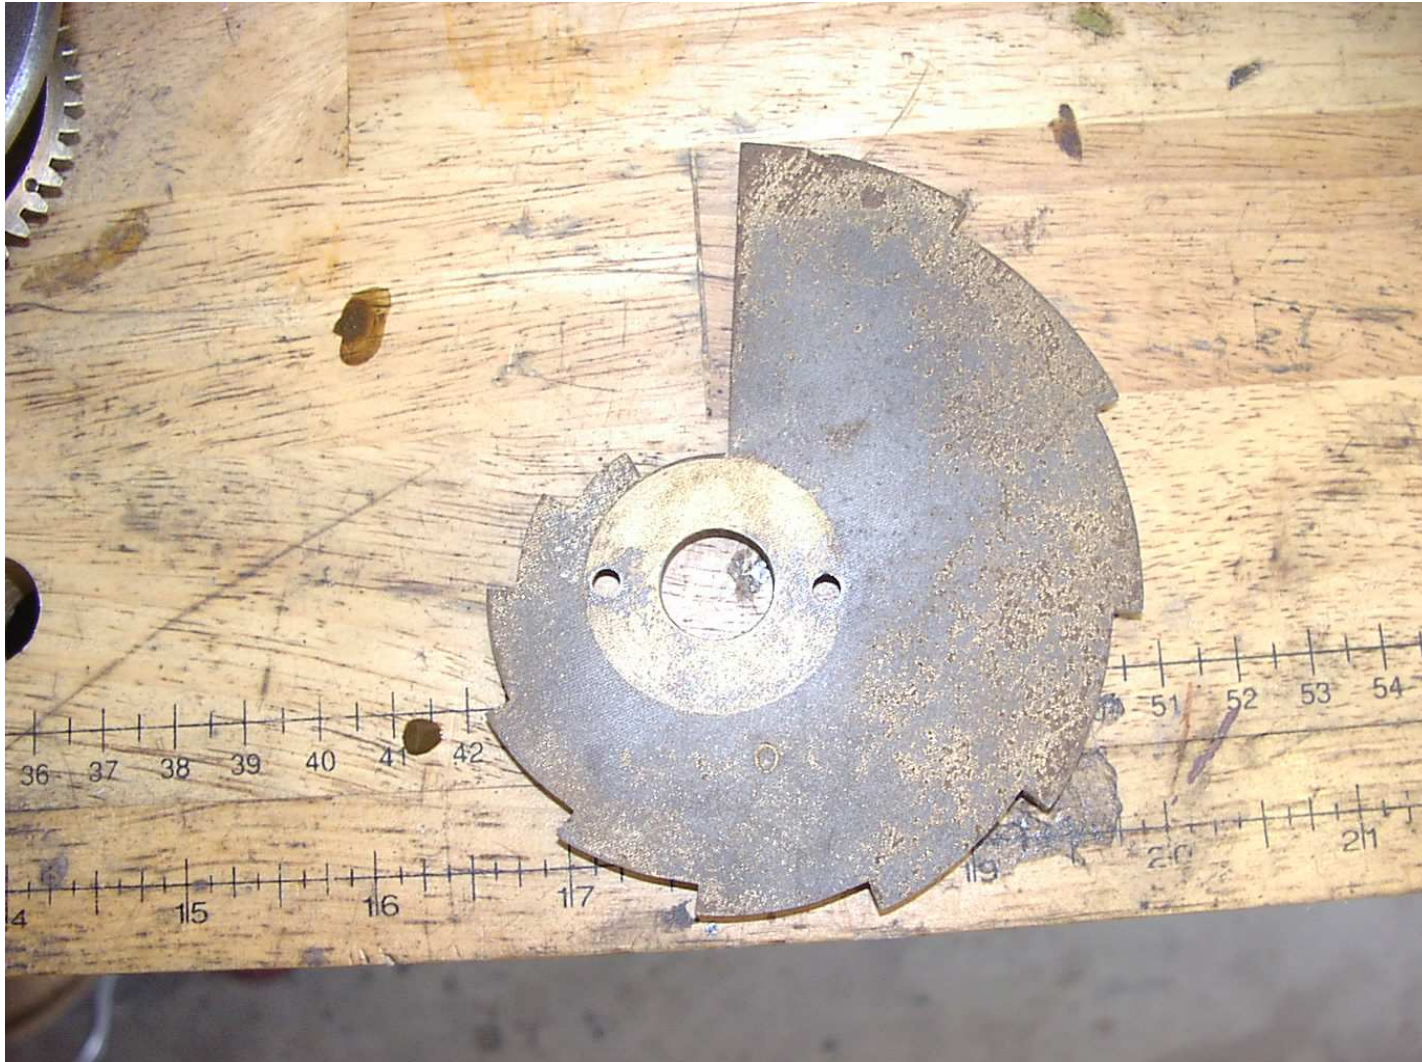
Traces of original paint

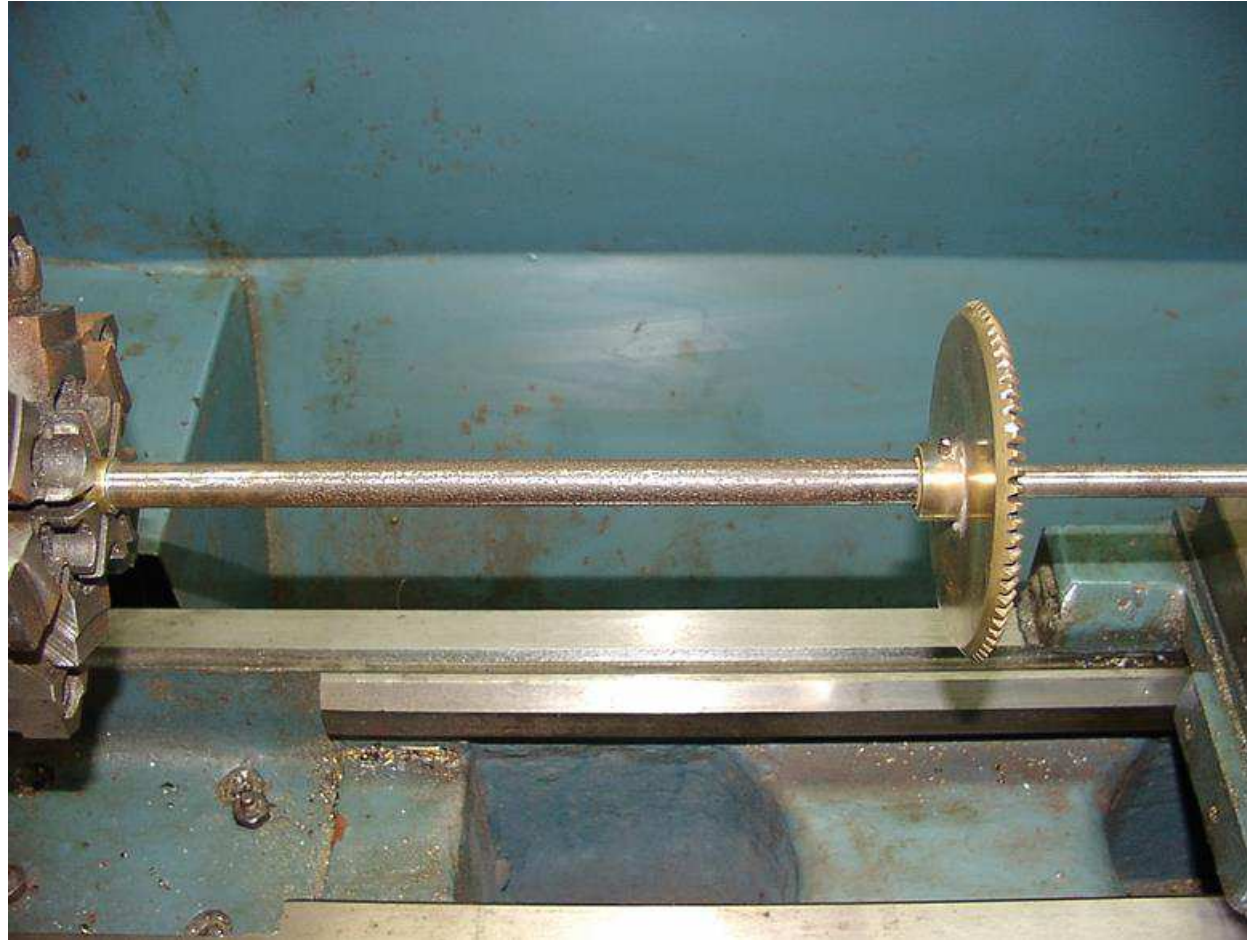
Cleaning is a combination of chemicals, files, emery paper, wire brushing etc.

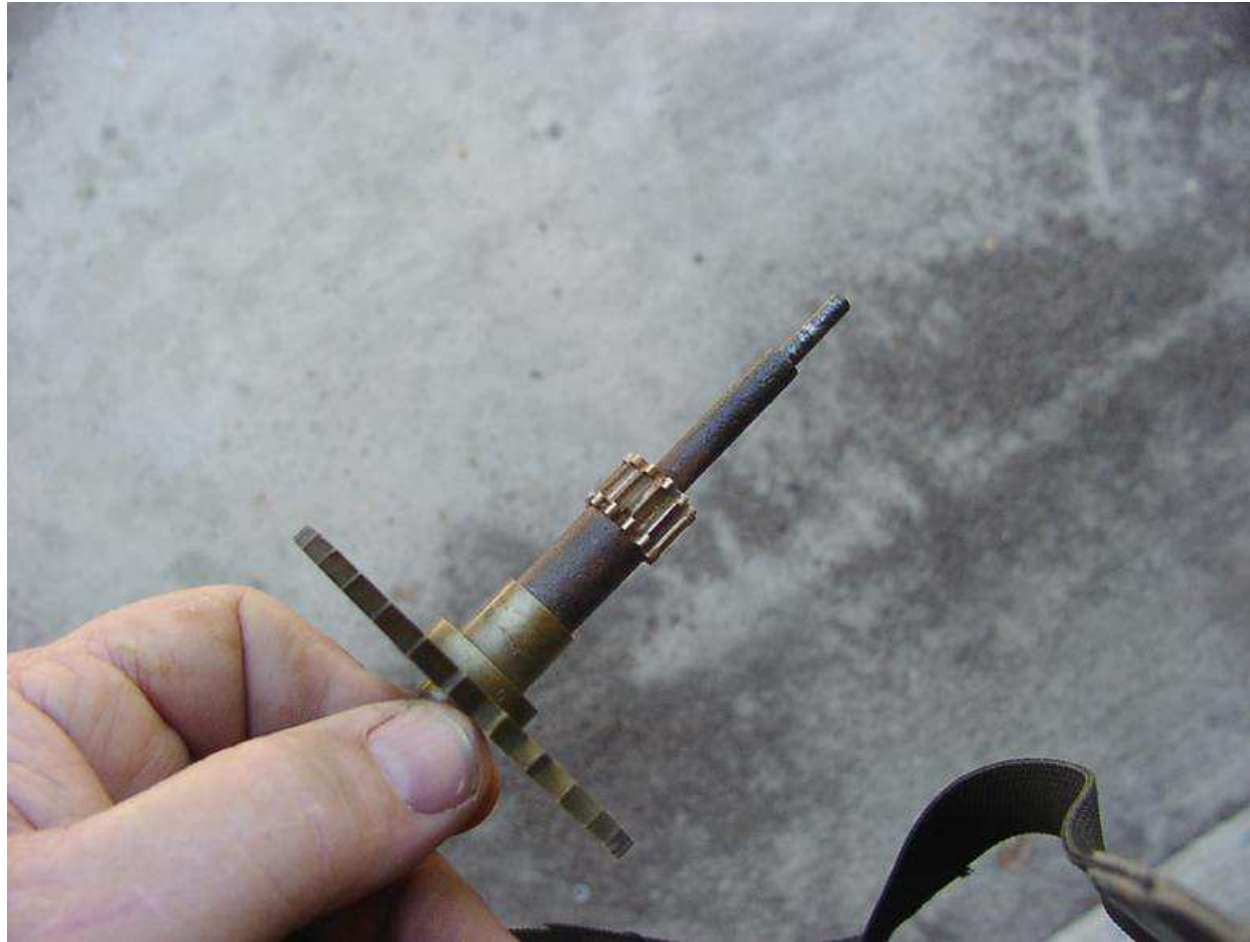
Worn pinion, requires replacement

- Escape wheel pinion and 3rd wheel pinion very badly worn, both require replacement
- Fly bushing out board end (cobbled) requires replacement
- Frame requires rust removal to preserve remaining paint
- Legs, same, lower 10-12" missing paint, rusty, still has soil on backsides
- Missing one leg of fly assembly
- Missing fan blades and brackets to hold them
- Missing entire pendulum assembly, rating nut, keystone, mounting bolt, etc.
Missing all suspension spring pieces, as well as rating nut, cheeks, and sliding bolt for rating
- Missing crutch
- Missing verge
- Missing chocks to hold verge shaft and crutch
- Missing setting dial, hands, drive bevel gear, mounting brackets, and motion works
- Bent winding shaft on strike drum
- Missing rack
- Handle missing for winding crank

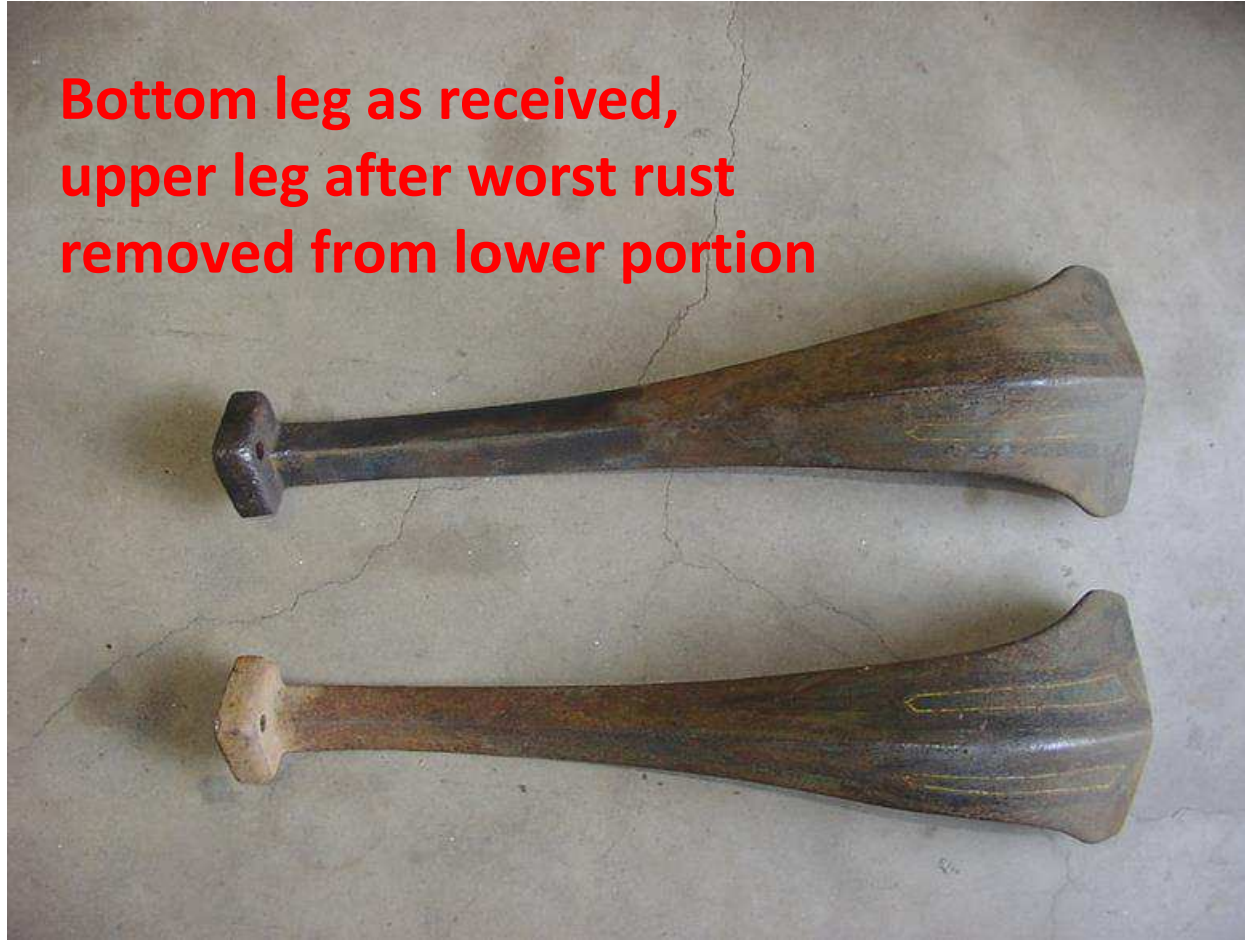
**Bottom leg as received,
upper leg after worst rust
removed from lower portion**

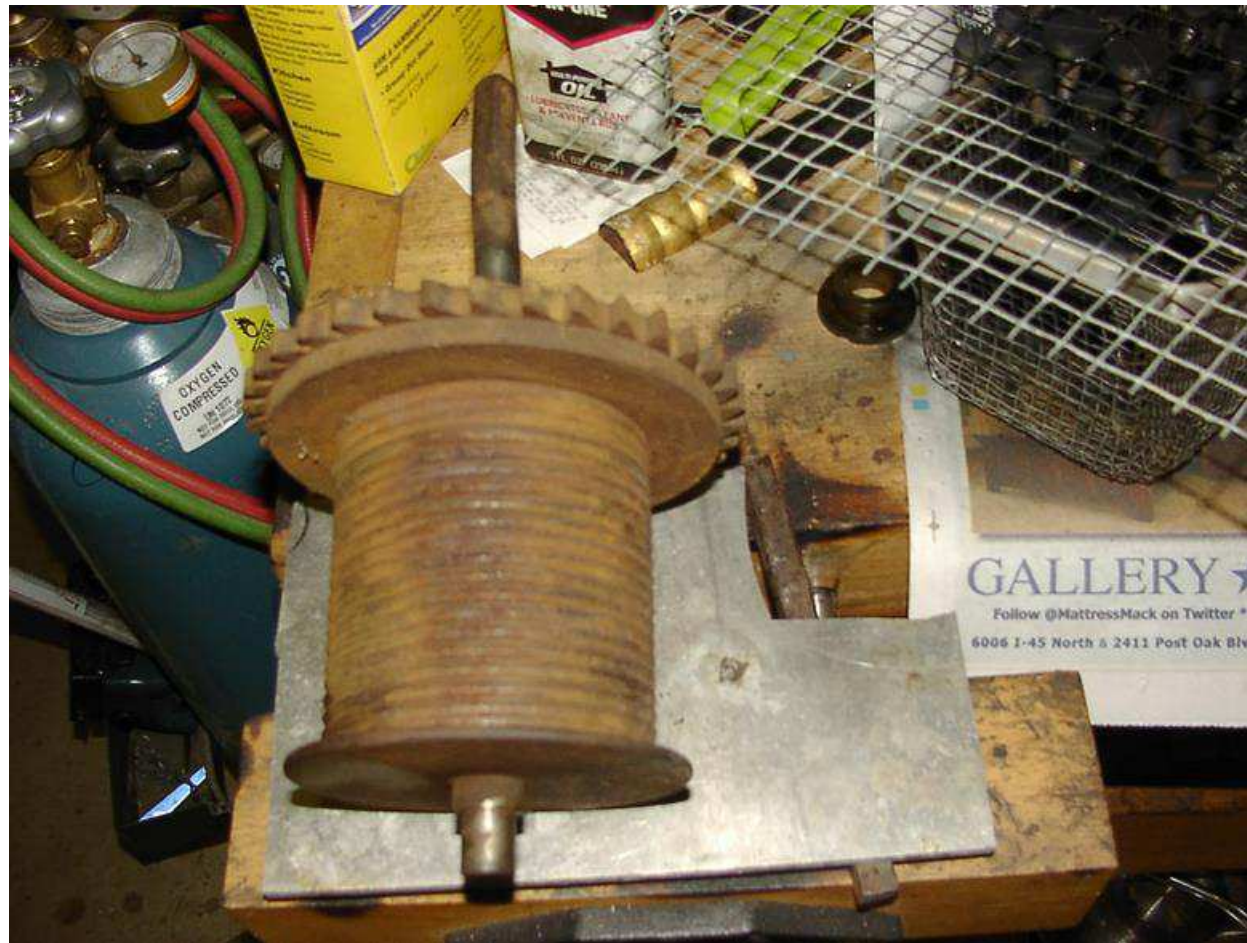
Rusty drum before cleaning

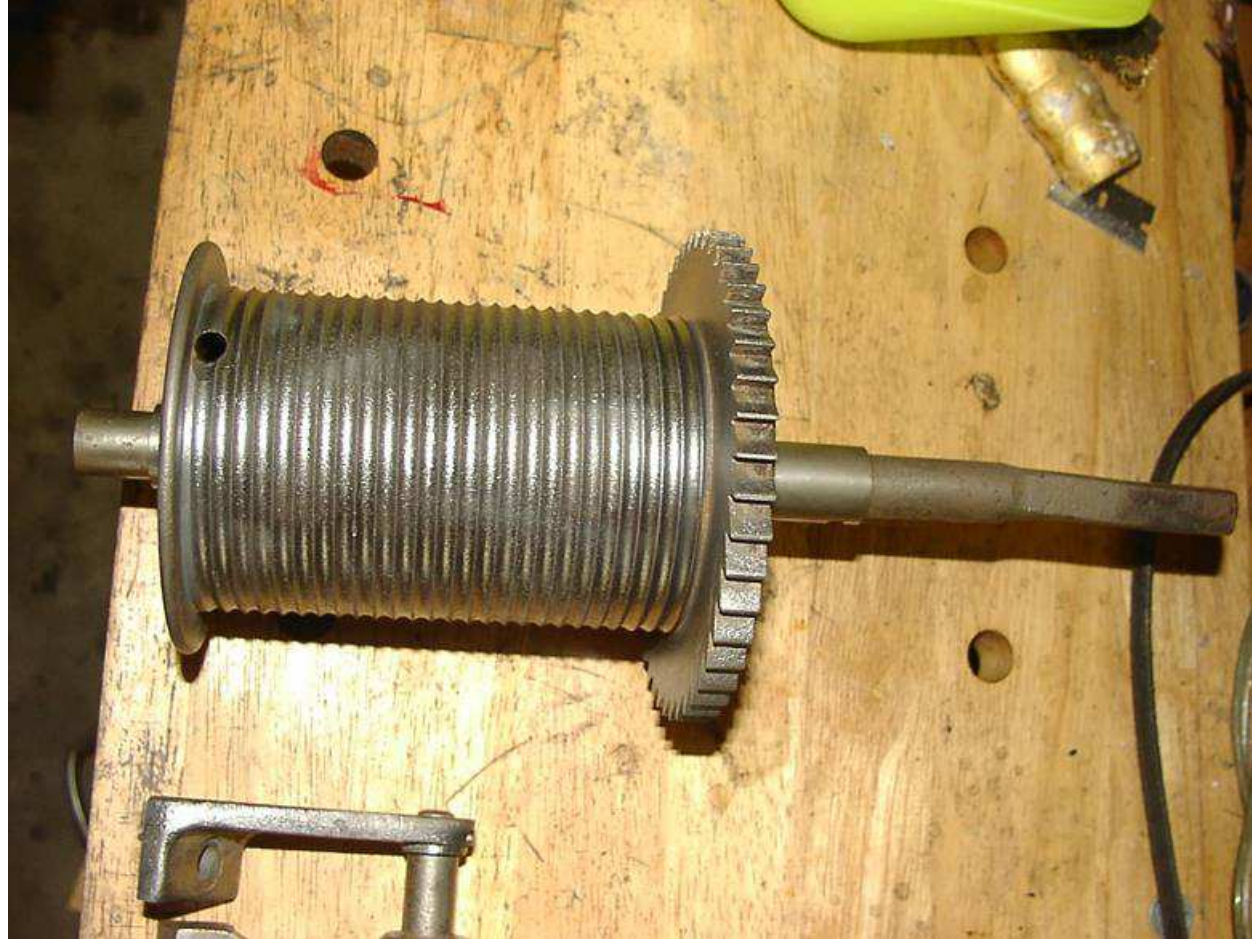
Drum chemically cleaned and wire brushed

Some very good news had to do with findings under the rust. It appeared as if the strike train had never been dissembled, its screws, nuts, bolts, and other parts were “unmarked” by the usual poor repair practices seen in many tower clocks. Original paint was found on several parts including the wheel spokes, the backside of the winding drums etc. The restoration used these same paints as completed. Examples follow in which the strike side winding drum clearly showing the original gold paint.

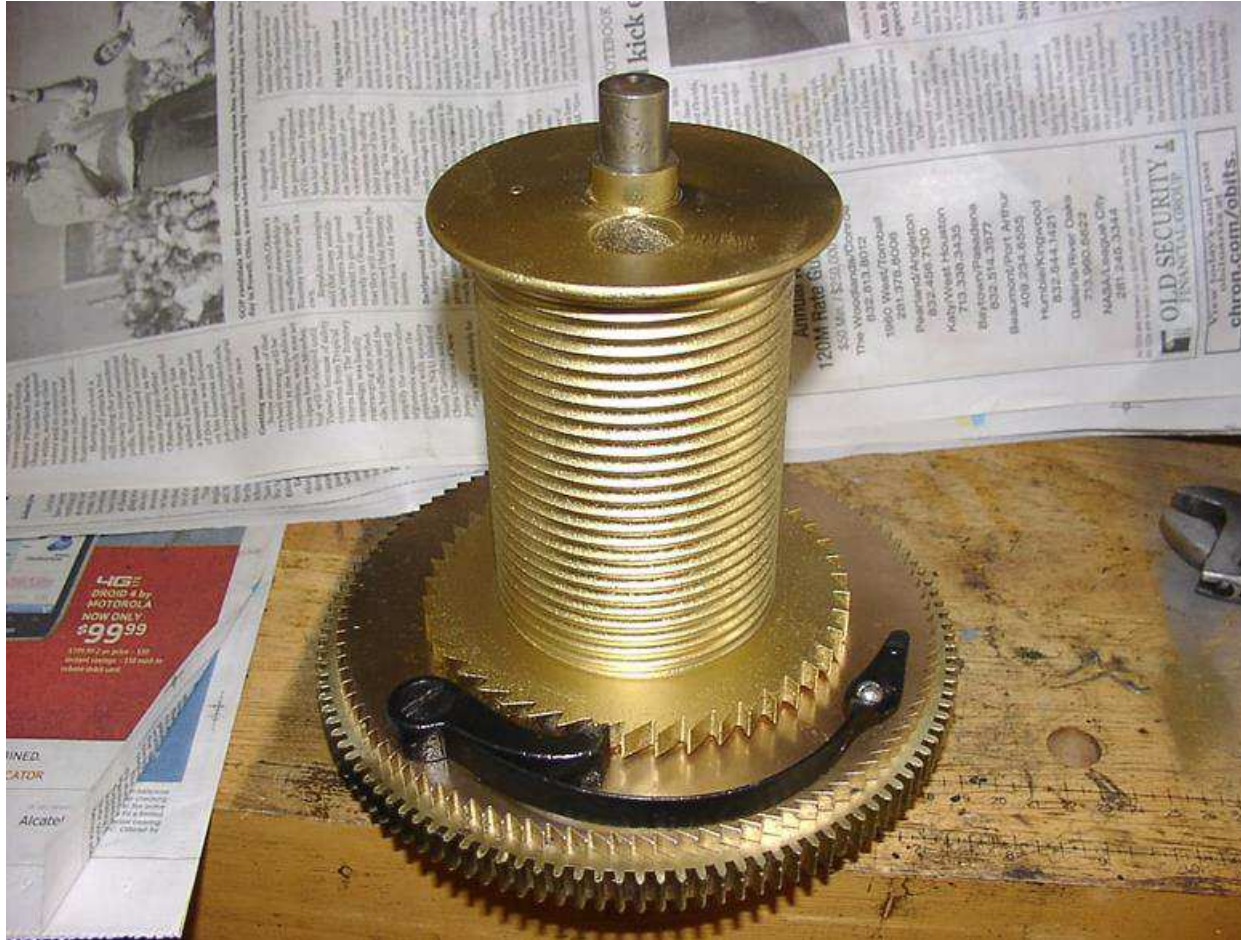
Ready for installation in frame

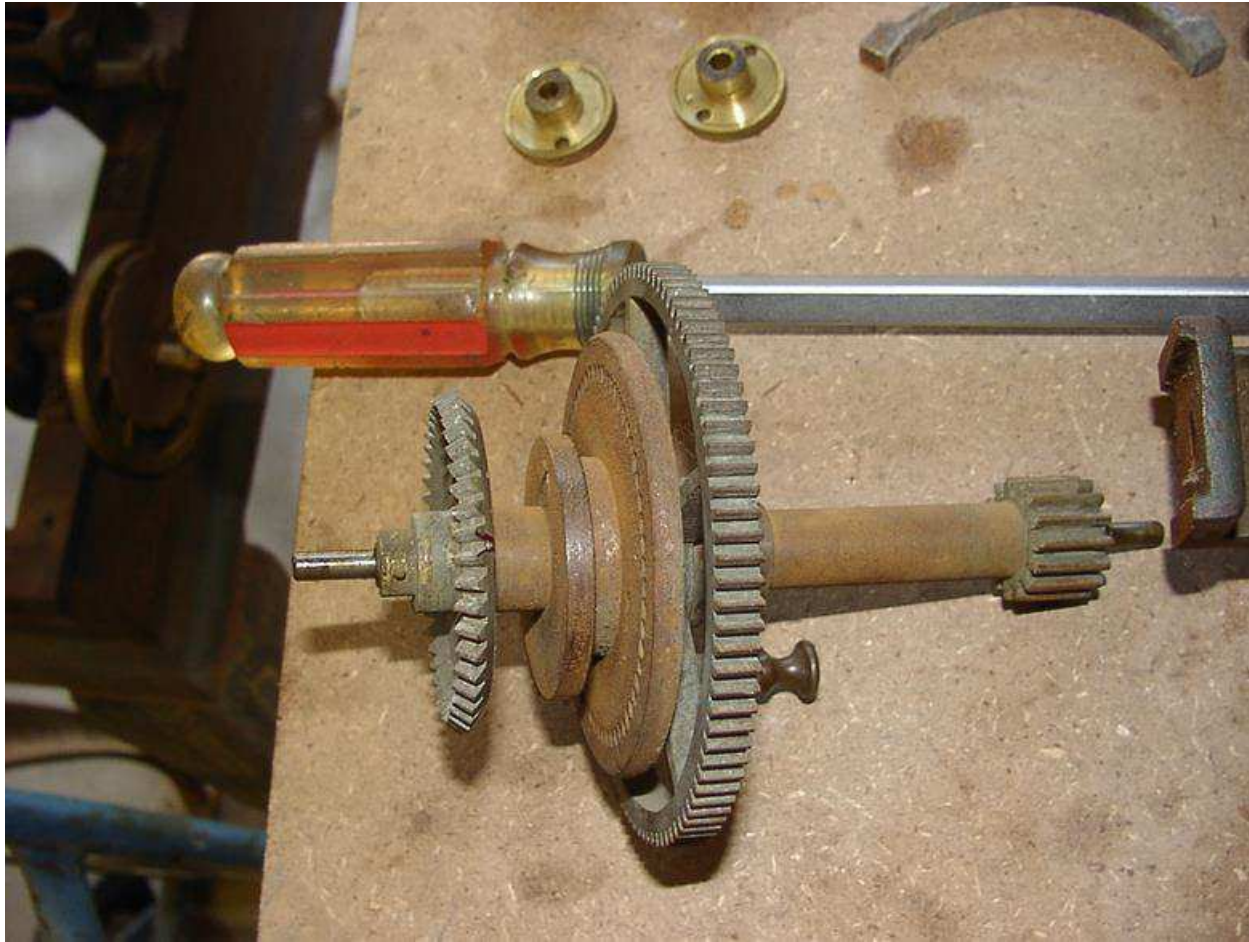
Center shaft as received

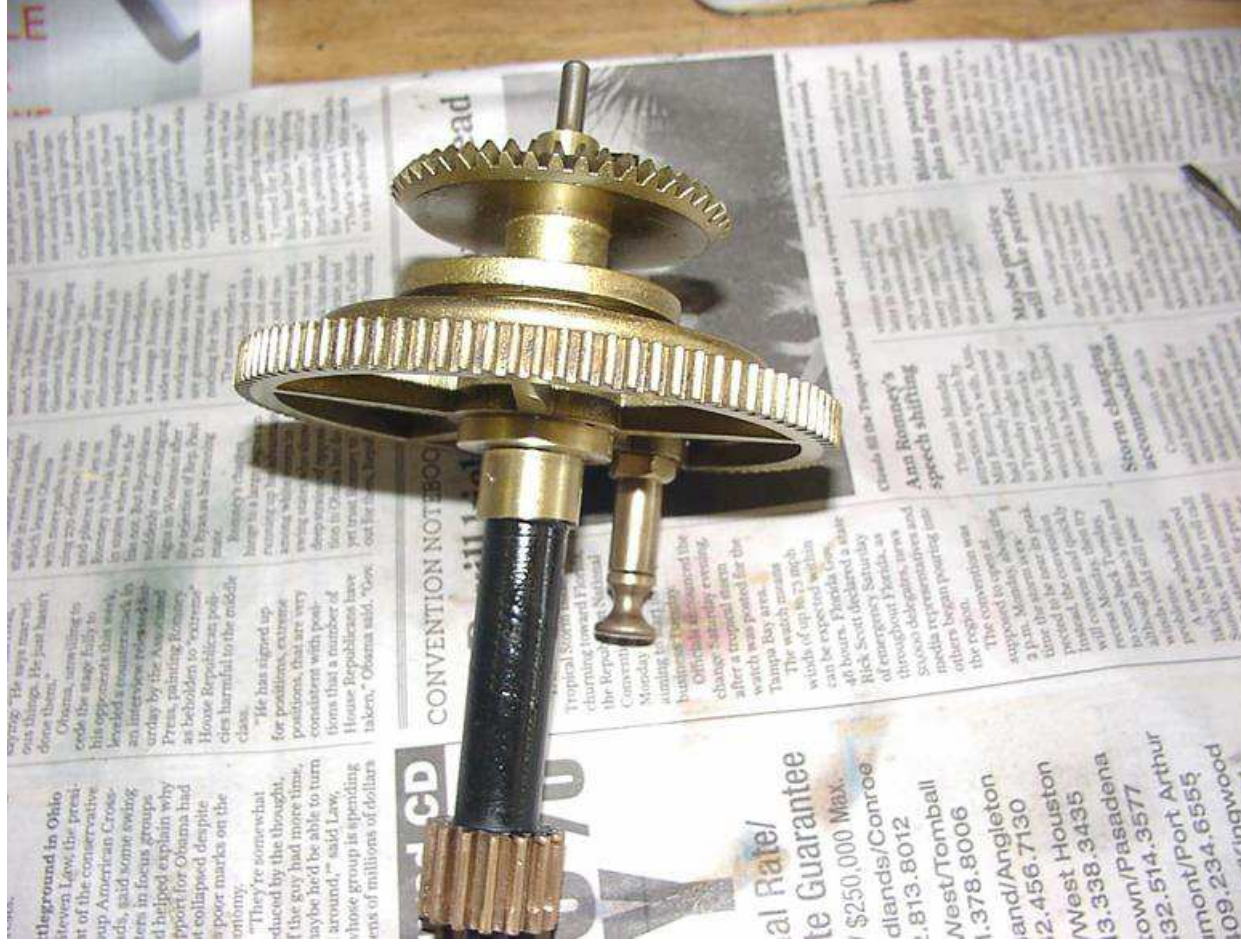
**Center shaft
assembly after
cleaning and paint**
