E Howard Tower Clock Renovation

Today's Discussion

The subject of this monograph is the smallest sized E Howard time and strike tower clock made. A local collector/dealer purchased it at the 2012 NAWCC Texas regional in Houston. It changed hands to a second party and 3 months later found its way to my shop. The owner asked

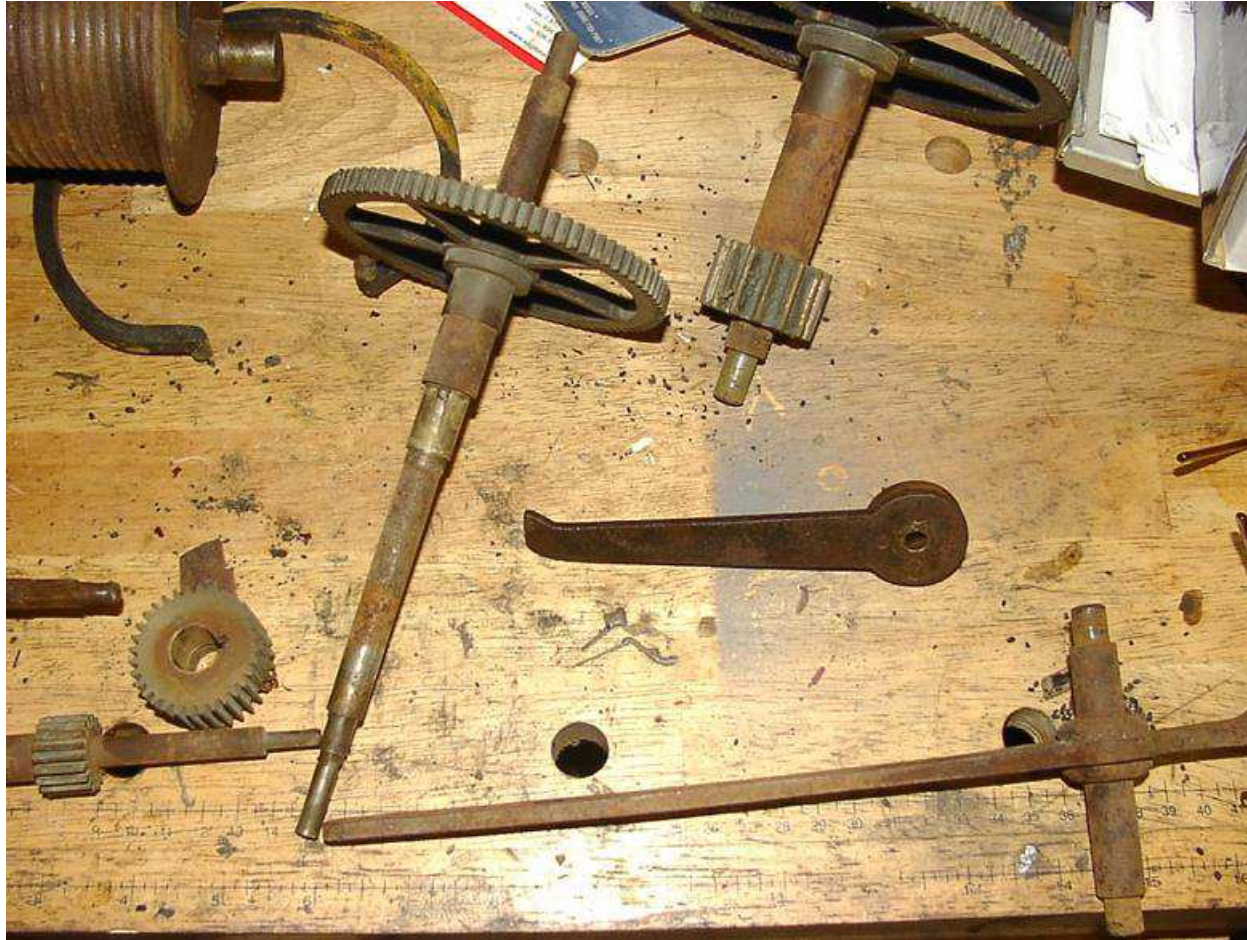
Rust abounds

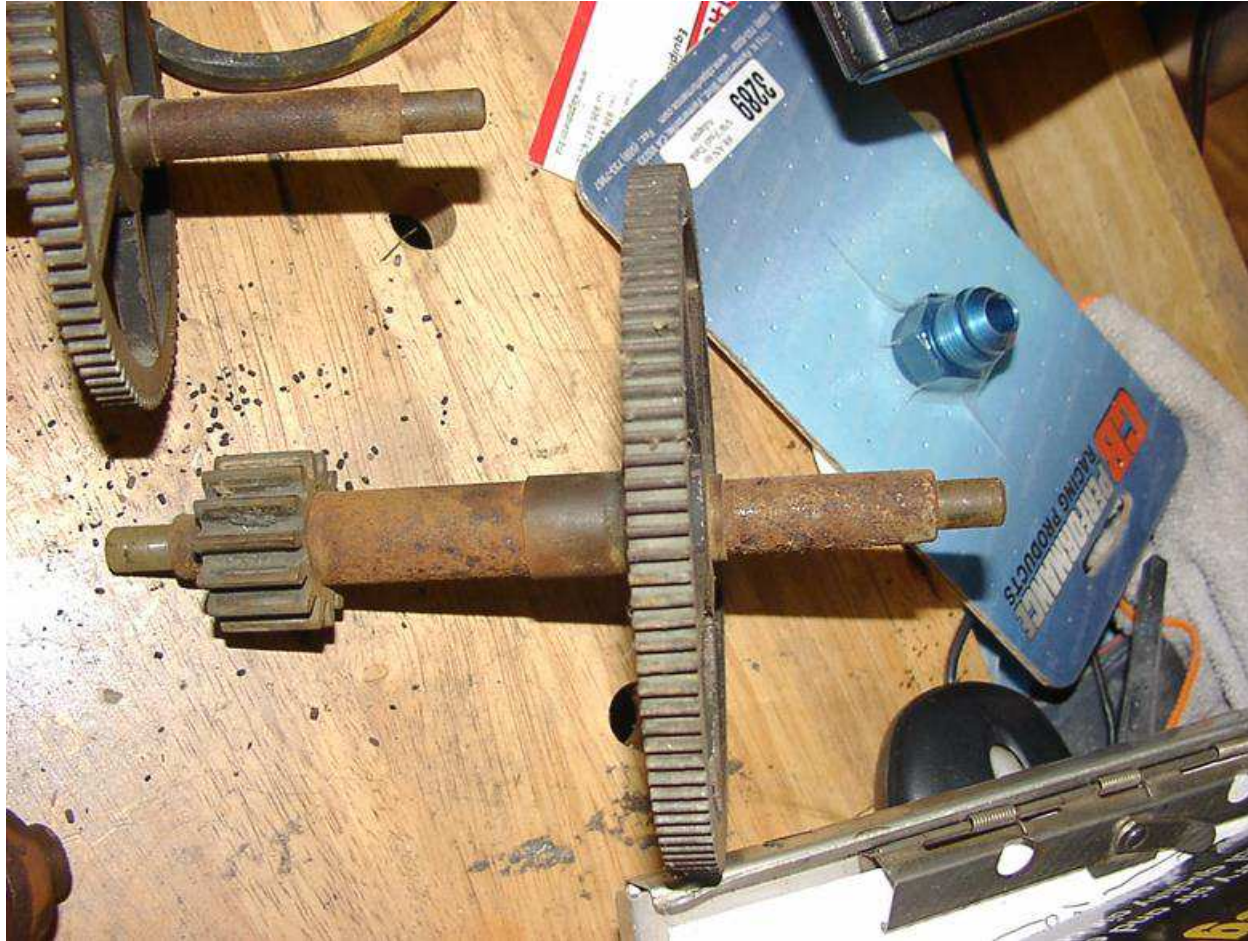
Rust abounds

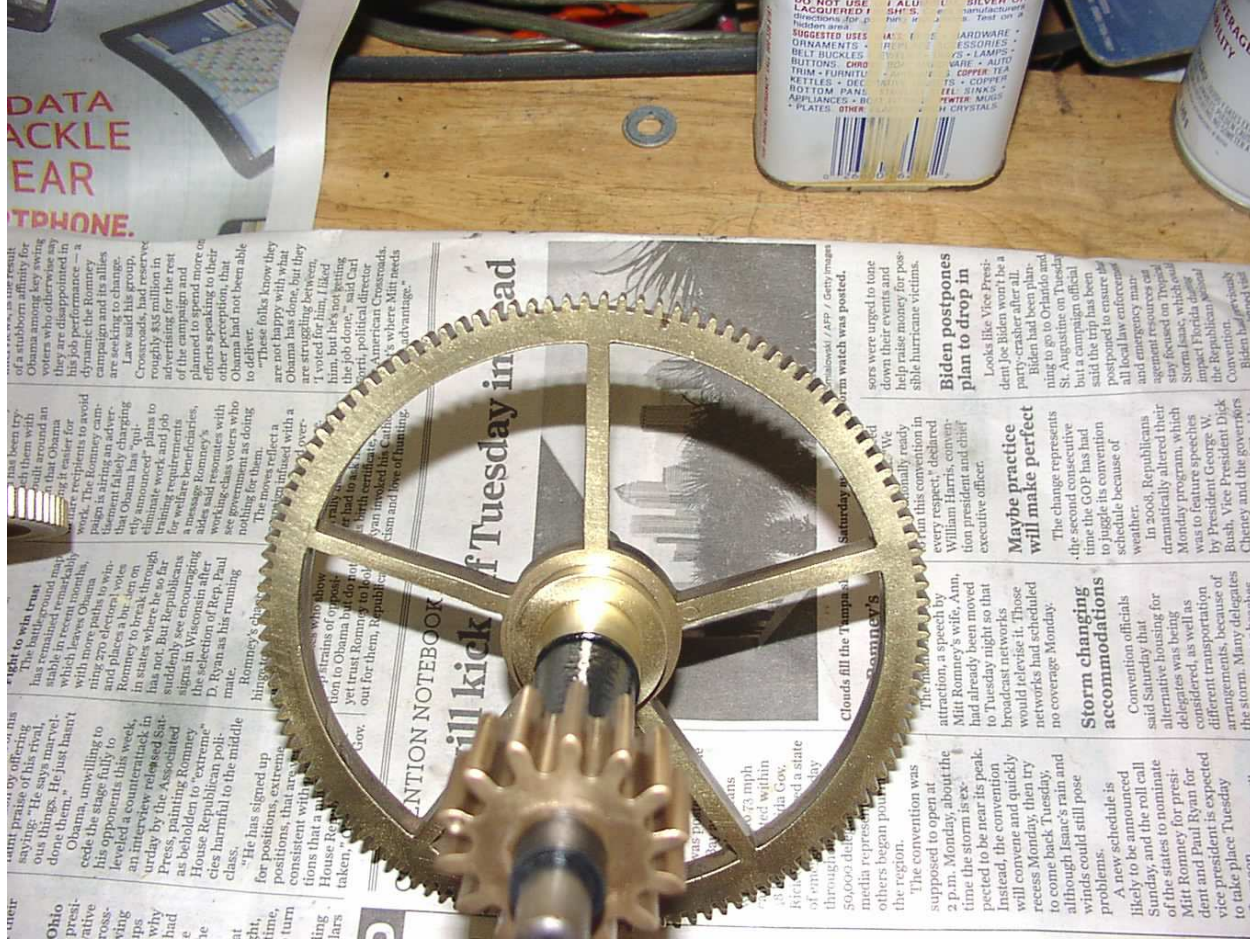
Ready for re-installation

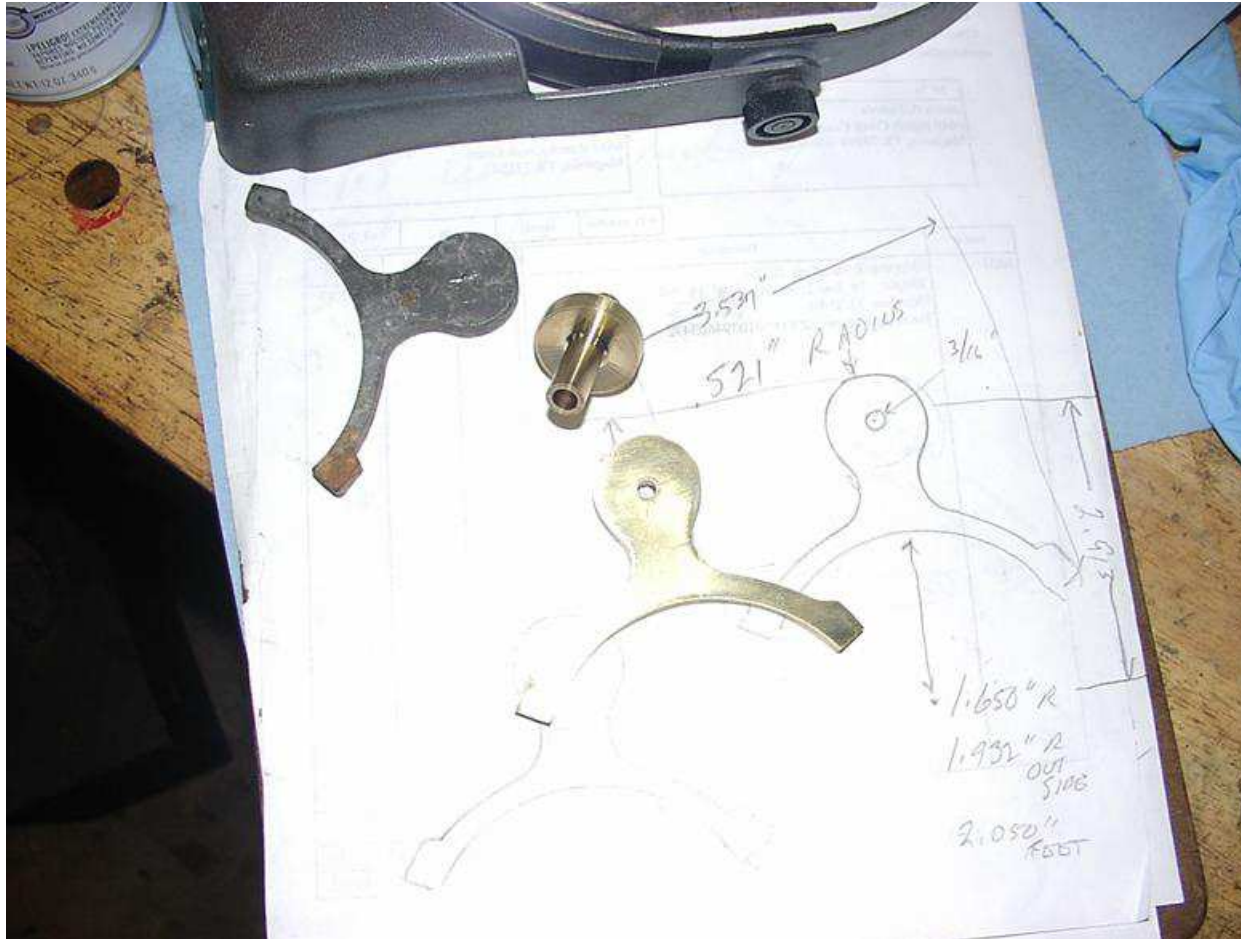
**Pattern, rough drawing, measurements,
and resultant verge**

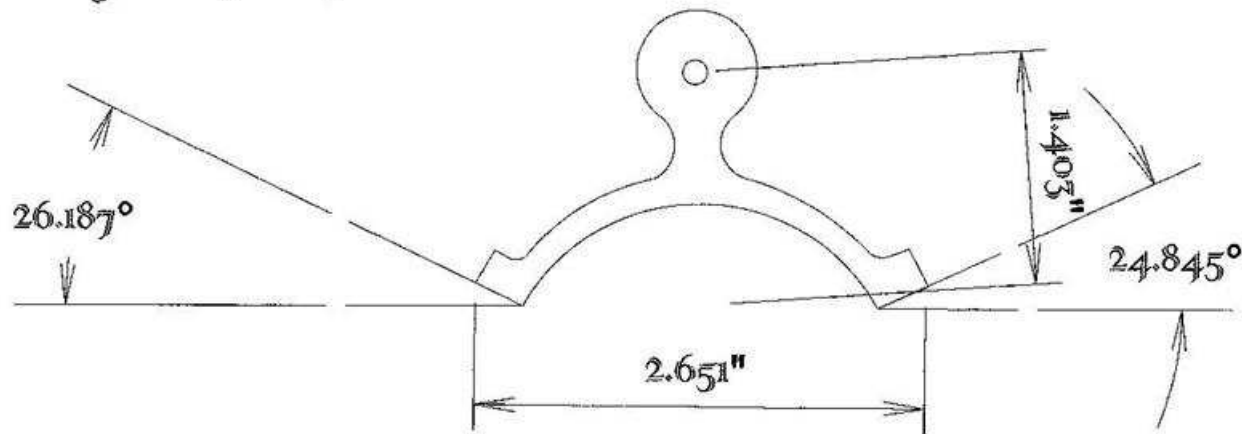
E Howard Street Clock
Verge Assy. 1/4" brass

Verge details and measurements, I highly recommend computer aided drafting, this drawing was translated into machine code and the verge blank was cut on CNC mill

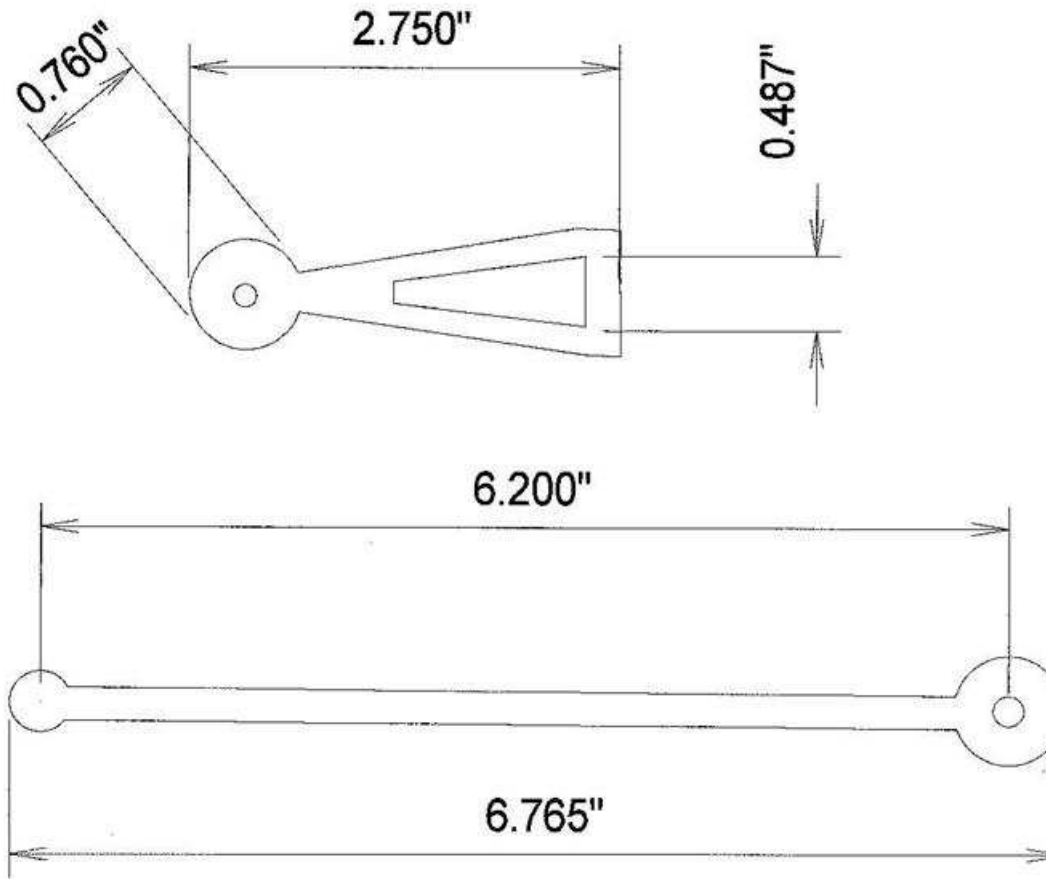
E. Howard Street Clock Assemblies
Crutch

1/4" brass

**Also made crutch and blank for crutch
adjustment on CNC mill**

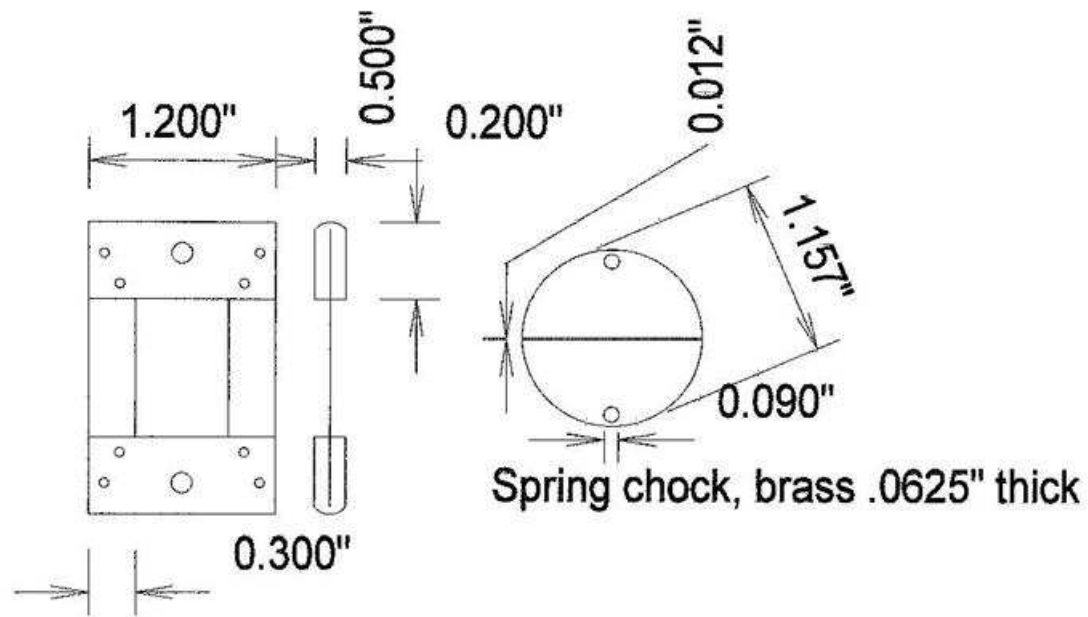
E Howard Suspension spring
Brass end blocks, .015" steel
spring

Suspension spring and chock needed to be made, pretty much a hand process that takes more time than one might think

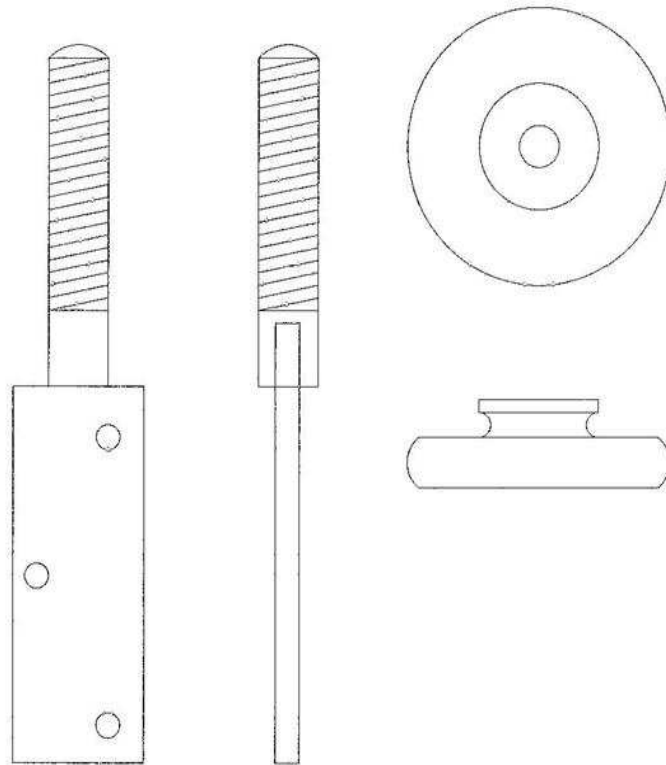
E Howard Pendulum Spur & Rating nut
thread .375X20. Steel .200" thick, weld
on threaded rod

Rating nut cast iron, drill & tap
as required, paint black

No CNC for this, all lathe work and hand assembly

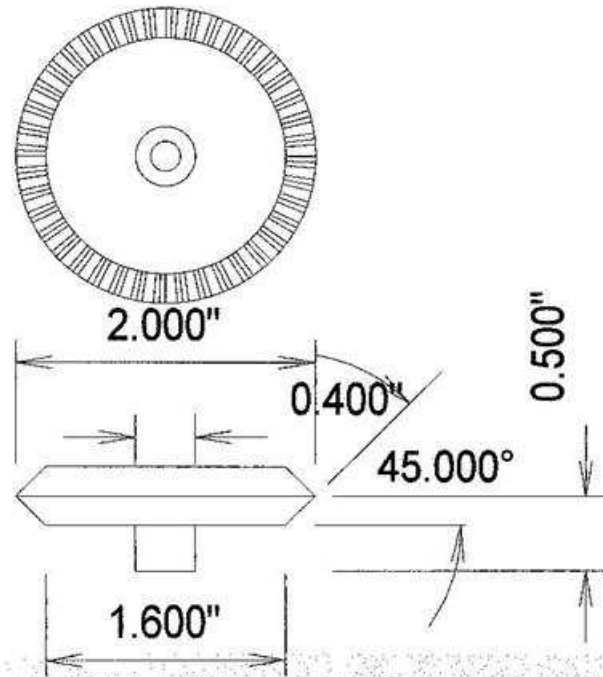
E Howard Street Clock
top drive unit, bevel gear
take off. make 2 per movement
brass, 60 teeth

Rough details of bevel gears used in these clocks

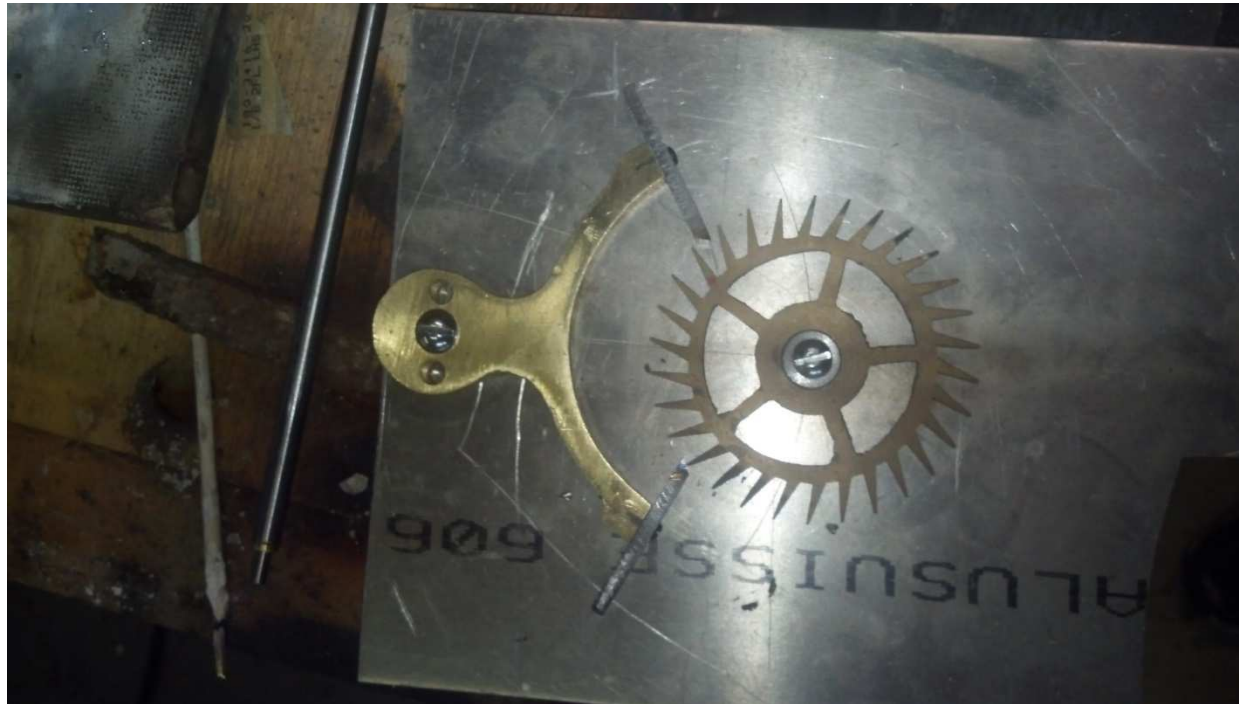
Testing of depthing, required making sliding depthing tool to properly fit. .010" between escaping and not escaping.....

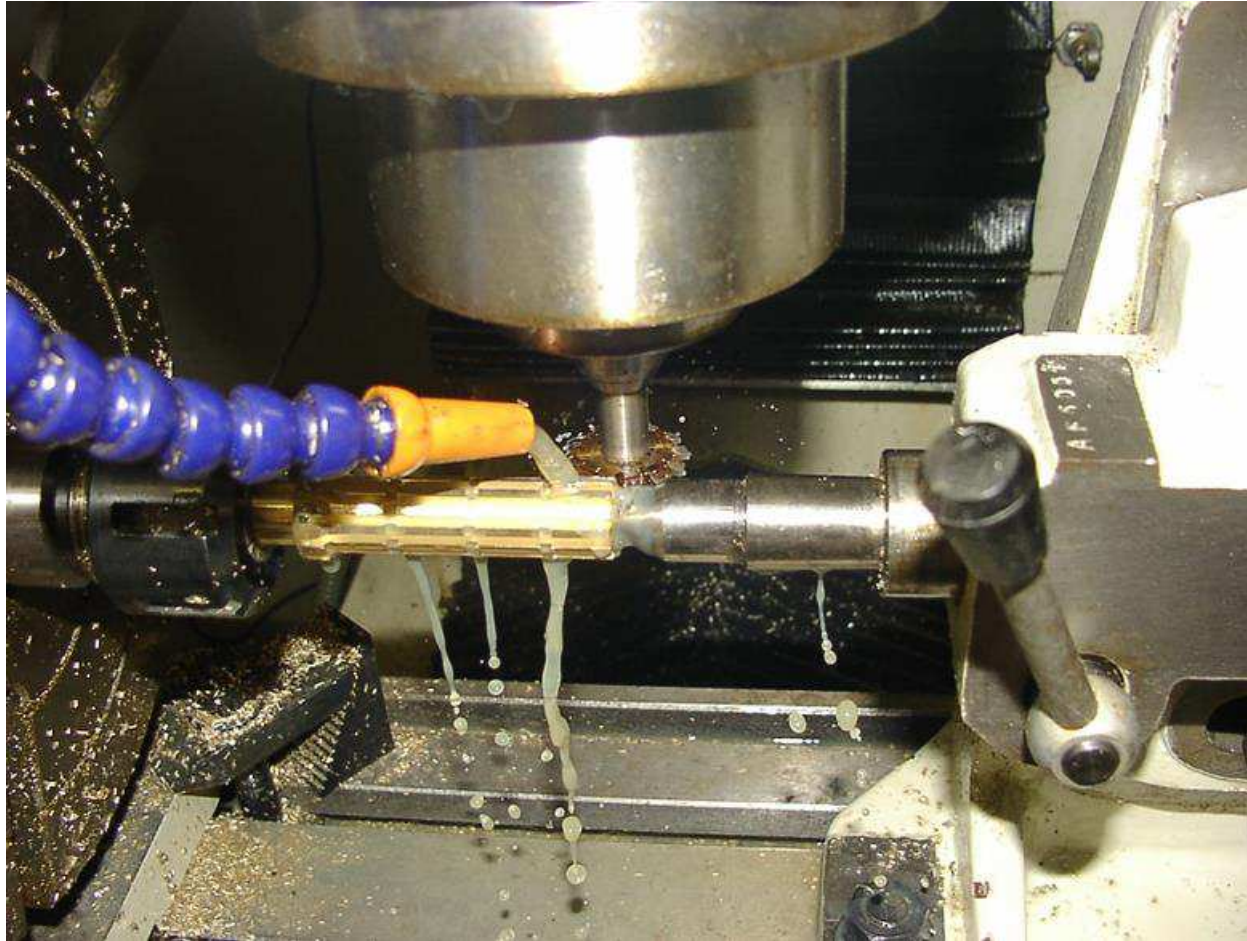
Cutting multiple pinion gears

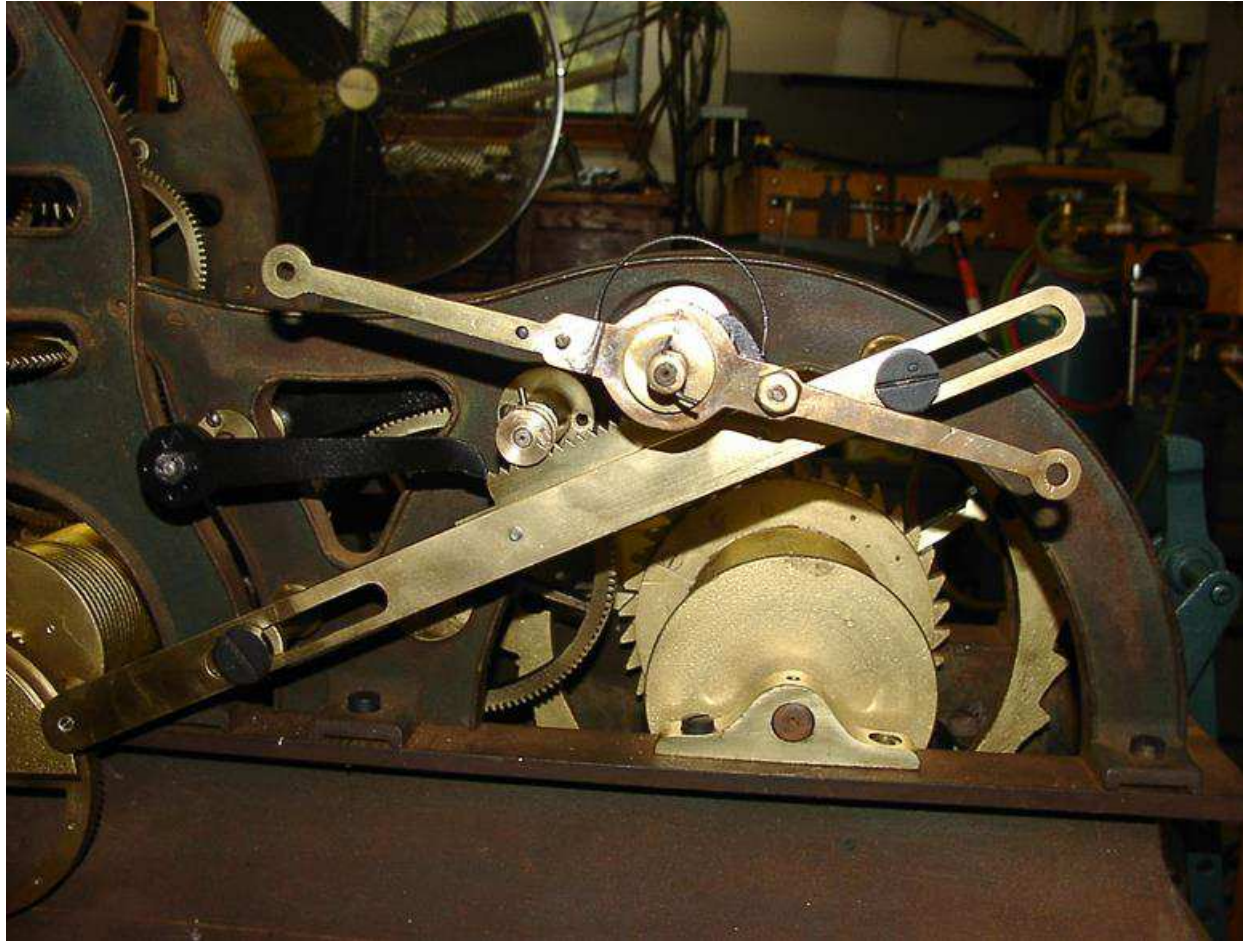
Fan arm details as well as sliding rack frame

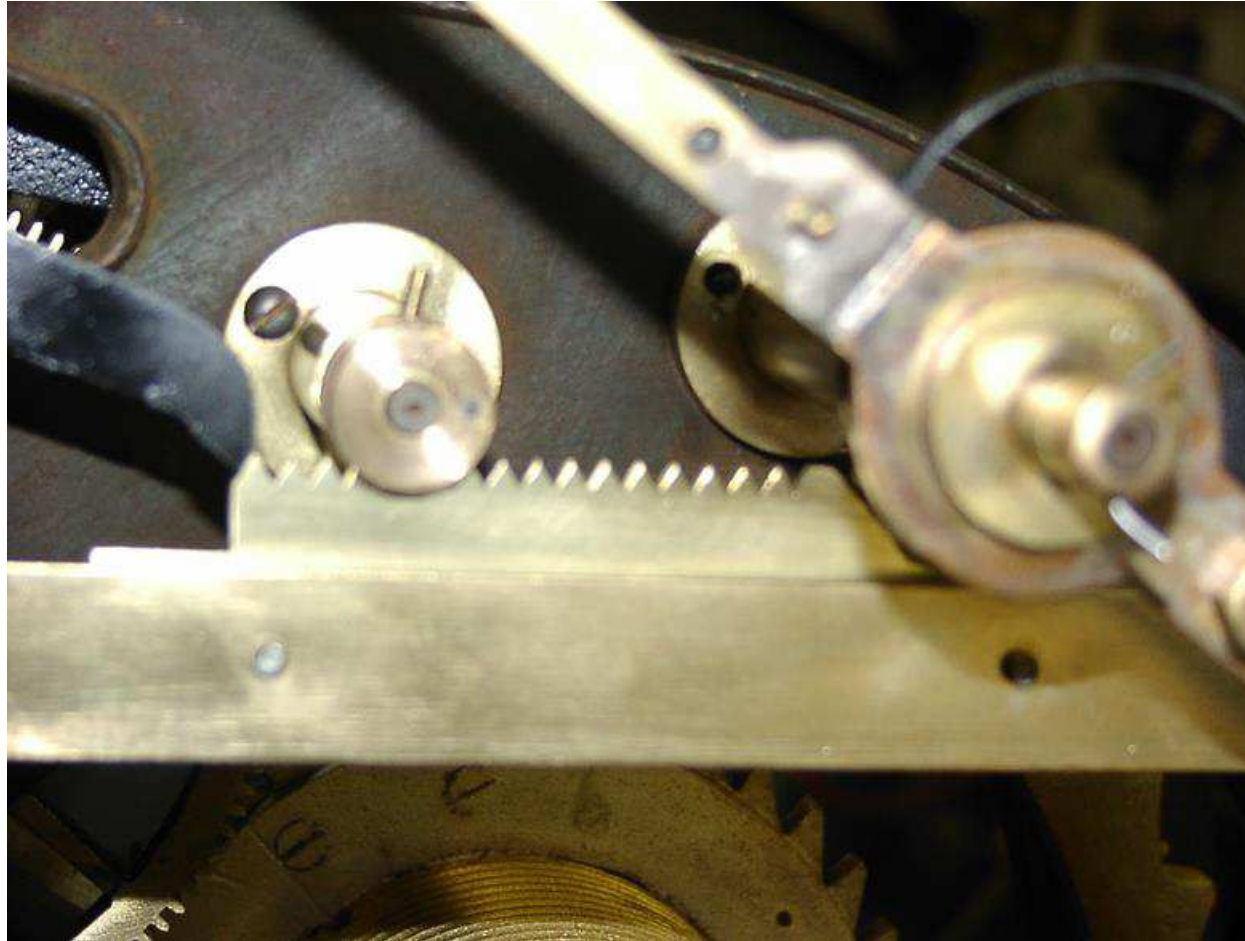
Make rack and rack bracket

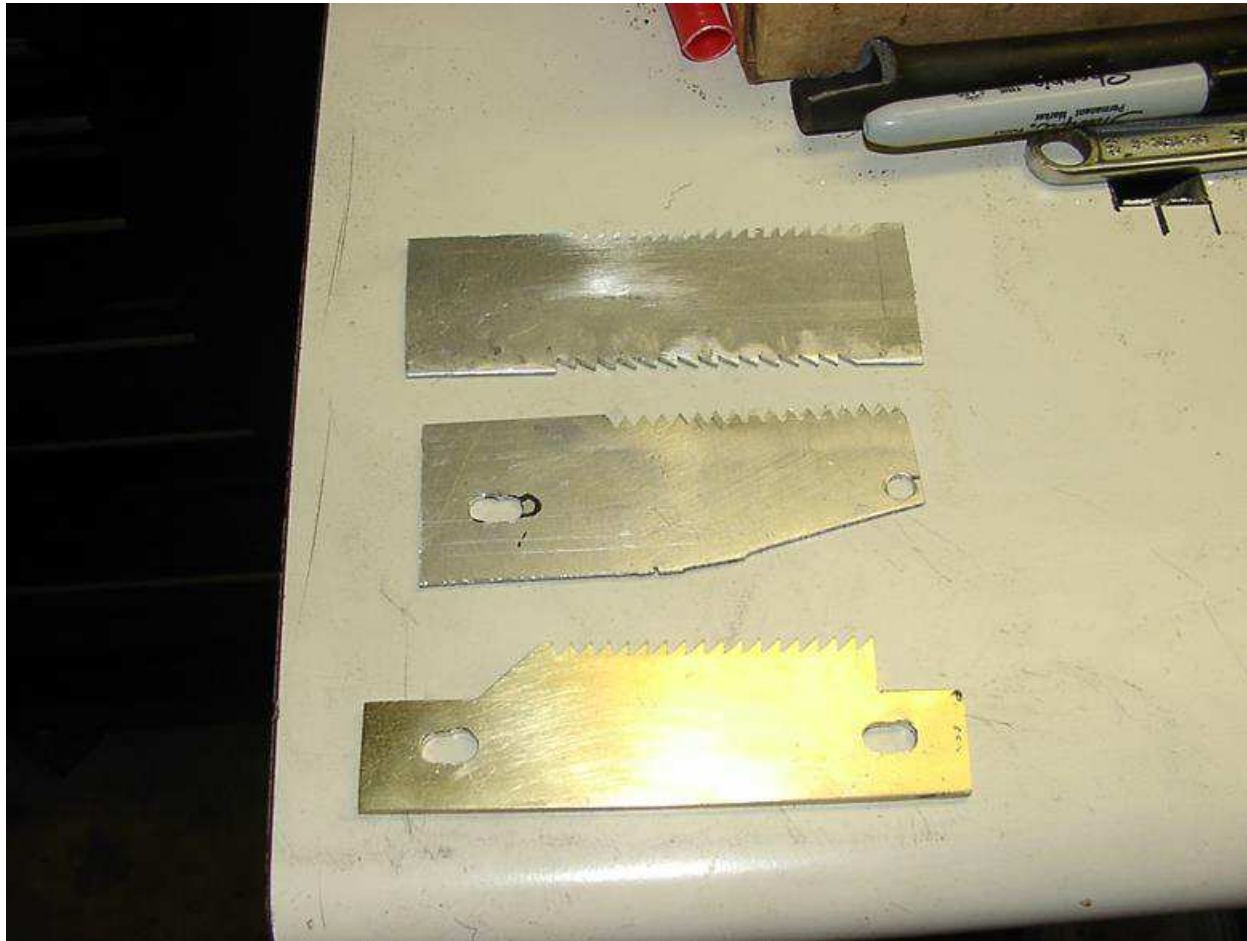
**Test racks to test
measurements and
function (they didn't)**

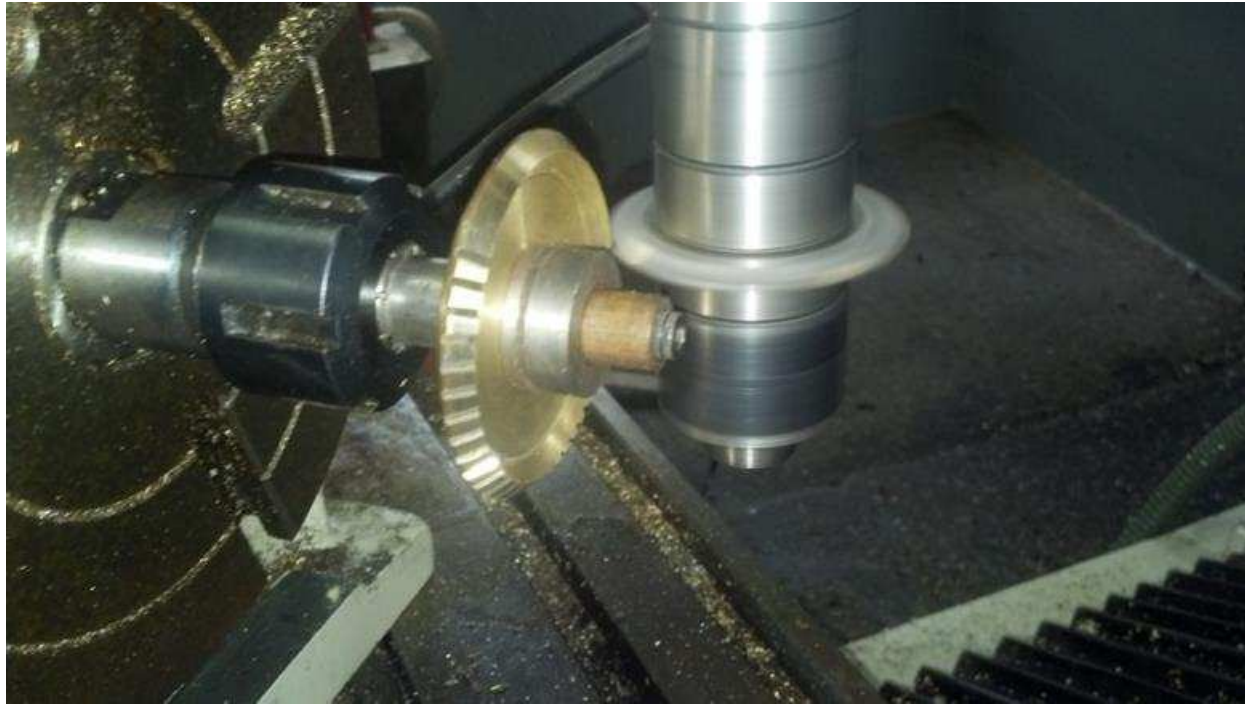
**CNC milling of
bevel gears**

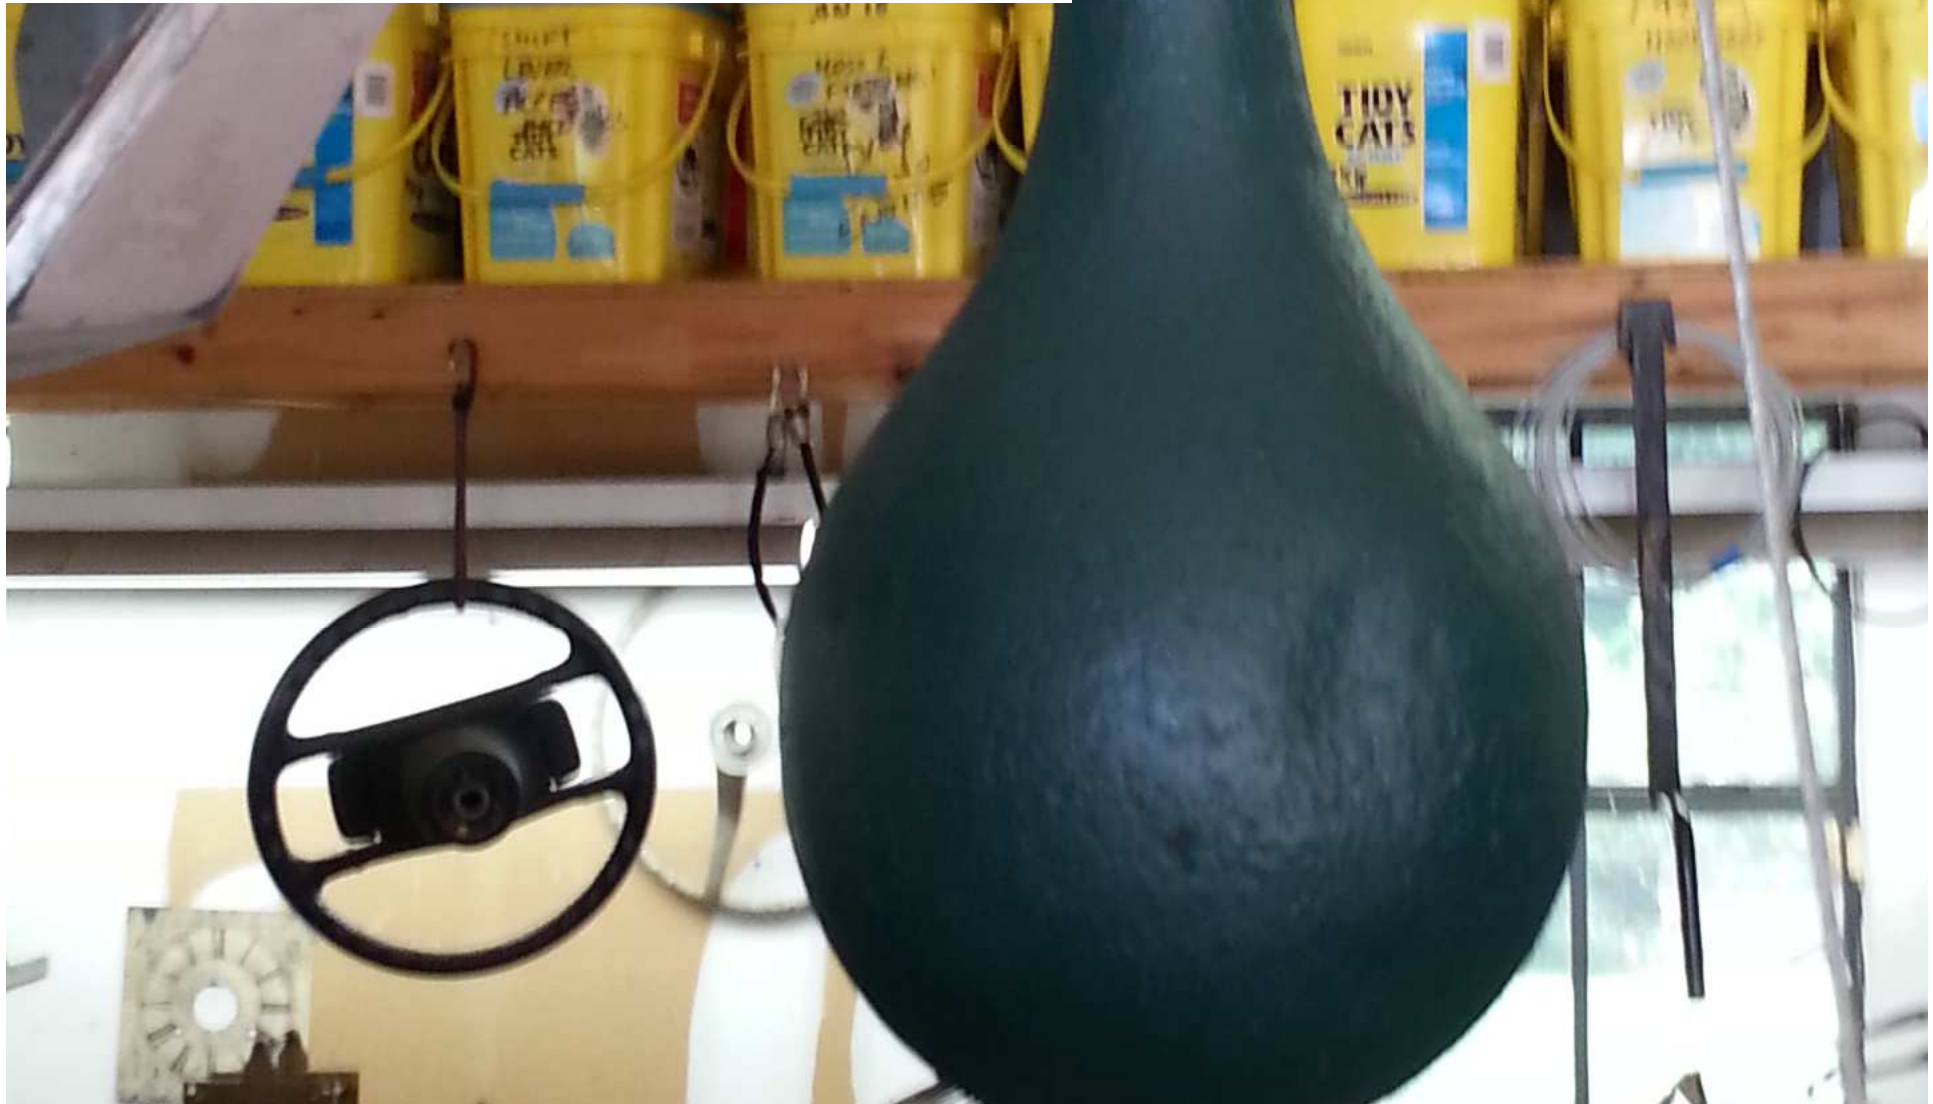
Drive weight for time side, originally cast as pendulum bob for very large E Howard tower clock but also used as the time side drive weight.....

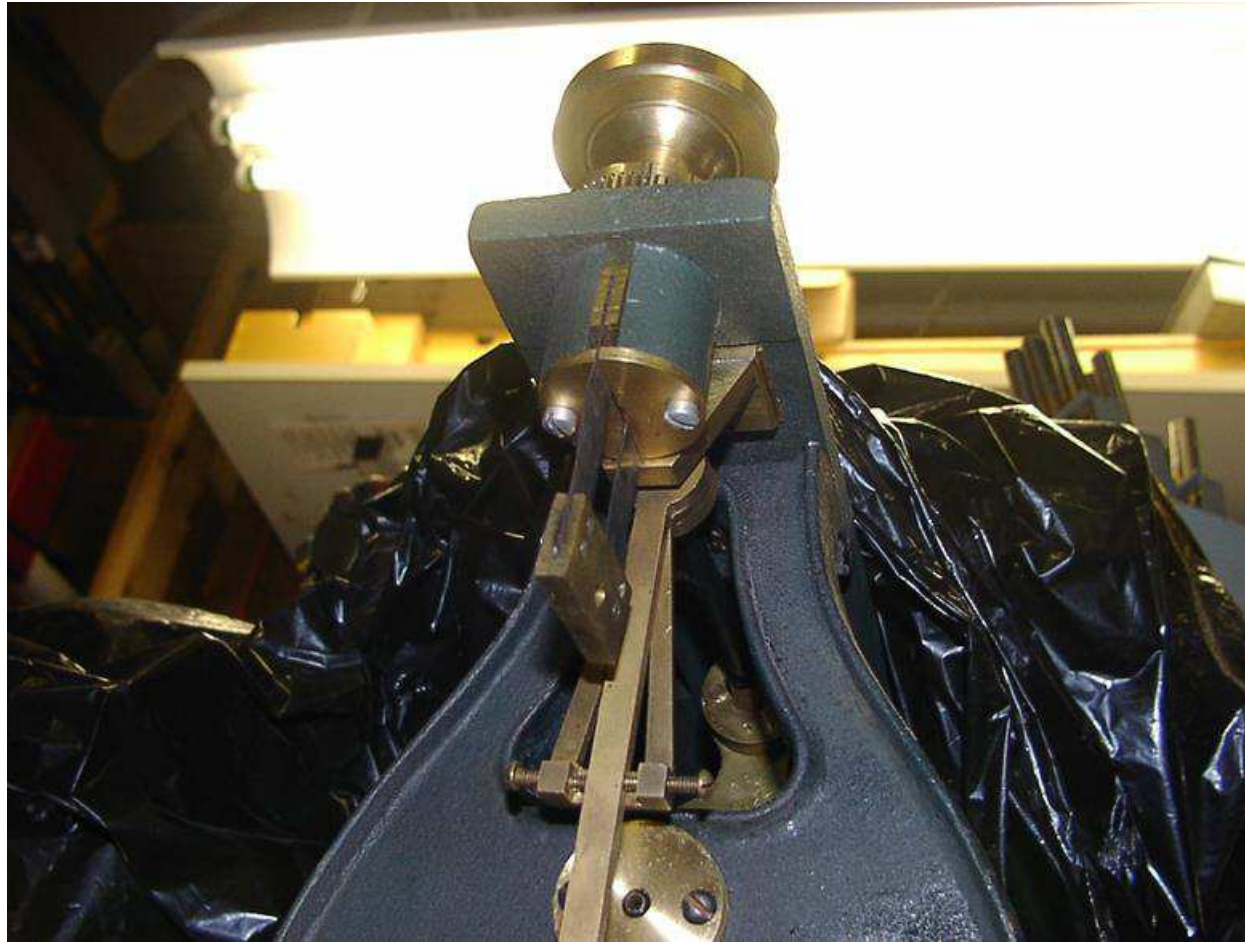
Make suspension spring, cheeks, regulator nut, and mechanism

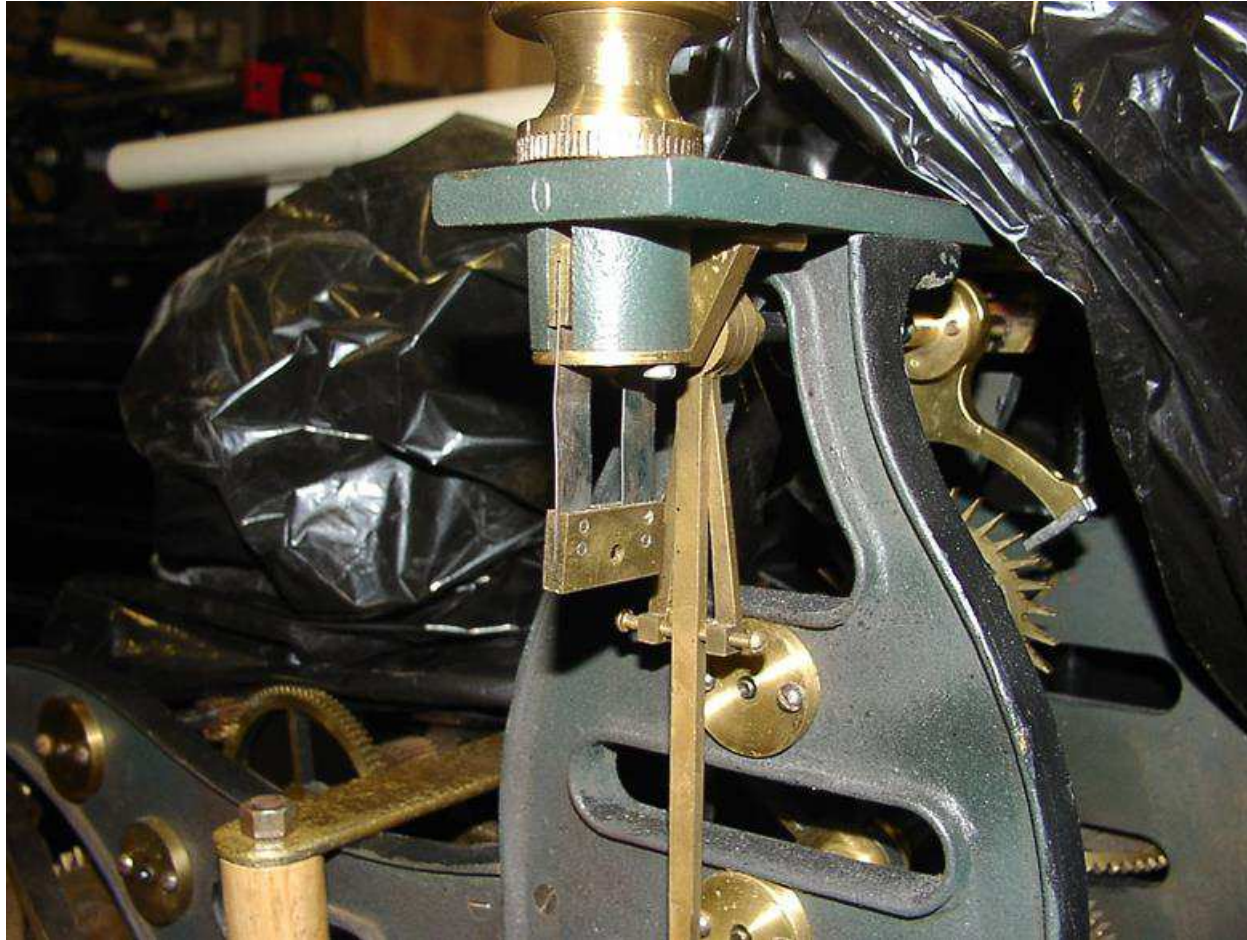
Make verge, crutch, verge adjustable assembly

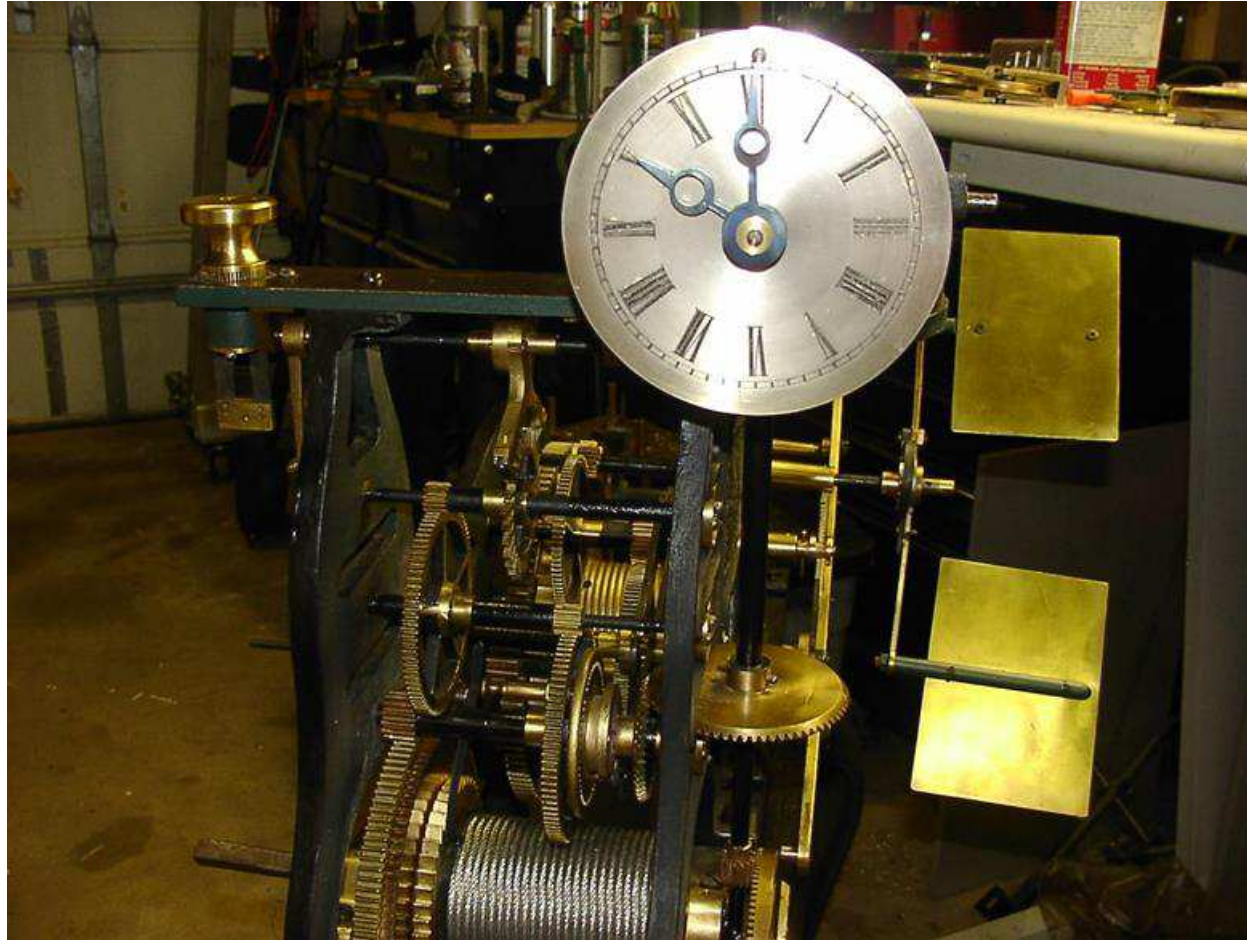
Make dial, hands, motion works, support bracket as well as fan blades and arm for fan

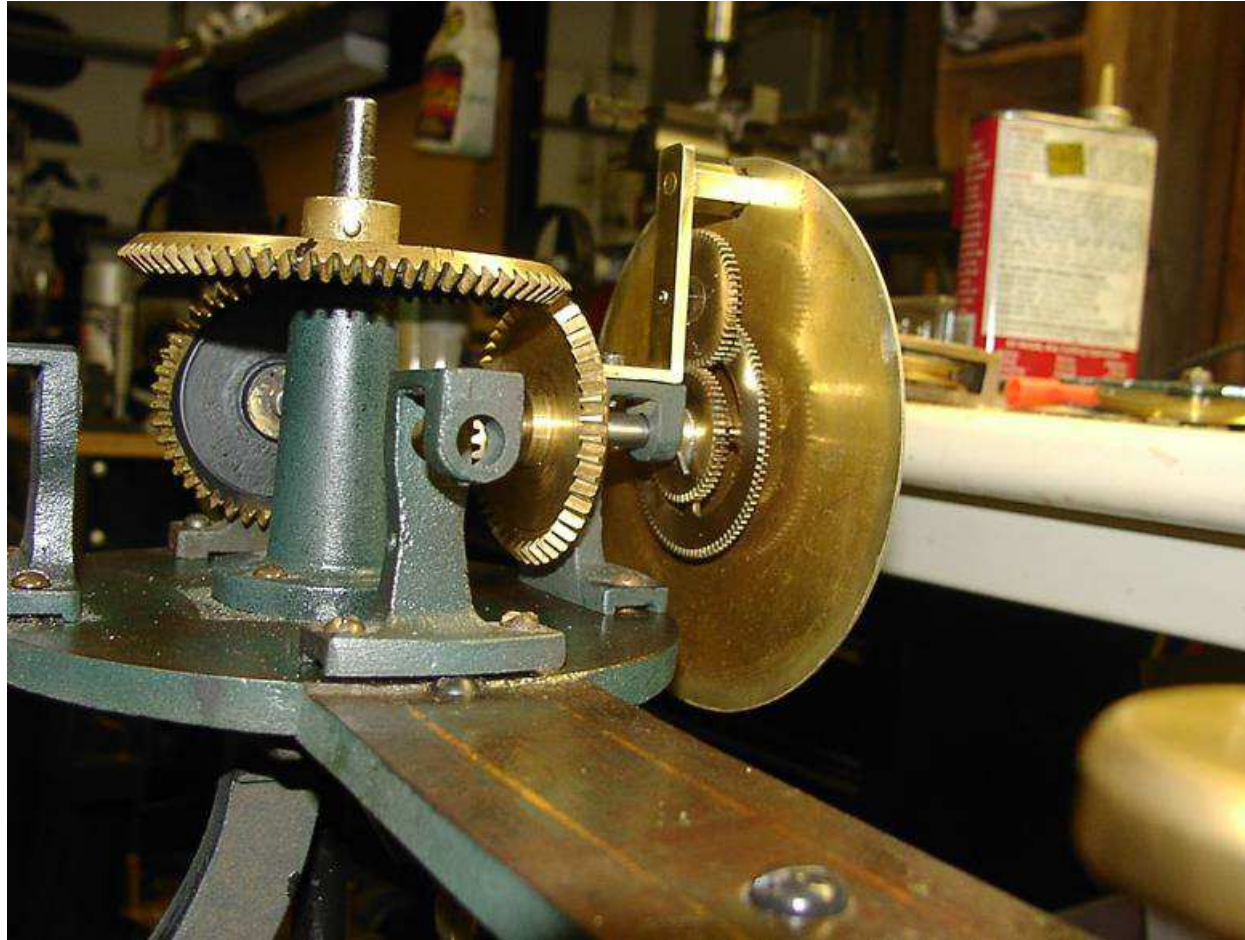
**Motion work and drive (bevel) gear,
backside of dial also made for this clock**
