E Howard Tower Clock Renovation

Today's Discussion

The subject of this monograph is the smallest sized E Howard time and strike tower clock made. A local collector/dealer purchased it at the 2012 NAWCC Texas regional in Houston. It changed hands to a second party and 3 months later found its way to my shop. The owner asked

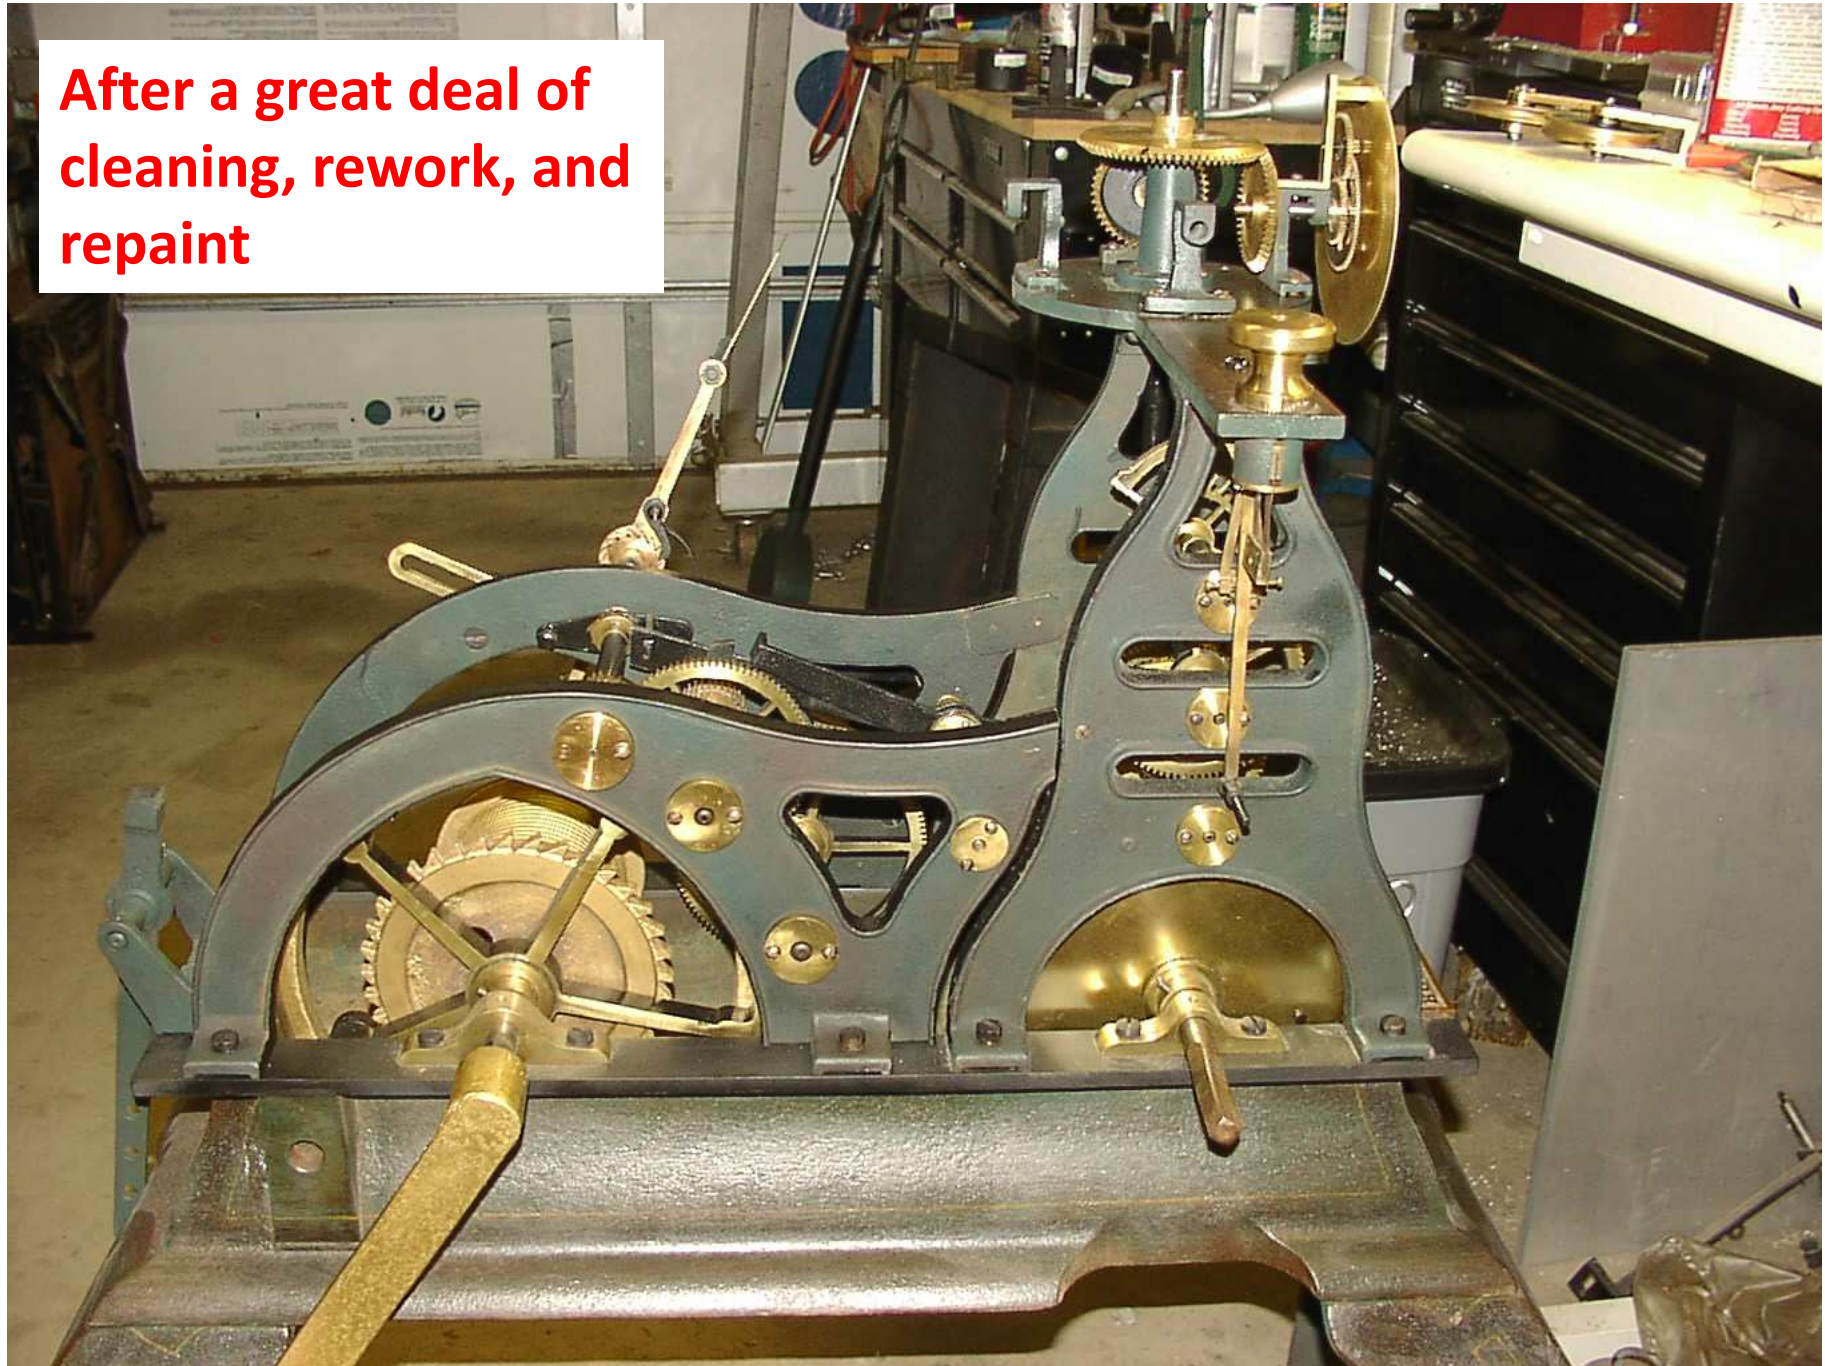
After a great deal of cleaning, rework, and repaint

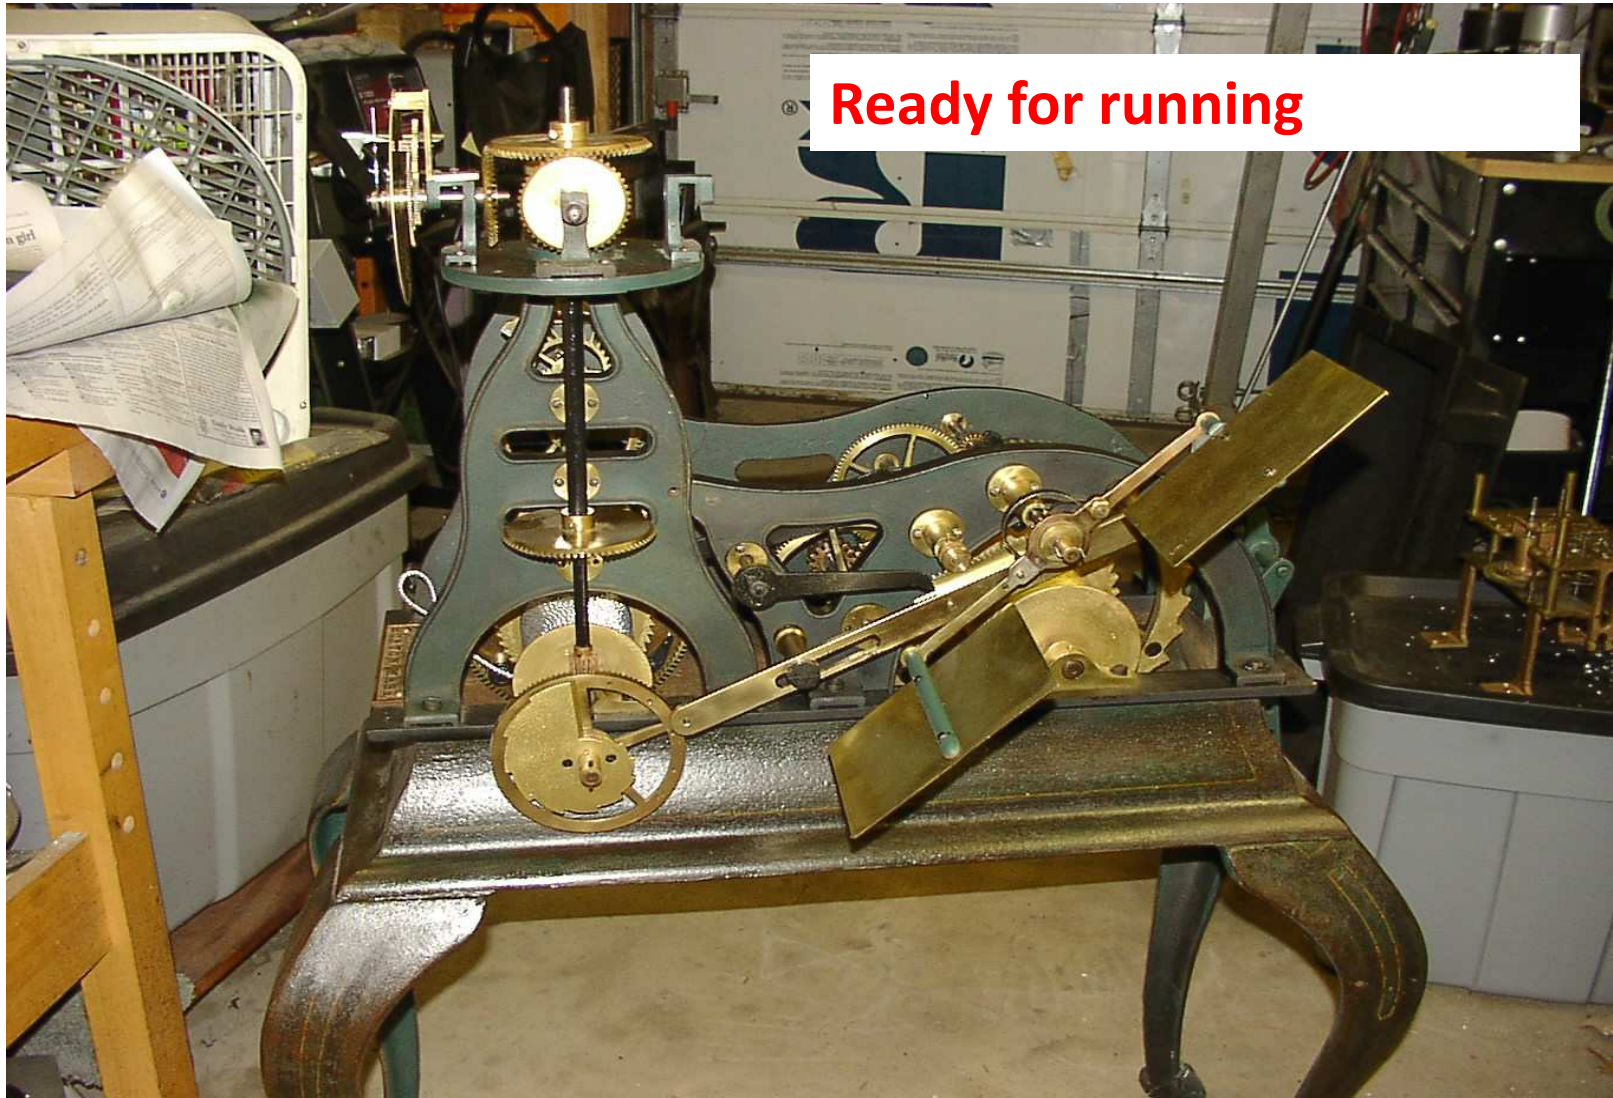
Ready for running
