Restoration of a Flood-Damaged Pocket Watch

Shaun Clarke

NAWCC San Jacinto Chapter 139

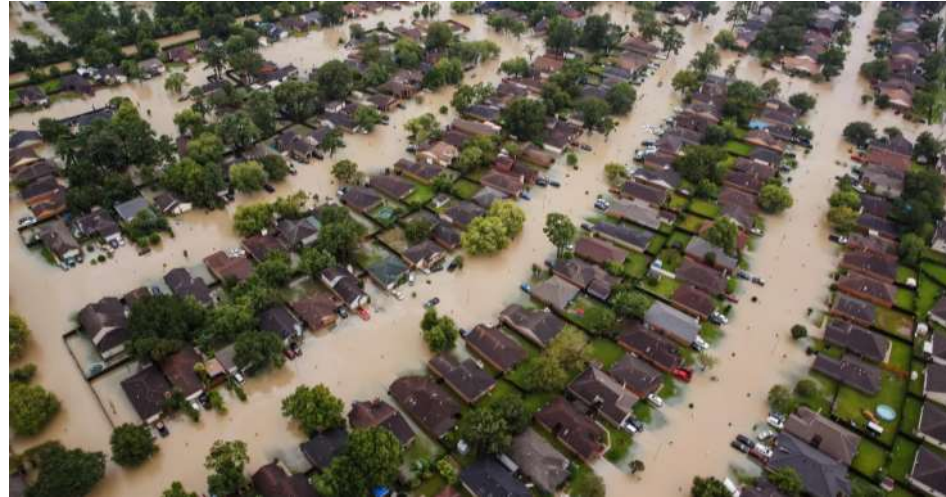
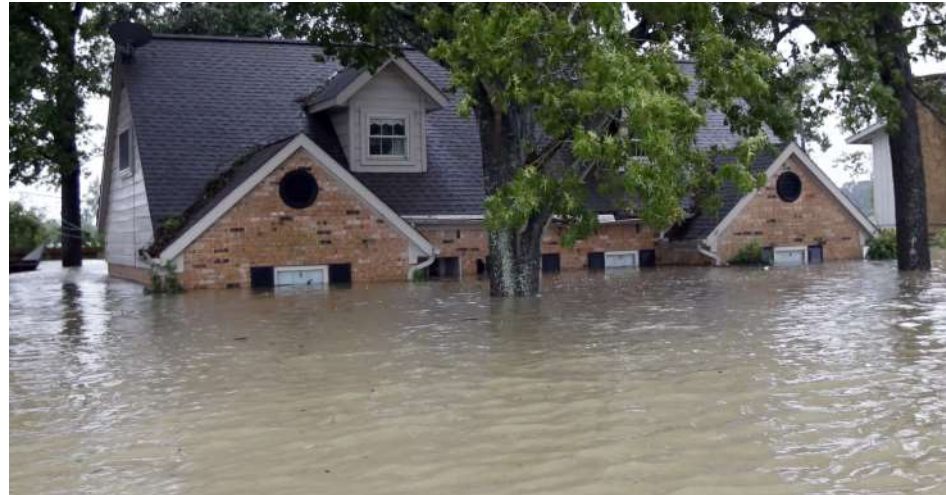
- In August 2017, residents of Houston, TX were inundated with Category 4 Hurricane Harvey
- The storm dumped trillions of gallons of water, causing over US\$125 billion in damages
- Floodwaters caused damage to over 200,000 homes
- This is the story of complete restoration of a flood damaged Omega pocket watch

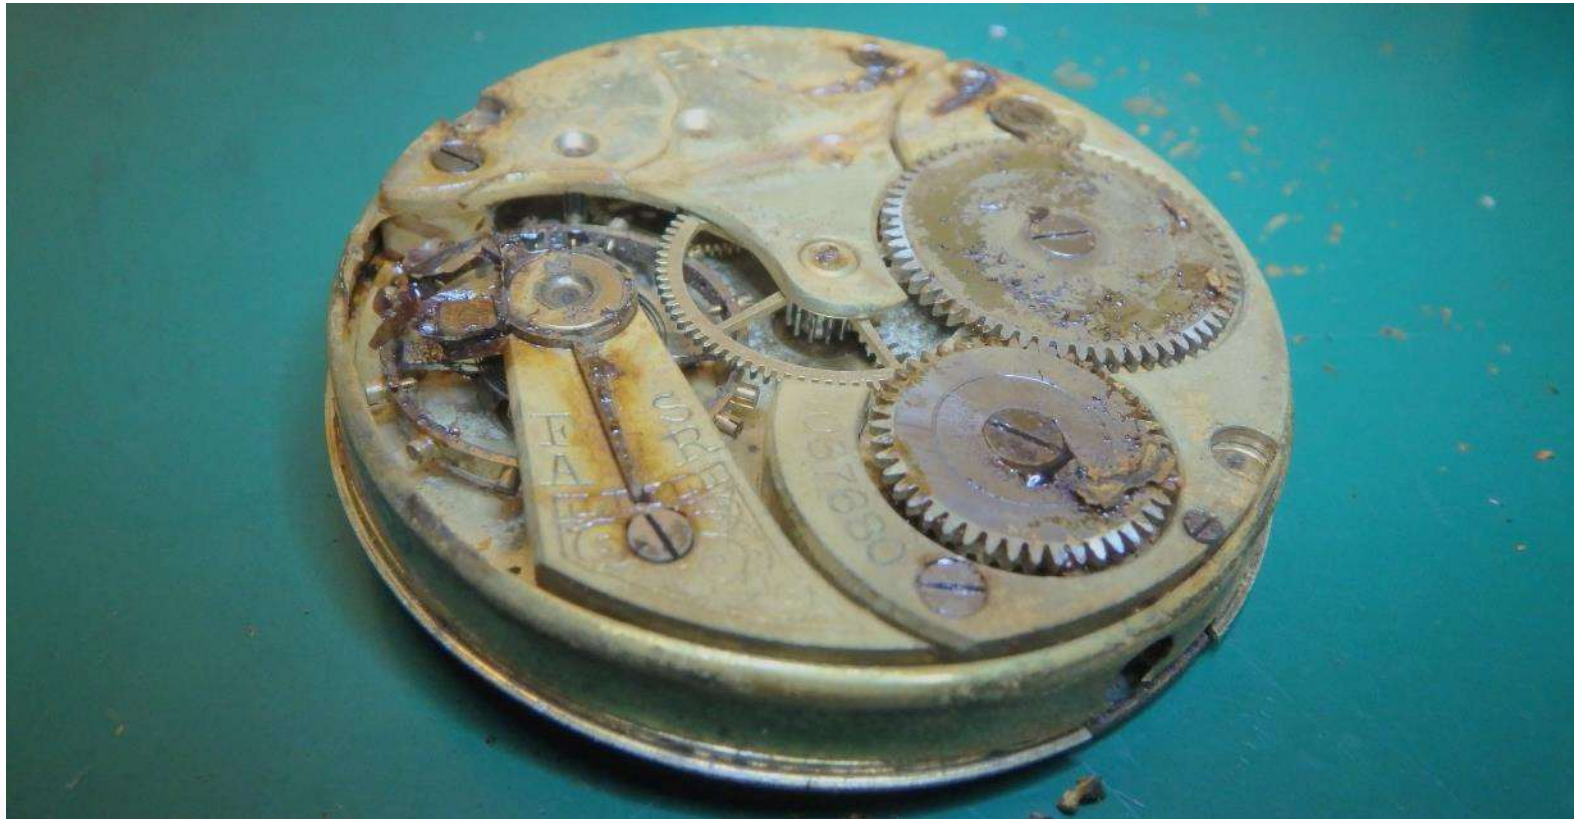
- With restoration of any sentimental piece, it is important to consult with the owner in order to understand their expectations.
- The owner had expressed a desire to have the watch mechanically and cosmetically restored.

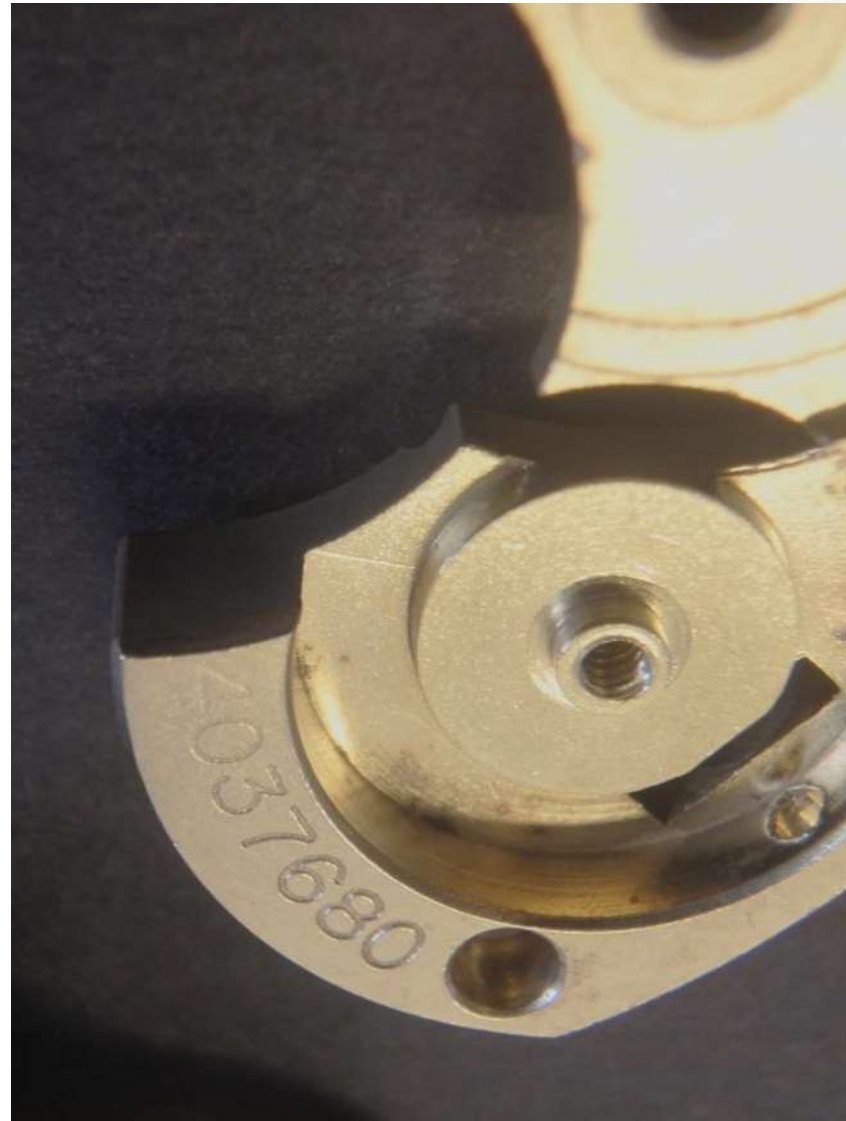
Movement Identification

- The movement number is **4037680** and factory records indicate a manufacture date of approximately 1912
- The movement is 15 jewel, open face, pendent wind/set and gilt finish
- Online investigation determined it is an Omega 19LB movement.
- Searching found a donor in London, England. This partial movement was ordered in November and proved to be a good match. The balance staff and hairspring were found to be in good condition.

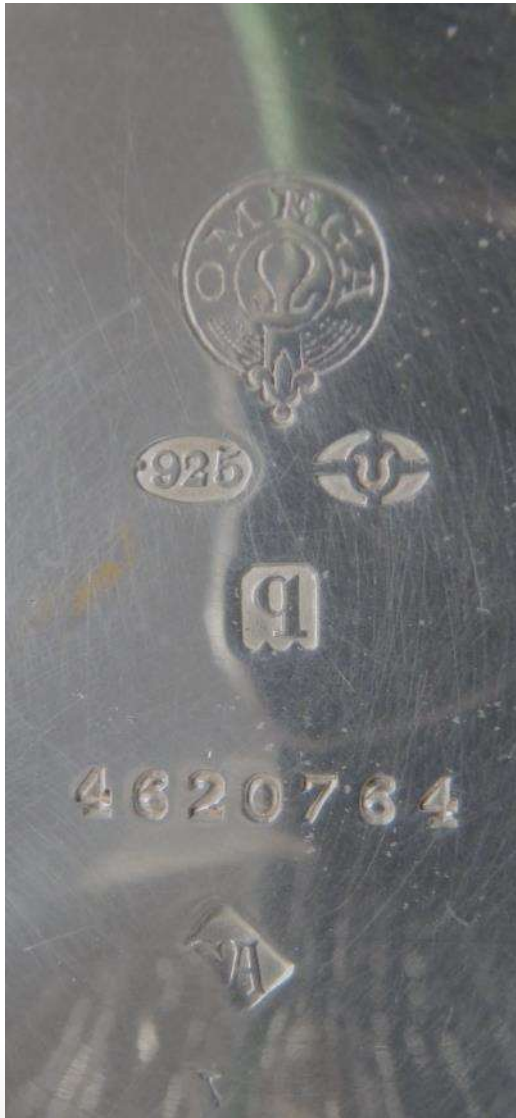
Case Identification

- The case is number **4620784** and hallmarks indicate it was imported to London:
 - The standard mark showing the fineness of the metal as .925 for sterling silver.
 - The town mark showing where the article was assayed and hallmarked, in this case the zodiac sign of Leo used by the London Assay Office on imported items.
 - A date letter showing when it was hallmarked, in this case the "q" of 1911.
 - A sponsor's mark showing who submitted the article for hallmarking, in this case the initials "SA" in a diamond, the registered mark of "Selling Agency" (1910-1919), Watch Importers of London.
