What It Takes To Repair A Small Ansonia Carriage Alarm Clock

Why Did You Have My Clock So Long?

Ansonia (Astral) Novelty Carriage Alarm

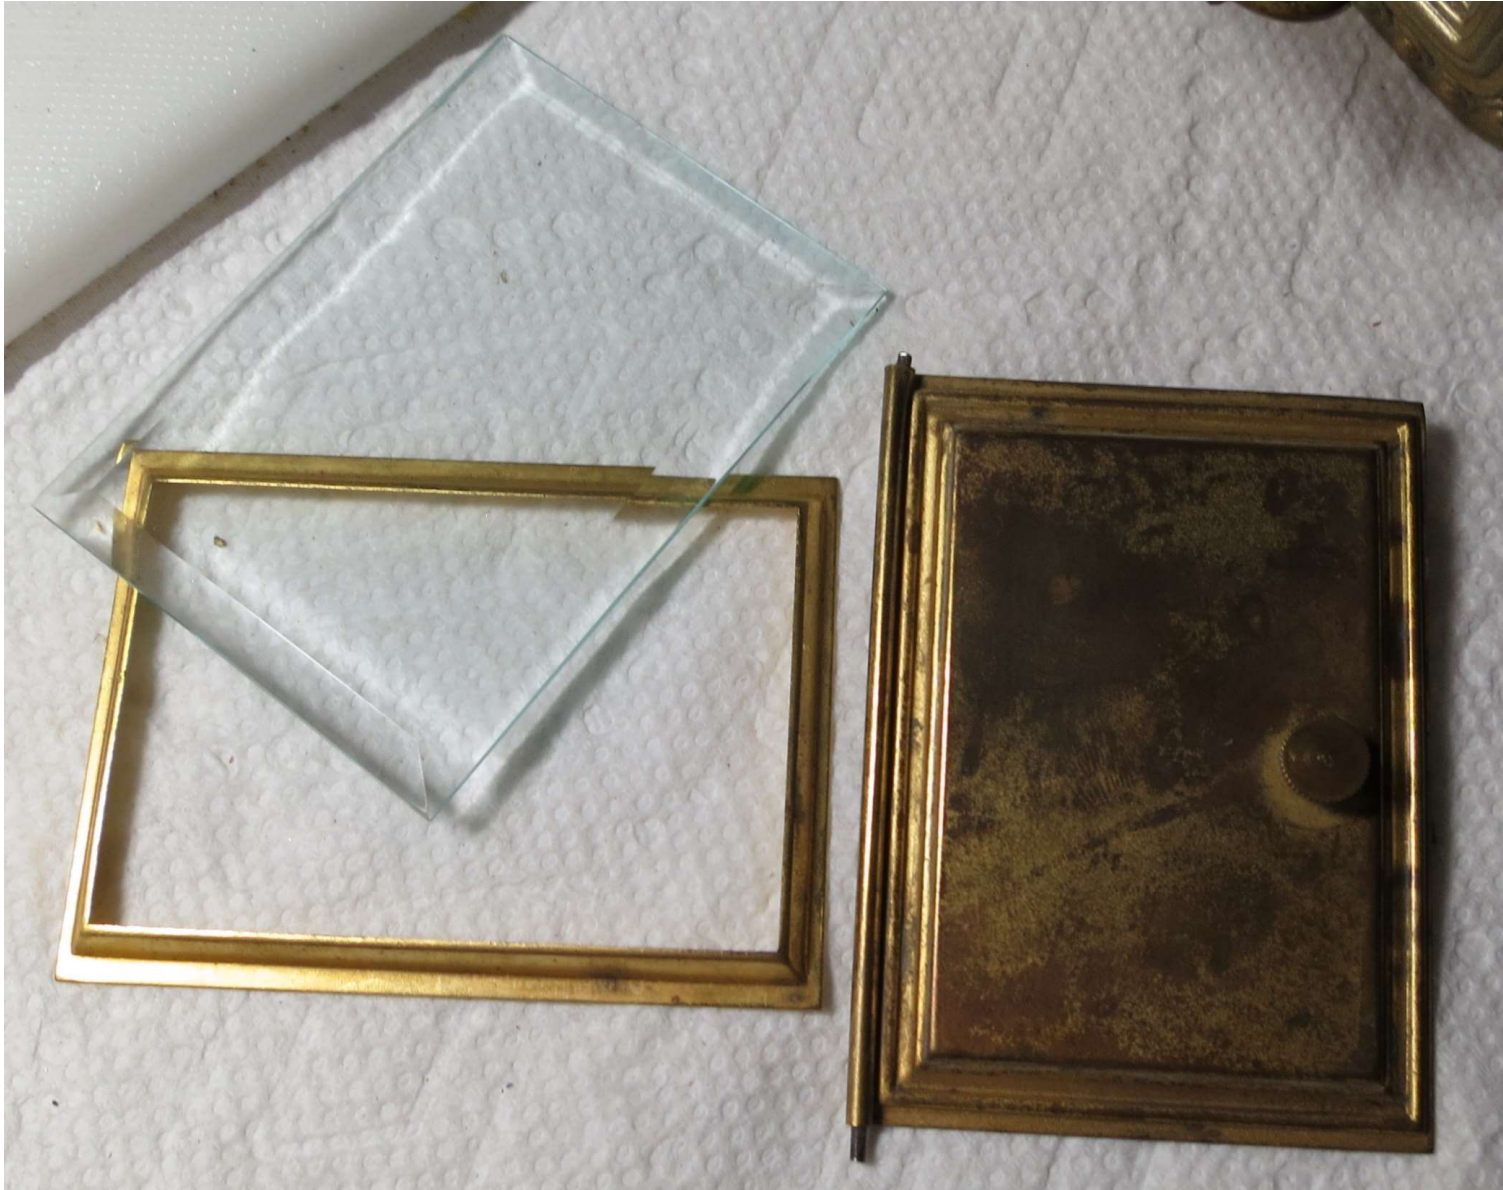
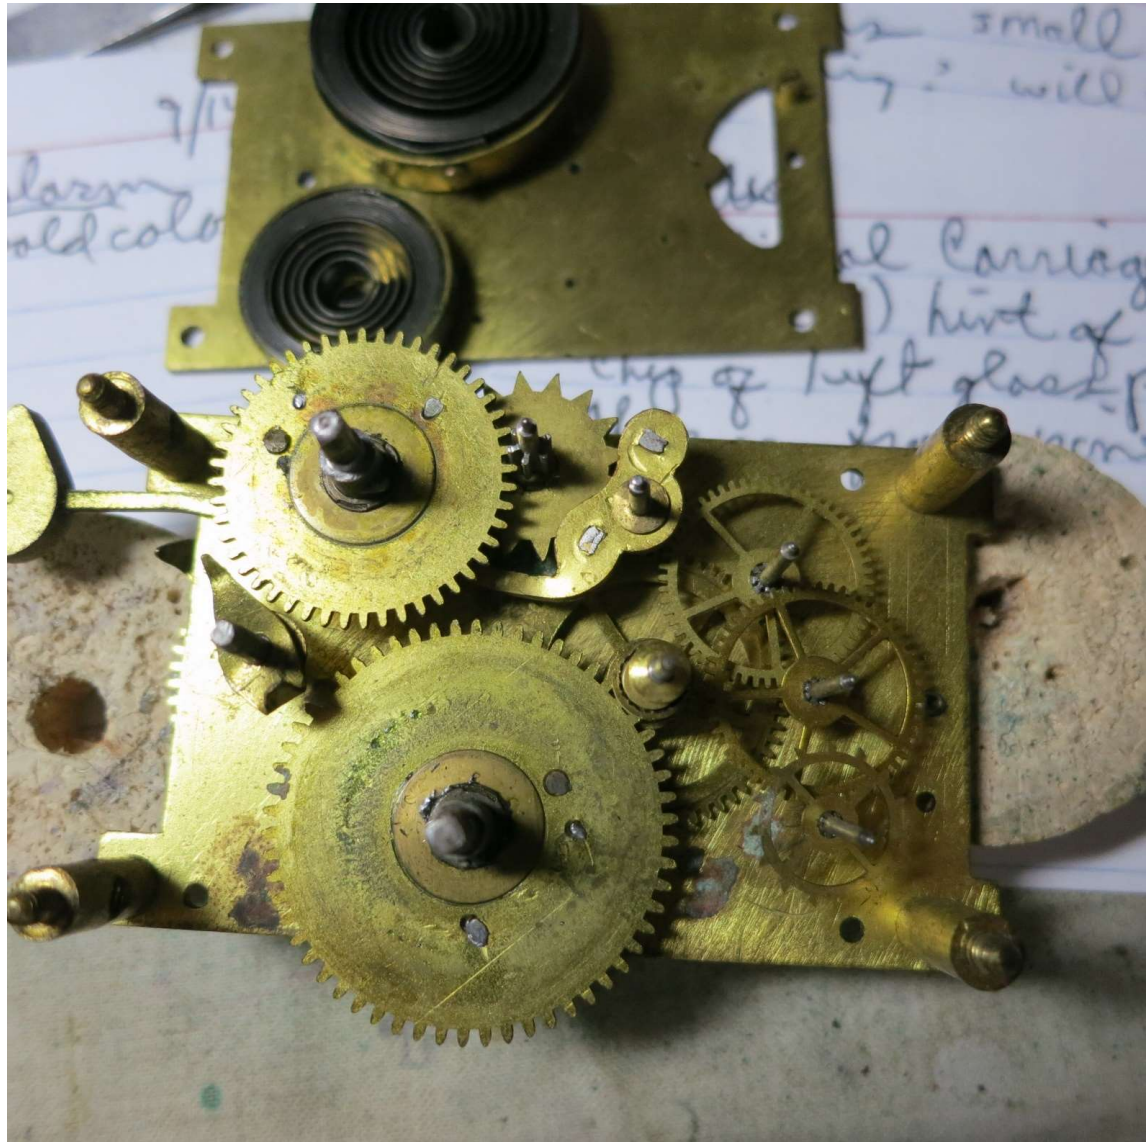
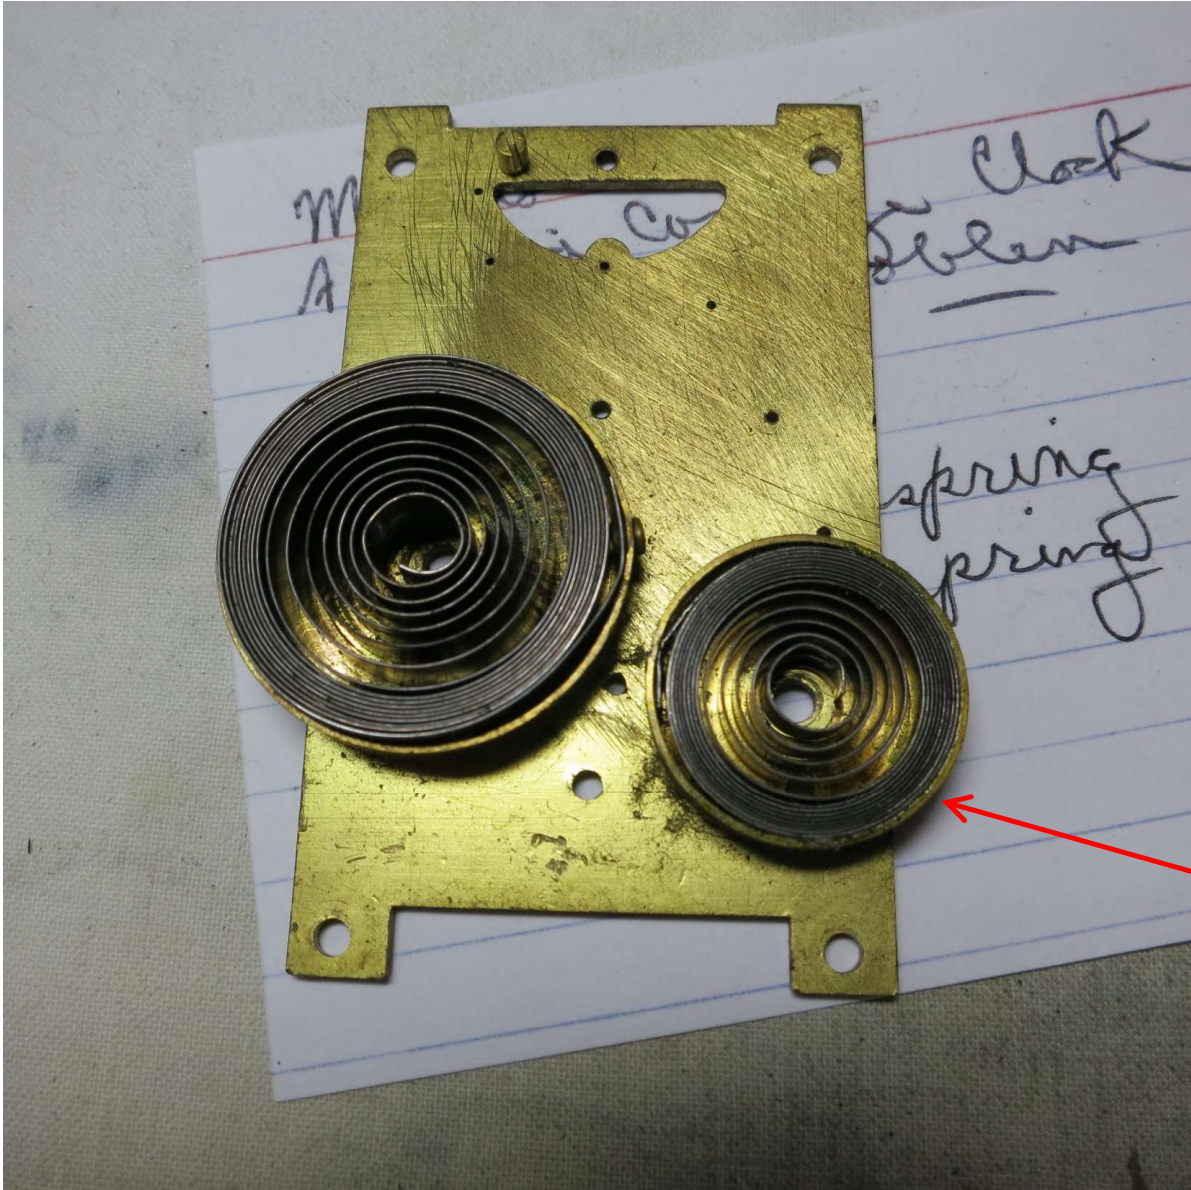
M
A

Co

clock
plate

spring
spring

replaced

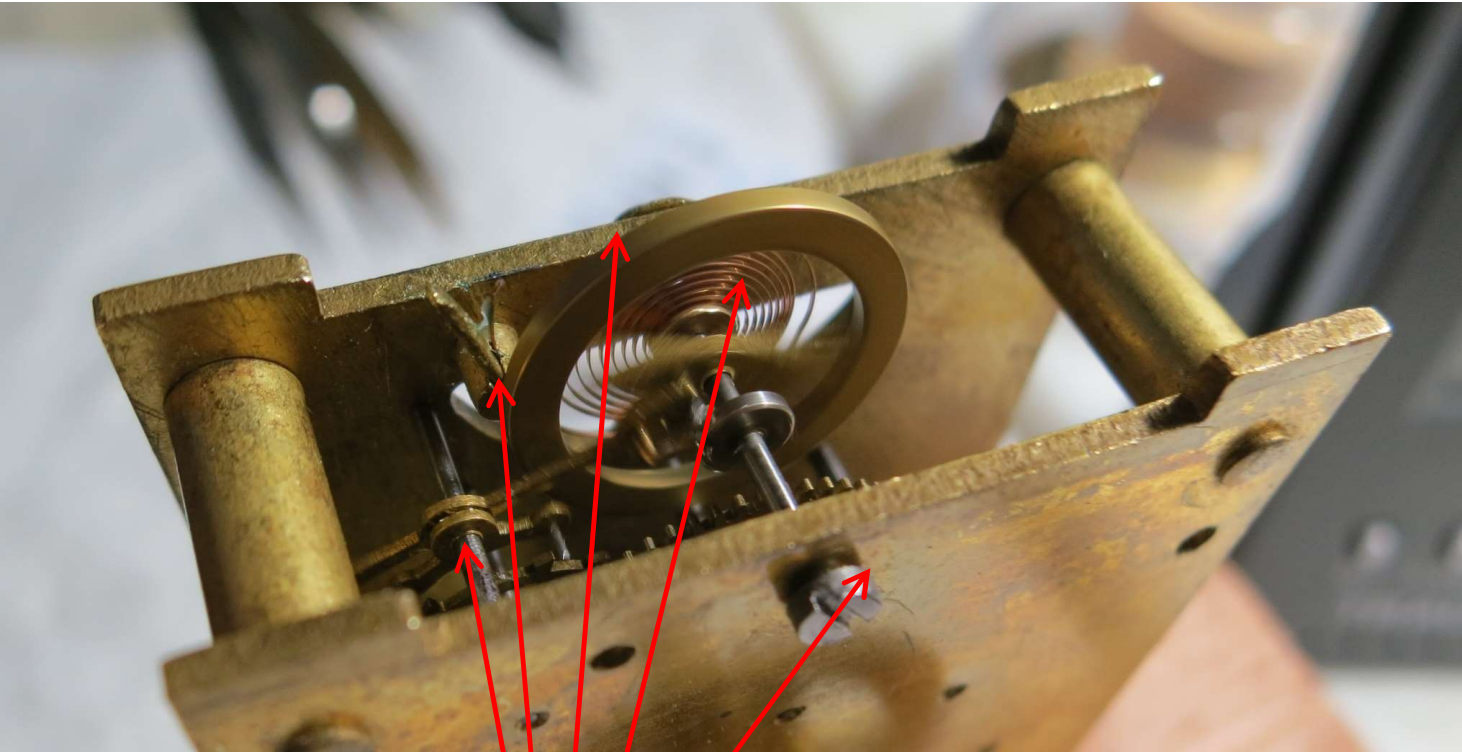
Balance problems

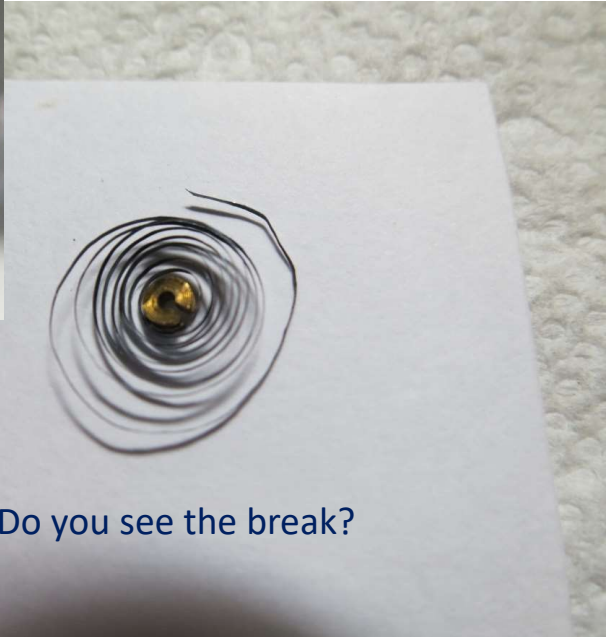
Do you see the break?

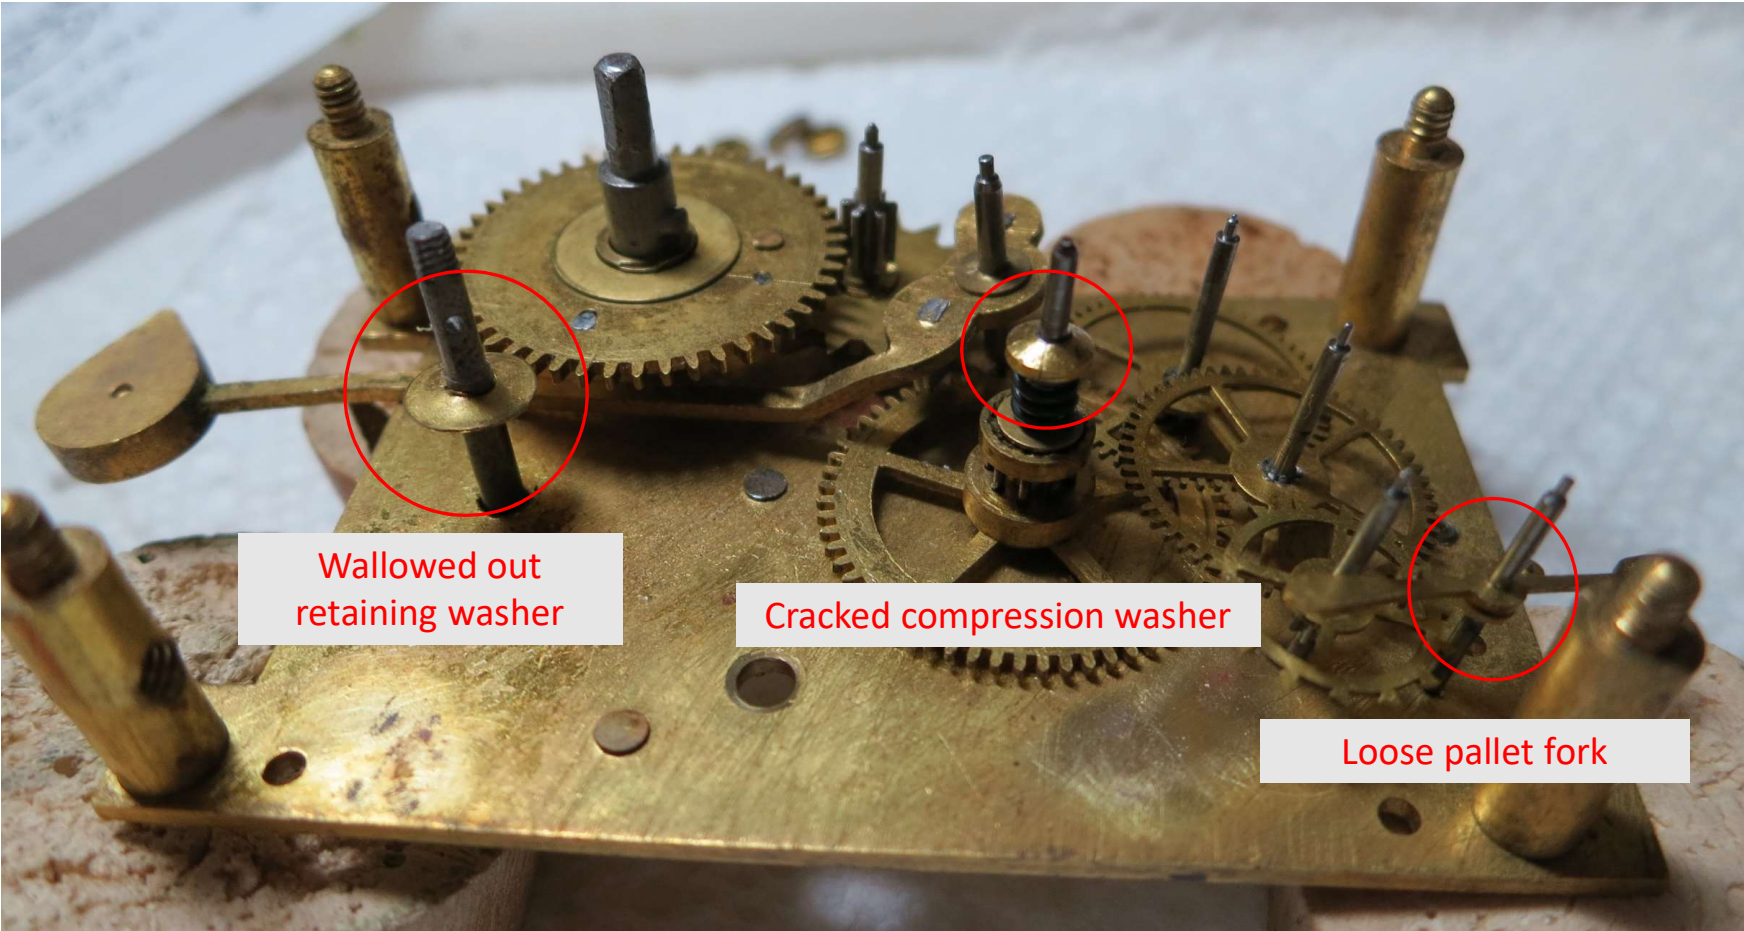
Some Problem Areas

Wallowed out retaining washer

Cracked compression washer

Loose pallet fork

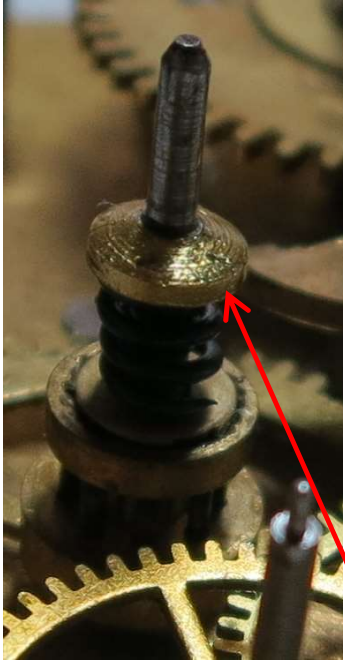
Second wheel compression washer
Result = erratic, slow or no hand movement

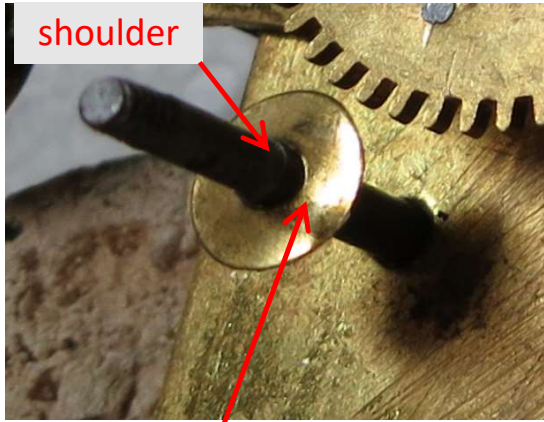
shoulder

Damaged retaining washer on alarm setting arbor

Replaced
(be aware of thickness)

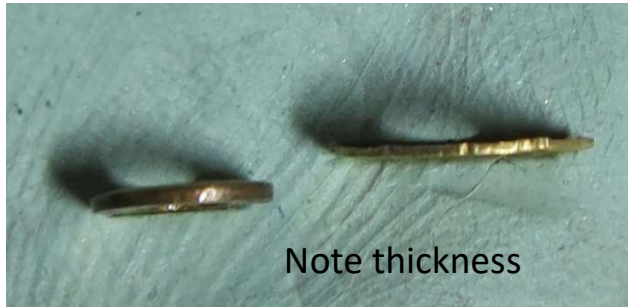
Note thickness

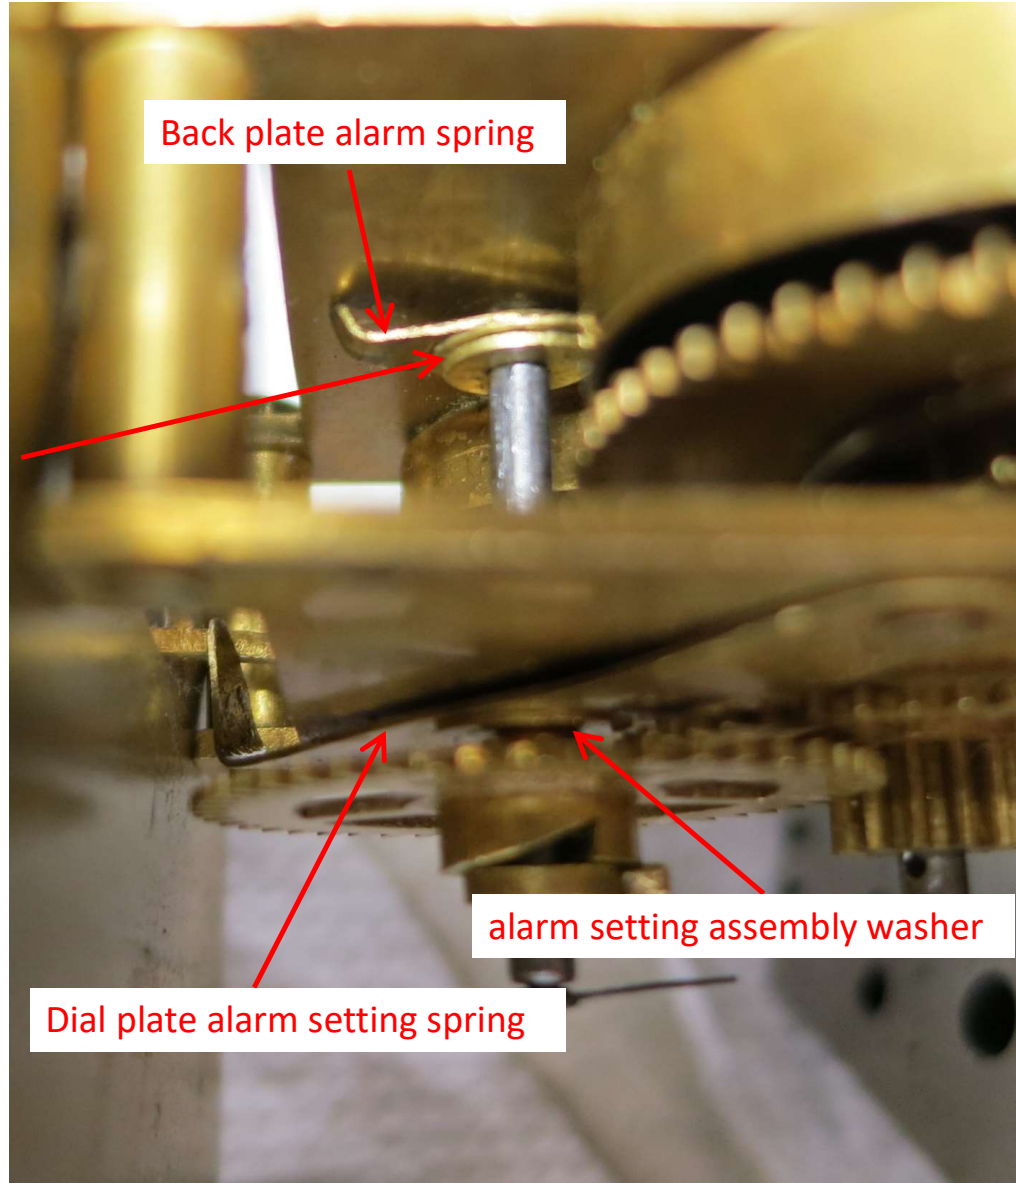
Back plate alarm spring

alarm setting assembly washer

Dial plate alarm setting spring

Back plate spring must provide greater friction on components than that of the dial plate alarm spring or the alarm setting will move with time train
